**NORTHERN CORRIDOR TRANSIT AND  
TRANSPORT COORDINATION AUTHORITY**

# **REPORT ON BLACK SPOTS SURVEY** ALONG THE NORTHERN CORRIDOR ROUTES IN RWANDA AND UGANDA

**February 2020**

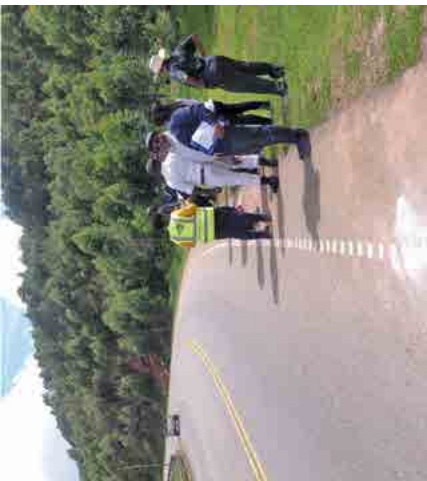
| S/N | Name of the Spot | Chain-age (Km) | Survey Observations and Findings | Analysis/Diagnosis | Suggested Recommendation for improvement |
|---|---|---|---|---|---|
| 2. | <b>Kabaraga (67Km to Ntungamo)</b> <p><i>Sharp curve likely to lead to loss of control for descending motorists</i></p> | | <ul style="list-style-type: none"> <li>Sharp horizontal curve on a descent towards Kabale town. A section of the road has an island separating the directions of traffic</li> <li>Base deformation/heaving due to soil subsidence on some sections of the left lane from Kabale to Ntungamo</li> <li>Missing road signs</li> <li>Missing reflective studs on the inner side of the guard rails</li> <li>Missing chevrons/directional arrow signs at the sharp curves, damaged bollards on the traffic islands separating directions of traffic</li> <li>Risky culvert inlet ditch</li> <li>Missing speed limit signs</li> </ul> | <ul style="list-style-type: none"> <li>Single fatal accidents due to veering of over speeding vehicles.</li> <li>No warning signage i.e. sharp curve ahead, speed limit signs</li> <li>Vehicles/ drivers heading to Kabale fail to negotiate sharp curve/corner.</li> </ul> | <ul style="list-style-type: none"> <li>Separation of the two directions of traffic using kerbstone (traffic islands) to avoid head on collisions</li> <li>Speed calming measures be put in place i.e. Rumble strips/ humps to slow down descending traffic</li> <li>Installation of directional arrow signs/chevron signs to warn motorists on the sharp change of direction.</li> <li>Installation of speed limit, sharp curve ahead warning signage.</li> <li>Installation of reflective studs on the carriage way and on guard rails for reflectivity at night.</li> <li>Installation of speed cameras enforcement of speed limits (50kph) by Traffic Police.</li> <li>Installation of gantry road signs cautioning motorists against freewheeling and urging them to engage low gears on the descents</li> </ul> |

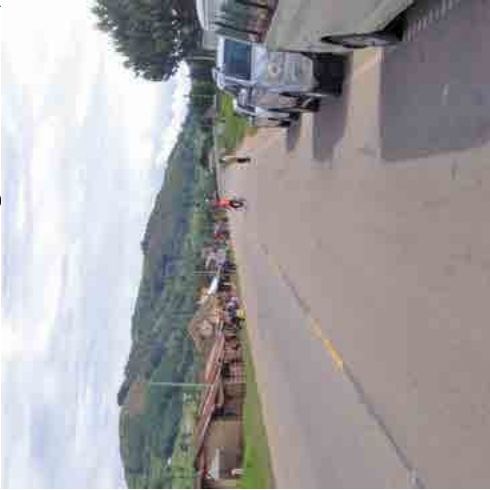
| S/N | Name of the Spot | Chain-age (Km) | Survey Observations and Findings | Analysis/Diagnosis | Suggested Recommendation for improvement |
|---|---|---|---|---|---|
| 3. | <b>Kakatunda (47Km to Ntungamo)</b> <p><i>Relatively built up area along a straight stretch with significant cross road movements</i></p> | | <ul style="list-style-type: none"> <li>One of the coldest places in the area, fog in the morning hours a common occurrence</li> <li>A straight stretch of about 1Km with a good sight distance</li> <li>Built-up area with several schools - One primary school &amp; 2 secondary schools and health centers. No designated pedestrian crossings have been provided</li> <li>Missing/vandalized speed limit signs</li> <li>The area is always foggy (misty) during early morning hours</li> <li>Presence of police has helped to reduce on the frequency of accidents</li> </ul> | <ul style="list-style-type: none"> <li>Overspeeding vehicles through the trading center the main cause of pedestrian knock downs</li> <li>Foggy pavement surfaces cause motorists to skid and overturn</li> <li>Accidents are predominantly single (overturning) due to reckless driving at night, poor visibility and over speeding</li> </ul> | <ul style="list-style-type: none"> <li>Provide designated pedestrian crossing points along the centre (raised pedestrian crossings/table tops are more desirable as they double up as speed calming measures)</li> <li>Reinstatement of speed limit signs and installation of pedestrian crossing signs</li> <li>Enhanced road user sensitization drives and enforcement of safety</li> <li>Installation of speed cameras to monitor travel speeds</li> <li>Provision of streetlights (solar powered) to illuminate the centre at night and when visibility is low due to fog</li> <li>Installation of informative signs cautioning motorists to proceed with caution due to fog/mist</li> </ul> |

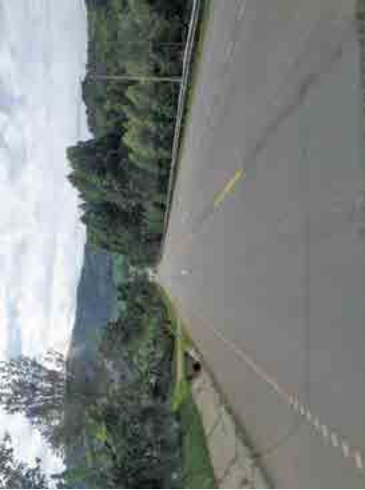
| S/N | Name of the Spot | Chain-age (Km) | Survey Observations and Findings | Analysis/Diagnosis | Suggested Recommendation for improvement |
|---|---|---|---|---|---|
| 4. | <b>Nyakanengo (44Km to Ntungamo)</b> <p><i>Gently rolling terrain that is marred by visibility problems due to fog/mist</i></p> | | <ul style="list-style-type: none"> <li>• A rolling terrain section</li> <li>• The area is usually foggy/misty during early morning hours</li> <li>• Most pedestrians knocked are drunkards</li> <li>• Accidents are mainly head-on collision and single (overturning) due to poor visibility and over speeding</li> </ul> | <ul style="list-style-type: none"> <li>• Visibility problems mainly occasioned by fog the main cause of head-on and single accidents</li> </ul> | <ul style="list-style-type: none"> <li>• Enhanced driver training, sensitization and enforcement</li> <li>• Installation of advance warning and informative signs cautioning motorists to proceed with caution due to fog/mist</li> <li>• Provision of streetlights (solar powered) to illuminate the centre</li> <li>• Installation of speed cameras to monitor travel speeds</li> <li>• Application of fresh retro-reflective road marking and delineator road studs to mark the lane extents.</li> </ul> |

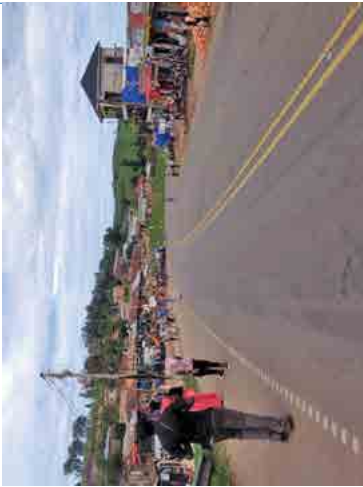
| S/N | Name of the Spot | Chain-age (Km) | Survey Observations and Findings | Analysis/Diagnosis | Suggested Recommendation for improvement |
|---|---|---|---|---|---|
| 5. | <b>Rwahi Town</b> | | <ul style="list-style-type: none"> <li>• Sharp long curve on a steep slope</li> <li>• Daily road side market (onions market) characterized by hawkers continuously making cross road movements to sell their goods to travelers</li> <li>• Defective brakes make some vehicles lose control resulting in accidents</li> </ul> | <ul style="list-style-type: none"> <li>• Predominant accidents are fatal involving pedestrians, motorcycle riders, pedal cyclists and roadside traders</li> </ul> | <ul style="list-style-type: none"> <li>• Provide designated pedestrian crossing facilities at the town (raised pedestrian crossings/table tops are more desirable)</li> <li>• Enhanced road signage i.e pedestrian crossing signs, junction ahead signs etc</li> <li>• Enhanced road user sensitization and enforcement of safety by ensuring vehicles are inspected</li> </ul> |

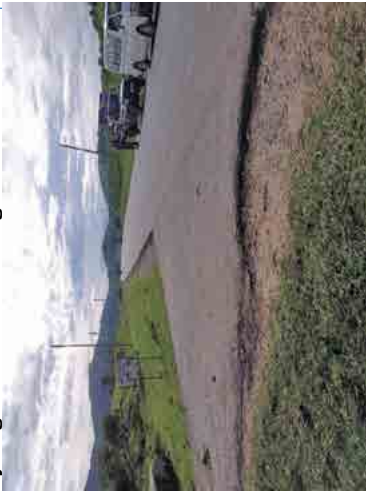
| S/N | Name of the Spot | Chain-age (Km) | Survey Observations and Findings | Analysis/Diagnosis | Suggested Recommendation for improvement |
|---|---|---|---|---|---|
| 6. | <b>Nyabugando (33Km to Ntungamo)</b> <p><i>Dangerously oriented access on the RHS with insufficient visibility splays for motorists joining the main highway</i></p> | | <ul style="list-style-type: none"> <li>The road is at a lower level while drivers speed to join the highway heading to Kabale</li> <li>Rolling terrain</li> <li>Side road with eroded gravel pavement lower than the highway level</li> <li>No resting space for the vehicles joining the highway</li> <li>No provision for acceleration and deceleration lanes at the access</li> <li>Missing road signs</li> </ul> | <ul style="list-style-type: none"> <li>Accidents occur due to insufficient visibility splays as drivers try to join the highway</li> <li>Crashes mainly involve commercial vehicles collecting agricultural produce from the access</li> </ul> | <ul style="list-style-type: none"> <li>Improve the junction by raising the eroded gravel pavement to provide enough resting space for vehicles joining the highway</li> <li>Provide acceleration and deceleration lanes</li> <li>Redesign the junction to provide for resting area for joining traffic</li> <li>Installation of enhanced road signs including Give Way signs on the access road and junction ahead signs on the main highway.</li> </ul> |

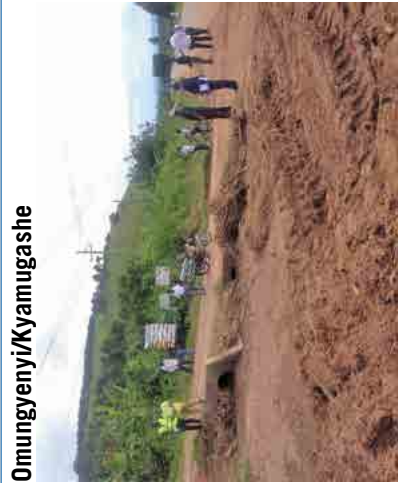
| S/N | Name of the Spot | Chain-age (Km) | Survey Observations and Findings | Analysis/Diagnosis | Suggested Recommendation for improvement |
|---|---|---|---|---|---|
| 7. | <b>Omungyenyi/Kyamugashe</b><br><br><i>Accumulation of silt and debris on the carriageway due to clogged access culverts</i> | | <ul style="list-style-type: none"> <li>Blocked drainage system due to poor maintenance that has led to heaping of silt and debris carried by rain runoff to the highway hence causing obstruction</li> <li>Presence of floods during rainy season</li> <li>Small culvert that can't contain the flow of water</li> </ul> | <ul style="list-style-type: none"> <li>Soil erosion into the highway due to blockage of drainage and waterway.</li> <li>As a result, silt has accumulated on the carriageway constricting the available motorable width</li> </ul> | <ul style="list-style-type: none"> <li>Immediate cleaning/unclogging of the drainage system</li> <li>Provision of cut off drains on the upstream side</li> <li>Sustained routine maintenance</li> <li>Install road signs to indicate sharp curves</li> <li>Enhance driver sensitization/training and enforcement of safety (spot checks)</li> <li>In the long term, consider raising the road as it is on a low-lying area and to separate it from the existing waterway</li> </ul> |

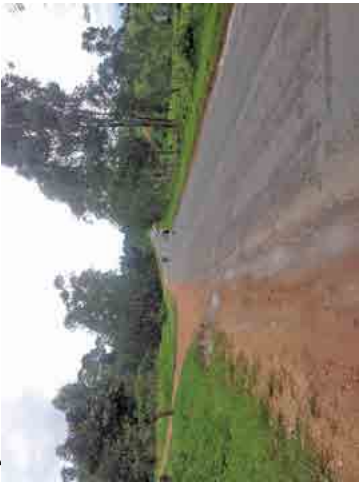
| S/N | Name of the Spot | Chain-age (Km) | Survey Observations and Findings | Analysis/Diagnosis | Suggested Recommendation for improvement |
|---|---|---|---|---|---|
| 2. | <b>Nyamufumula</b> <p><i>Sharp curve with obstructed sight distances</i></p> | | <ul style="list-style-type: none"> <li>Blind curve on rolling terrain</li> <li>Transition problems from a horizontal to a vertical curve</li> <li>The carriageway width at the curve is 6m and shoulder width is 0.8m</li> <li>Visibility for the descending vehicles is obstructed by trees which are too close to the road</li> <li>Road marking is faded; the continuous yellow centerline is barely visible</li> <li>Siltation on the road edges narrowing the effective carriageway</li> </ul> | <ul style="list-style-type: none"> <li>All categories of vehicles (trucks and small cars) are involved in accidents due to speed from upside, lack of street lights and visibility</li> </ul> | <ul style="list-style-type: none"> <li>Provision of appropriate warning signs and additional speed calming measures (rumble strips) on the approaches to the sharp curve</li> <li>Clearing of the trees within the road reserve/trimming of overgrown twigs to enhance sight distances</li> <li>Widen the road (to at least 3.5m lane widths) and provide adequate curve radius</li> <li>Application of retro-reflective road marking on the road and installation of delineator road studs</li> <li>Review the geometric design to ensure a smooth transition of horizontal and vertical curves</li> <li>Routine maintenance of the road including regular de-siltation</li> </ul> |

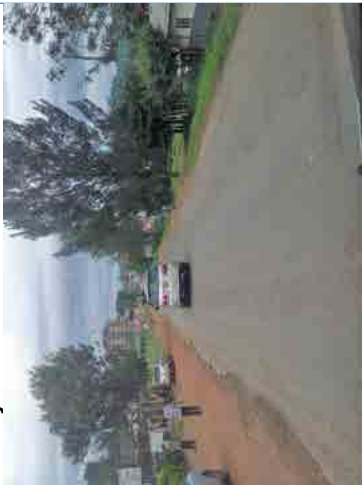
| S/N | Name of the Spot | Chain-age (Km) | Survey Observations and Findings | Analysis/Diagnosis | Suggested Recommendation for improvement |
|---|---|---|---|---|---|
| 4. | <b>Bushenyi Town</b> | | <ul style="list-style-type: none"> <li>Distressed pavement</li> <li>Narrowed carriageway</li> <li>Absence of parking facilities for motorcyclists and Public Service Vehicles</li> </ul> | <ul style="list-style-type: none"> <li>Absence of parking facilities and narrow road leads to frequent accidents</li> </ul> | <ul style="list-style-type: none"> <li>Provision of parking facilities and expansion of carriageway to provide enough space for traffic maneuverability</li> <li>Rehabilitation and widening of the carriageway to at least 3.5m lane widths</li> </ul> |

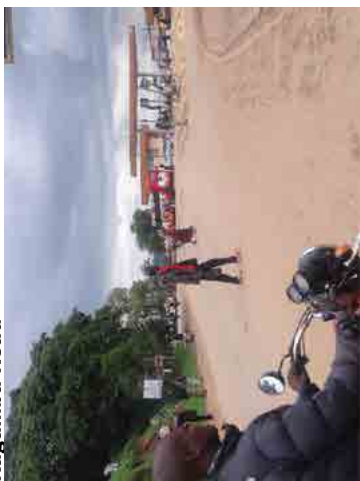
| S/N | Name of the Spot | Chain-age (Km) | Survey Observations and Findings | Analysis/Diagnosis | Suggested Recommendation for improvement |
|---|---|---|---|---|---|
| 5. | <b>Ishaka Junction with Mitooma &amp; Kagamba Road</b> | | <ul style="list-style-type: none"> <li>Due to land conflict, the stage has been move from the gazetted parking to its current location</li> <li>Loading Taxis and Buses park on the road shoulders and part of the carriageway hence narrowing the highway</li> <li>Careless driving</li> <li>Lack of designated pedestrian facilities across the main highway</li> <li>Faded road marking</li> <li>Deteriorating road surface (potholes and worn out shoulders) especially as you proceed towards Mpondwe</li> </ul> | <ul style="list-style-type: none"> <li>Congestion at the roadside because of loading and off-loading of trucks causes pedestrians crashes</li> <li>Accidents involve pedestrians, students, motorists and <i>bodaboda</i> riders.</li> <li>Side impact and head on collisions common at the location</li> <li>Political issue involving the bus bays beyond the Municipality capacity</li> </ul> | <ul style="list-style-type: none"> <li>The municipal council should ensure that all vehicles load and offload from gazetted parks</li> <li>Enhance sensitization to all road users and enforcement of safety</li> <li>Remove the parking from the road shoulders and ensure it is well relocated</li> <li>Provide designated pedestrian crossings across the main highway on either side of the junction (raised pedestrian crossings/table tops are more desirable)</li> <li>Application of retro-reflective road marking and delineator road studs</li> <li>Rehabilitation of the deteriorating pavement</li> <li>In the long term, consider provision of service lanes with controlled access and separate NMT facilities at the town or constructing a bypass for through traffic</li> </ul> |

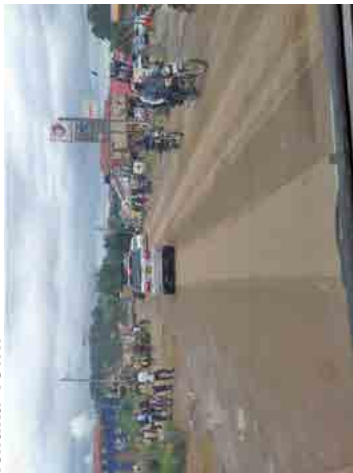
| S/N | Name of the Spot | Chain-age (Km) | Survey Observations and Findings | Analysis/Diagnosis | Suggested Recommendation for improvement |
|---|---|---|---|---|---|
| 7. | Ishaka Town<br> | | <ul style="list-style-type: none"> <li>Road edges have are worn out leading to narrow traffic carriageway</li> <li>Absence of designated parking facilities for motorcyclists</li> </ul> | <ul style="list-style-type: none"> <li>Narrow carriageway causes opposing traffic to collide or brush their bodies</li> <li>Unregulated motorcycle activities leads to frequent accidents involving the motorcyclists and highway traffic</li> </ul> | <ul style="list-style-type: none"> <li>Rehabilitation and expanding of the carriageway to provide ample space for motorists maneuver</li> <li>Provision of designated parking for the motorcyclists and other Public Service Traffic</li> </ul> |

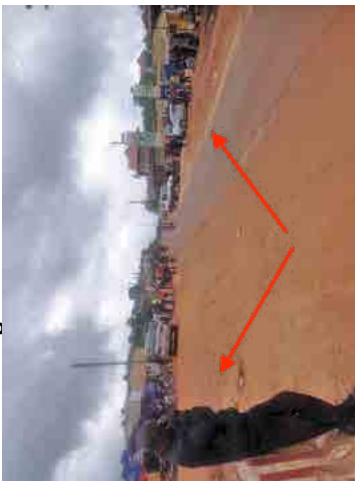
| S/N | Name of the Spot | Chain-age (Km) | Survey Observations and Findings | Analysis/Diagnosis | Suggested Recommendation for improvement |
|---|---|---|---|---|---|
| 8. | Butare Trading Centre<br><br><i>Cross junction at the road which is already under construction is responsible for side impact crashes</i> | | <ul style="list-style-type: none"> <li>Busy developed area with multiple accesses hence the need for service lanes with controlled access to the main road</li> <li>There is tea factory in the area that generates heavy vehicles traffic</li> <li>Cross road junction responsible for many side impact collisions</li> <li>The road is under rehabilitation but the design could not be ascertained to know how safety was considered</li> <li>Inadequate work zone signage and temporary traffic management plans</li> </ul> | <ul style="list-style-type: none"> <li>Accidents are mainly due to motorcyclists entering and exiting the highway recklessly and heedless of other traffic (unsafe road user behavior)</li> <li>The work zone also needs to be managed better through enhanced signage and control of traffic to allow for safe passage within the town</li> </ul> | <ul style="list-style-type: none"> <li>Since the road in under rehabilitation, there is need to look at the design and find out how safety was considered mostly on: <ul style="list-style-type: none"> <li>NMT and pedestrian crossing facilities</li> <li>Junction design improvement (i.e. consider staggering the accesses at the junction and channelizing the intersection)</li> </ul> </li> <li>Provision of parking facilities for both motorcyclists and PSVs and service lanes with controlled access to the main road</li> <li>Enhance sensitization to all road users and enforcement of safe road user behaviour</li> <li>Enhanced temporary work zone signage and control of traffic to avert any possible incidents</li> </ul> |

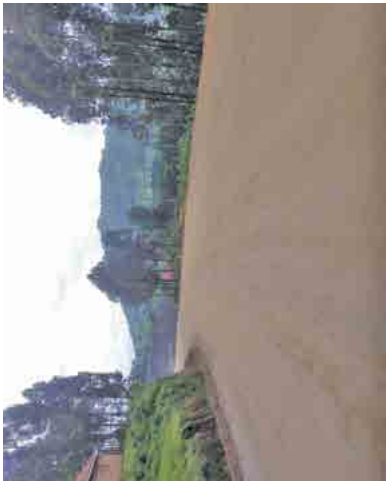
| S/N | Name of the Spot | Chain-age (Km) | Survey Observations and Findings | Analysis/Diagnosis | Suggested Recommendation for improvement |
|---|---|---|---|---|---|
| 9. | <b>Nkombe</b> <p><i>Sharp curve on a steep descent</i></p> | | <ul style="list-style-type: none"> <li>Steep slopes with combined curves on rolling to mountainous terrain</li> <li>Sharp corner likely to cause loss of control leading to run off collisions</li> <li>Accidents are mainly caused by over speeding and reckless driving (police issued 128 penalty tickets to reckless drivers in one month)</li> <li>Drivers use free gear on steep slopes which results in loss of vehicle control</li> </ul> | <ul style="list-style-type: none"> <li>Predominant crashes are mainly run off involving heavy goods vehicles</li> </ul> | <ul style="list-style-type: none"> <li>Since the road is under rehabilitation, there is need to look at the design and find out how safety was considered mostly on: <ul style="list-style-type: none"> <li>Lane separation (separation of the two directions of traffic using a central median might be necessitated)</li> <li>Provision of climbing lanes</li> <li>Road signs and speed calming humps/rumble strips</li> <li>Consider installation of informative signage cautioning motorists against freewheeling and urging them to engage low gears during descent</li> <li>Installation of directional arrow/chevron signs at the tight curve</li> <li>Enhance sensitization to all road users and enforcement of safety</li> </ul> </li> </ul> |

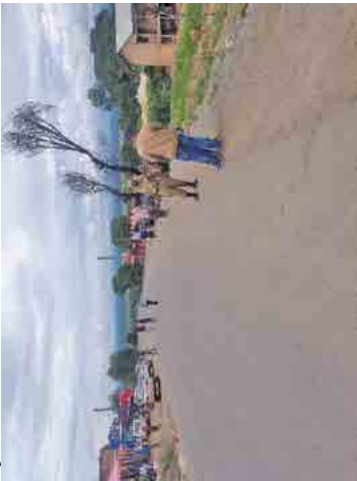
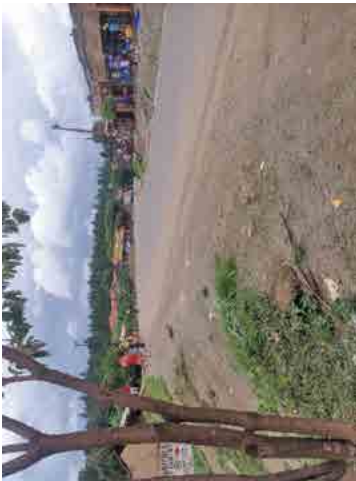
| S/N | Name of the Spot | Chain-age (Km) | Survey Observations and Findings | Analysis/Diagnosis | Suggested Recommendation for improvement |
|---|---|---|---|---|---|
| 12. | <p><b>Kyambura Market Centre</b></p> <p><i>Wreckage of a fuel tanker that was involved in a catastrophic run off accident</i></p> <p><i>Extremely sharp curve at the market centre with no provision for safety fences on high embankment</i></p> | | <ul style="list-style-type: none"> <li>• Sharp combined curves on rolling-mountainous terrain</li> <li>• Built-up area with a daily market</li> <li>• The road is under rehabilitation and this particular section has been sealed but a climbing lane and lane separation have not been considered</li> <li>• This is the exact location where over 22 people perished in August 2019 when a fuel tanker got an accident</li> <li>• Side road to Katerera at midway curve</li> <li>• Missing safety fences and directional arrow signs as you descend down the stretch</li> <li>• Inadequate warning signage and speed calming measures</li> </ul> | <ul style="list-style-type: none"> <li>• The stretch traverses a hilly terrain with successive combinations of horizontal and vertical curves</li> </ul> | <ul style="list-style-type: none"> <li>• Provide appropriate road signs along the stretch (speed limit and sharp curve ahead warning signs)</li> <li>• Provide pedestrian crossing facilities for safe cross road movements within the market</li> <li>• Installation of safety fences (flex beam guardrails with reflective studs) and directional arrow (chevron) signs at the tight curves</li> <li>• Enhance sensitization to all road users and enforcement of safety</li> <li>• Review the design to consider: <ul style="list-style-type: none"> <li>- Lane separation with central medians</li> <li>- Speed calming humps and rumble strips to the descending lane</li> <li>- Provision of climbing lanes</li> <li>- Redesign the RHS side junction to provide adequate turning radius and speed change (acceleration and deceleration) lanes</li> </ul> </li> </ul> |

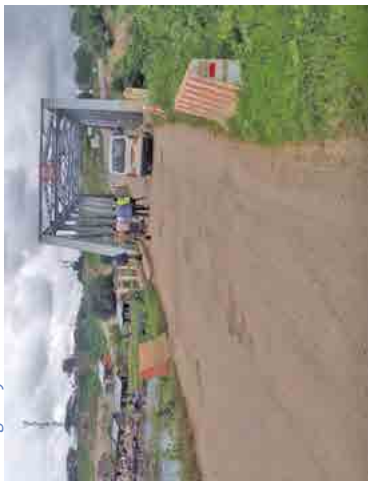
| S/N | Name of the Spot | Chain-age (Km) | Survey Observations and Findings | Analysis/Diagnosis | Suggested Recommendation for improvement |
|---|---|---|---|---|---|
| 13. | <b>Katunguru (Kazinga Channel Bridge) -located at the separation of Lake George and Lake Edward</b><br> <p><i>Gaping hole on the middle of the bridge deck carriageway</i></p> <p><i>Pothole ridden bridge approach with missing hazard marker signs</i></p> | | <ul style="list-style-type: none"> <li>The Bridge is damaged on the Kyambura side approach (bridge deck failure has left a gaping hole in the middle of the carriageway) resulting into a black spot</li> <li>The bridge handles huge volumes of traffic of taxis, trucks and buses on a daily basis hence paralyzing traffic</li> <li>Narrow carriageway with pothole ridden approaches on the Kyambura approach</li> <li>Missing/non-reflective hazard marker signs on the bridge approaches</li> </ul> | <ul style="list-style-type: none"> <li>The portal frame bridge crosses the channel joining Lake George and Lake Edward</li> </ul> | <ul style="list-style-type: none"> <li>During the survey UNRA decided to close Katunguru Bridge, which connects Kasese and Rubirizi districts, after it got damaged.</li> <li>Kasese road traffic was therefore diverted to allow for remedial works</li> <li>Consider rehabilitating the approaches to rid them of potholes</li> <li>Installation of bridge ahead and hazard marker signs</li> <li>In the long term, consider widening the bridge and provision of pedestrian walkways</li> </ul> |

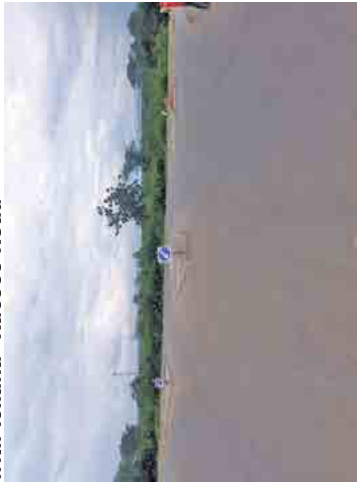
| S/N | Name of the Spot | Chain-age (Km) | Survey Observations and Findings | Analysis/Diagnosis | Suggested Recommendation for improvement |
|---|---|---|---|---|---|
| 15. | Kikorongo (47Km to Mpondwe ) Junction with Ishaka -Kasese Road<br> | | <ul style="list-style-type: none"> <li>Need for speed restrictions for vehicles approaching the T-Junction especially from Mpondwe</li> <li>Need for speed limit and Stop signs at the junction</li> </ul> | <ul style="list-style-type: none"> <li>The recently completed T-junction has been channeled for safe passage of traffic</li> </ul> | <ul style="list-style-type: none"> <li>Provide appropriate road signs (speed limit signs on the approach to the T-Junction, Stop and Give Way signs)</li> <li>Limit the speed towards the junction in the form of speed calming rumble strips</li> <li>Application of retro-reflective road marking on the recently completed junction</li> </ul> |

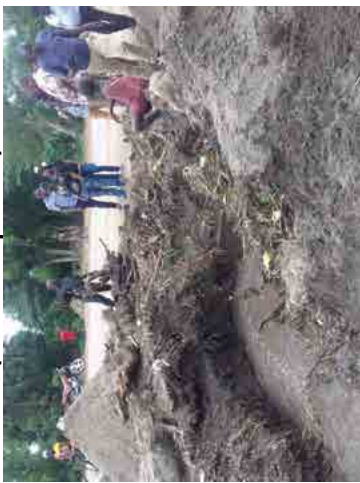
| S/N | Name of the Spot | Chain-age (Km) | Survey Observations and Findings | Analysis/Diagnosis | Suggested Recommendation for improvement |
|---|---|---|---|---|---|
| 16. | Rusheshe (13Km to Mpondwe)<br> | | <ul style="list-style-type: none"> <li>Seasonal River crossing</li> <li>Size of the cross drain (culvert) is inadequate</li> <li>The river is silted and narrow at the culvert inlet</li> <li>Heavy runoff from the mountains carry debris that blocks the culvert hence the road</li> </ul> | <ul style="list-style-type: none"> <li>Vehicles don't cross the road at this point during heavy rains due to flash floods</li> <li>There is river sand mining at this point by the locals and as a result, the people mining sand block the culvert intentionally thus causing flooding</li> </ul> | <ul style="list-style-type: none"> <li>Sand mining should be stopped/relocated immediately</li> <li>Desilt the cross culvert and the river inlet and outlet drain</li> <li>Ensure routine maintenance is carried out</li> <li>Enhance sensitization and enforcement of safety</li> <li>Carry out "River Training" works</li> </ul> |

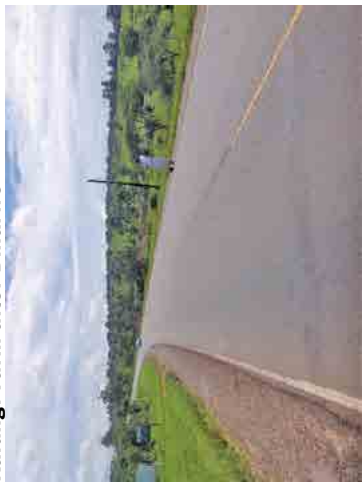
| S/N | Name of the Spot | Chain-age (Km) | Survey Observations and Findings | Analysis/Diagnosis | Suggested Recommendation for improvement |
|---|---|---|---|---|---|
| 3. | <b>Kalungi Farm after Biharwe</b><br> | | <ul style="list-style-type: none"> <li>Sharp horizontal curve into a crest curve</li> <li>No center line markings only edge markings are visible hence drivers tend to overtake causing accidents</li> <li>Speeding motorists and dangerous overtaking are common at the location</li> </ul> | <ul style="list-style-type: none"> <li>Run off and head on collisions are possible at the location</li> </ul> | <ul style="list-style-type: none"> <li>Provide retro-reflective continuous center line marking in addition to delineator road studs</li> <li>Re-application of thermoplastic paint on the edge lines</li> <li>Enhanced road signage warning motorists accordingly</li> </ul> |

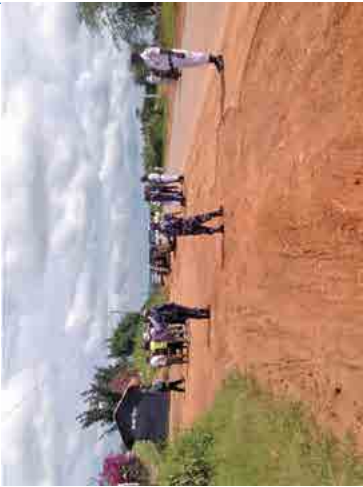
| S/N | Name of the Spot | Chain-age (Km) | Survey Observations and Findings | Analysis/Diagnosis | Suggested Recommendation for improvement |
|---|---|---|---|---|---|
| 4. | <b>Kibeega</b><br><br><i>Faded centre line marking at a dangerous curve</i> | | <ul style="list-style-type: none"> <li>Missing advance warning signage to indicate the presence of a junction</li> <li>Missing Stop/Give Way signage on the minor road</li> <li>Drivers entering and exiting to the minor road arbitrarily responsible for a number of crashes</li> <li>Blind corners at a crest</li> <li>Side Road to Kiruhura at the crest of the vertical curve</li> <li>Road marking along the location completely faded</li> <li>Rugged road shoulders</li> <li>No road signs both on the highway and minor side road</li> </ul> | <ul style="list-style-type: none"> <li>Motorists exiting to or joining from the gravel access heedless of other traffic causes the location to be a hazardous spot</li> </ul> | <ul style="list-style-type: none"> <li>Application of retroreflective road marking (including a continuous yellow centre line at the location) and delineator road studs</li> <li>Installation of Junction Ahead signs on either side of the location</li> <li>Installation of Stop/Give Way signage on the minor road</li> <li>Redesign the side road junction to provide adequate turning radius and speed change (acceleration and deceleration) lanes</li> <li>Rehabilitation of the deteriorated road edges</li> <li>Need of maintenance of the road side and clearing of the roadside bushes to increase visibility splays</li> <li>In the long term, consider improvement of the vertical curve to improve on the sight distances</li> </ul> |

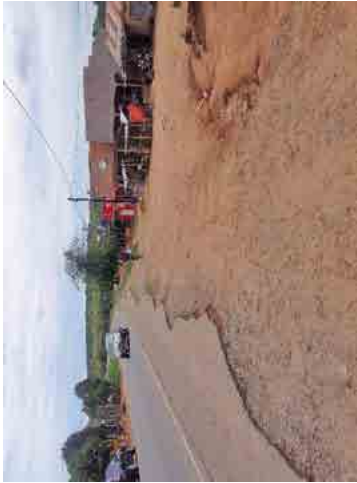
| S/N | Name of the Spot | Chain-age (Km) | Survey Observations and Findings | Analysis/Diagnosis | Suggested Recommendation for improvement |
|---|---|---|---|---|---|
| 5. | <b>Kyapa Trading Centre</b> <p><i>Centre is located on a blind curve from the Masaka side.<br/>Access on the RHS also lacks proper speed change lanes</i></p> | | <ul style="list-style-type: none"> <li>The location has been declared very dangerous by traffic Police</li> <li>Built-up area (trading center) on a rolling terrain with a blind corner</li> <li>No pedestrian crossing facilities</li> <li>Road markings are faded</li> <li>No road signs</li> <li>Vehicles park on the road on either side due to lack of designated parking areas</li> <li>Accidents mainly are due to over speeding and reckless driving</li> </ul> | <ul style="list-style-type: none"> <li>Over speeding vehicles cause frequent crashes involving pedestrians and motorcycles.</li> <li>According to traffic Police, this location is #2 in terms of prioritization</li> </ul> | <ul style="list-style-type: none"> <li>Application of retroreflective road marking (including a continuous yellow centre line at the location) and delineator road studs</li> <li>Provide appropriate road signs (speed limit and advance warning signs)</li> <li>Provide pedestrian crossing facilities for safe cross road movements by pedestrians</li> <li>Provide speed calming facilities on the approaches to the centre</li> <li>Rehabilitation of the deteriorating road edges and improvement of the RHS access to provide for speed change lanes</li> <li>Enhance sensitization to all road users and enforcement of safety</li> <li>Consider provision of streetlights to illuminate the centre at night.</li> </ul> |

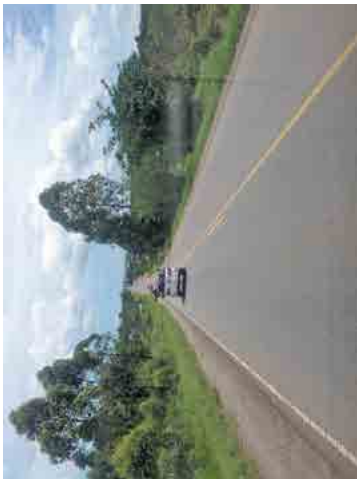
| S/N | Name of the Spot | Chain-age (Km) | Survey Observations and Findings | Analysis/Diagnosis | Suggested Recommendation for improvement |
|---|---|---|---|---|---|
| 6. | <p><b>Kyabazala village also known as Lyantonde rural (1Km to Lyantonde)</b></p> <p><i>Relatively straight and gently sloping stretch prompts motorists to overspeed and overtake dangerously</i></p> | | <ul style="list-style-type: none"> <li>It is a straight and gently sloping section of the road which encourages motor vehicles overspeeding</li> <li>It has insufficient signage for speed limit and warning of incoming traffic from community road. Hence Vehicles hit humps and overturn</li> <li>The road markings are visible but not reflective at night</li> <li>Side road junction leading to two (2) schools with insufficient turning radius</li> </ul> | <ul style="list-style-type: none"> <li>Most of the accidents are head-on and roll-over occurring at night due to over speeding coupled with invisible markings</li> </ul> | <ul style="list-style-type: none"> <li>Provide appropriate Road signs and relocate the existing speed limit signs to match the area development</li> <li>Need of a speed limit (e.g. 50 Km) signage at the crest</li> <li>Repaint the road markings with approved reflective paint and install delineator studs to the center and edge line markings</li> <li>Enhance sensitization to all road users and enforcement of safety</li> <li>Redesign the LHS side road junction to provide adequate turning radius and speed change (acceleration and deceleration) lanes</li> <li>Consider installation of streetlights to illuminate the stretch at night</li> </ul> |

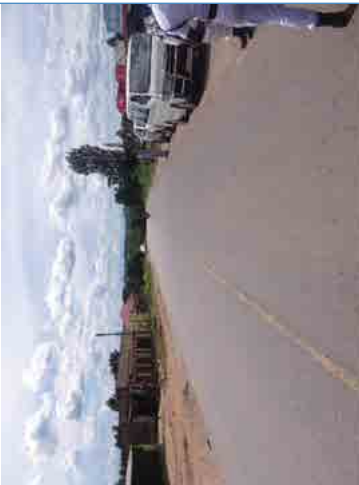
| S/N | Name of the Spot | Chain-age (Km) | Survey Observations and Findings | Analysis/Diagnosis | Suggested Recommendation for improvement |
|---|---|---|---|---|---|
| 7. | <p><b>Karegero Trading Centre (68Km to Masaka)</b></p> <p><i>RHS access lacks necessary speed change lanes with shoulders being rugged</i></p> <p><i>Centre lacks designated pedestrian crossings and road markings are faded</i></p> | | <ul style="list-style-type: none"> <li>Built-up area (trading center) on a rolling terrain</li> <li>The location is a notorious hazardous spot known for near daily accidents which involve children</li> <li>No provision for pedestrian crossings</li> <li>No road signs</li> <li>Road markings are faded</li> <li>Eroded shoulders at a side road junction cause the vehicles joining the highway to delay at the junction</li> </ul> | <ul style="list-style-type: none"> <li>Reckless driving and over speeding responsible for most pedestrian knockdowns</li> </ul> | <ul style="list-style-type: none"> <li>Provide appropriate Road signs</li> <li>Repaint the road markings with approved reflective paint and install delineator studs to the center and edge line markings</li> <li>Provide designated pedestrian crossing facilities for safe crossing movements</li> <li>Enhance sensitization to all road users and enforcement of safety</li> <li>Repair of the eroded shoulders</li> <li>Redesign the RHS side junction to provide adequate turning radius and speed change (acceleration and deceleration) lanes</li> </ul> |

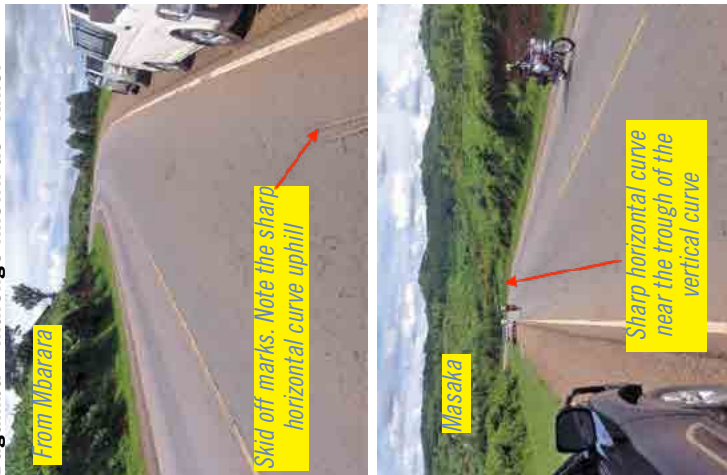
| S/N | Name of the Spot | Chain-age (Km) | Survey Observations and Findings | Analysis/Diagnosis | Suggested Recommendation for improvement |
|---|---|---|---|---|---|
| 8. | <p><b>Bugamba – Malongo known as “Killer”</b></p> | | <ul style="list-style-type: none"> <li>Long stretch of about 2km with sharp succession of horizontal curves on a very steep descent (rolling-mountainous terrain)</li> <li>Over speeding and dangerous overtaking common</li> <li>No advance warning road signs</li> <li>Faded road markings</li> <li>No climbing lane hence drivers tend to overtake slow moving vehicles on steep ascent</li> <li>The safety fences are damaged due to impact by vehicles that lose control</li> <li>Freewheeling by truckers at the location likely</li> </ul> | <ul style="list-style-type: none"> <li>Crashes mainly involve Masaka bound heavy goods vehicles which fail to negotiate the sharp succession of curves</li> <li>Predominant type of accidents: run off and head on collisions. In 2001 such accident resulted in 30 deaths on the spot</li> </ul> | <ul style="list-style-type: none"> <li>Consider provision of the following gantry type road signs: <ul style="list-style-type: none"> <li>No Freewheeling (Engage low gears)</li> <li>No Overtaking</li> <li>Observe Lane Discipline</li> </ul> </li> <li>Enhanced advance warning signs on the sharp dangerous curves</li> <li>Speed calming measures at the beginning of the descent (rumble strips and speed limits)</li> <li>Enhance sensitization to all road users and enforcement of safety</li> <li>Reinstatement of the damaged guardrails to offer restraint during emergencies</li> <li>Provide off-road truck run away ramps/sand arrester beds for vehicles that veer off at the curves</li> <li>Operationalizing motor vehicle inspection centres</li> </ul> <p>In the long term consider:</p> <ul style="list-style-type: none"> <li>Dualing the section/ separation of the traffic directions using a central island</li> <li>Widening the carriageway and provision of climbing lanes for ascending traffic</li> <li>Re-design/realignment of the section to eliminate the sharp curves.</li> </ul> |

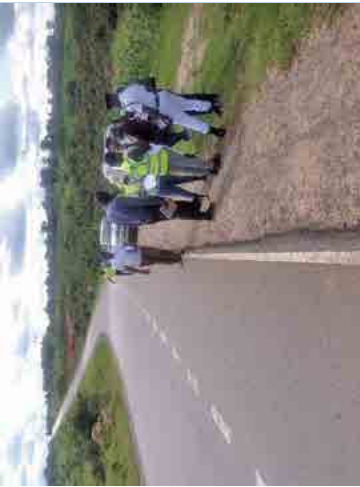
| S/N | Name of the Spot | Chain-age (Km) | Survey Observations and Findings | Analysis/Diagnosis | Suggested Recommendation for improvement |
|---|---|---|---|---|---|
| 9. | <b>Kamutuza Village</b><br> | | <ul style="list-style-type: none"> <li>Climbing lanes provided but head-on collisions occur at the termination of climbing lanes</li> <li>Road is properly marked</li> <li>No road signs</li> <li>Overspeeding, dangerous overtaking and general lane indiscipline responsible for majority of the crashes</li> <li>Missing directional arrow (chevron) signs</li> </ul> | <ul style="list-style-type: none"> <li>Fatal single accidents due to loss of control are common at the location</li> <li>A horizontal curve is located at the trough of a vertical curve</li> </ul> | <ul style="list-style-type: none"> <li>Provide appropriate road signs (speed limit and directional arrow signs at the trough of the horizontal curve)</li> <li>Installation of delineator road studs to mark the lane extents</li> <li>Enhance sensitization to all road users and enforcement of safety</li> <li>Review the design and markings</li> </ul> |

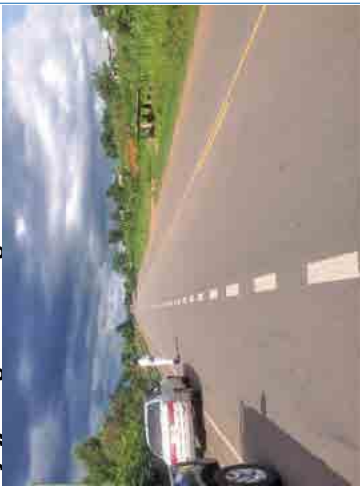
| S/N | Name of the Spot | Chain-age (Km) | Survey Observations and Findings | Analysis/Diagnosis | Suggested Recommendation for improvement |
|---|---|---|---|---|---|
| 10. | <b>Kvojja-Kaganda village</b><br> | | <ul style="list-style-type: none"> <li>Road wide enough with climbing lanes to the Masaka direction</li> <li>Priority is given on steep ascent</li> <li>Road markings are clearly visible</li> <li>Provision for overtaking extends to blind corner</li> <li>Knocked down safety fence on the LHS</li> <li>Overspeeding, dangerous overtaking and general lane indiscipline are all likely</li> <li>No road signs</li> <li>Missing road studs especially at the tight curves</li> </ul> | <ul style="list-style-type: none"> <li>Accidents are mainly due to trucks losing control as a result of over speeding and reckless driving</li> </ul> | <ul style="list-style-type: none"> <li>Provide appropriate road signs (speed limit and sharp curve ahead signs)</li> <li>Enhance sensitization to all road users and enforcement of safety</li> <li>Reinstatement of the damaged guardrails (with reflective studs on the inner side) to offer restraint during emergencies</li> <li>Installation of delineator road studs to mark the lane extents especially at tight curves</li> <li>Review of the road marking to prevent overtaking at blind corners</li> </ul> |

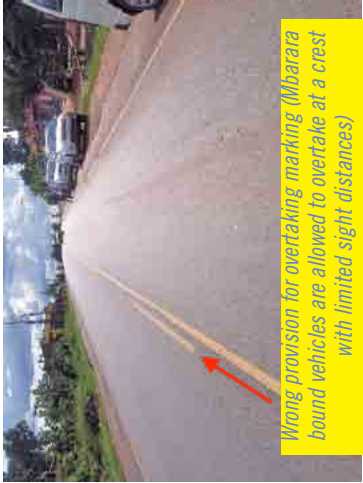
| S/N | Name of the Spot | Chain-age (Km) | Survey Observations and Findings | Analysis/Diagnosis | Suggested Recommendation for improvement |
|---|---|---|---|---|---|
| 11. | <b>Kyangoma</b><br> | | <ul style="list-style-type: none"> <li>Provision for overtaking has been extended to a crest with limited sight distances</li> <li>Type of accidents mainly fatal head-on collisions</li> <li>Missing/vandalized road signs</li> </ul> | <p>Overtaking priority at the crest</p> <p>Overtaking priority at the corner</p> | <ul style="list-style-type: none"> <li>Provide appropriate road signs (speed limit and sharp curve ahead signs)</li> <li>Enhance sensitization to all road users and enforcement of safety</li> <li>Review of the road marking to prevent overtaking at blind corners and curves</li> </ul> |

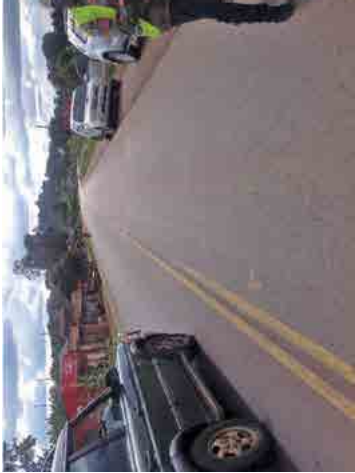
| S/N | Name of the Spot | Chain-age (Km) | Survey Observations and Findings | Analysis/Diagnosis | Suggested Recommendation for improvement |
|---|---|---|---|---|---|
| 12. | <b>Nkoni Shopping Centre</b><br> | | <ul style="list-style-type: none"> <li>Relatively busy centre with schools, a church and roadside establishments hence many pedestrians</li> <li>Straight section on a relatively flat terrain with a side road junction</li> <li>Missing road signs</li> <li>Overspeeding and dangerous overtaking common</li> <li>Faded edge line markings and missing road studs</li> </ul> | <ul style="list-style-type: none"> <li>Accidents involve pedestrians, school going children and motorcyclists</li> <li>Predominant crashes are hit and run</li> </ul> | <ul style="list-style-type: none"> <li>Provide speed limit signs on the approaches to the centre and pedestrian/children crossing warning signs</li> <li>Provide designated pedestrian crossings for safe crossing movements</li> <li>Enhance sensitization to all road users and enforcement of safety especially in restricting overtaking</li> <li>Improve the side road junction</li> <li>Installation of delineator road studs to mark the lane extents</li> </ul> |

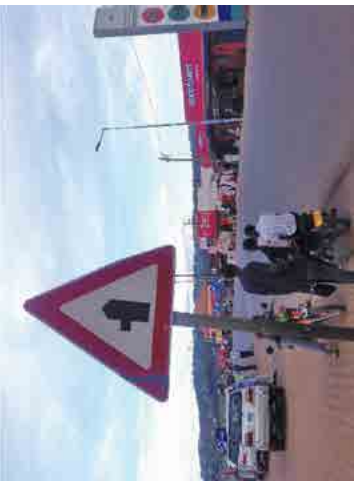
| S/N | Name of the Spot | Chain-age (Km) | Survey Observations and Findings | Analysis/Diagnosis | Suggested Recommendation for improvement |
|---|---|---|---|---|---|
| 13. | <b>Kyabakuza (about 3Km to Masaka)</b><br><br><i>Completely faded marking on the carriageway and speed humps</i> | | <ul style="list-style-type: none"> <li>Built-up busy town with multiple road side businesses</li> <li>Stopover for most of Mbarara bound vehicles</li> <li>No gazetted parking facilities for PSVs hence irregular parking on the shoulders</li> <li>Road marking is completely faded, the speed humps are not visible from a distance as a result</li> <li>Missing speed hump signage</li> </ul> | <ul style="list-style-type: none"> <li>The centre is on a descent and pedestrian knock downs are likely due to the multiple crossing movements</li> </ul> | <ul style="list-style-type: none"> <li>Application of retroreflective road marking and installation of delineator road studs</li> <li>Repaint the speed humps and crossing points with retro-reflective paint</li> <li>Provide appropriate road signs (speed humps ahead warning signs)</li> <li>Provide speed restrictions (speed limit signs)</li> <li>Enhance sensitization to all road users and enforcement of safety</li> <li>Provide designated bus stop bays on either side the road</li> <li>In the long term, consider provision of service lanes to the town</li> </ul> |

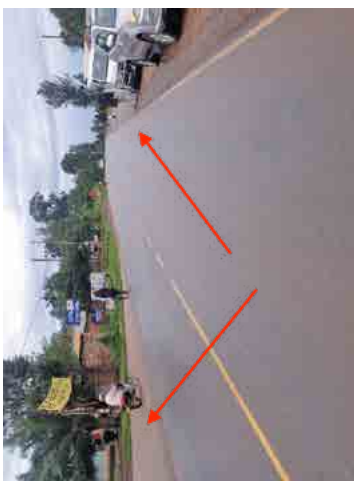
| S/N | Name of the Spot | Chain-age (Km) | Survey Observations and Findings | Analysis/Diagnosis | Suggested Recommendation for improvement |
|---|---|---|---|---|---|
| 14. | <b>Ssaza (2Km from Masaka town)</b><br><br><i>Accesses located near the crest of a horizontal curve with no speed restrictions in place</i> | | <ul style="list-style-type: none"> <li>Crossroad to Buganda Land Board at a trough on a rolling terrain</li> <li>Built-up area with a lot of social activities, many schools, etc.</li> <li>Being on the crest of a vertical curve, sight distances are impaired</li> <li>No speed limits are in place</li> <li>No pedestrian crossings</li> <li>Deteriorating road edges/rugged shoulders</li> <li>Accidents are mainly fatal involving all road users due to over speeding and reckless driving</li> </ul> | <ul style="list-style-type: none"> <li>Vehicles using the accesses tend to cut across main carriageway traffic at a bend creating a safety hazard</li> <li>Side impact collisions are therefore common at the location</li> <li>Pedestrian knockdowns are also common</li> </ul> | <ul style="list-style-type: none"> <li>Installation of appropriate advance warning signs (pedestrian crossings and junction ahead signage)</li> <li>Provision of pedestrian crossings at a safe distance from the blind spot (raised pedestrian crossings/table tops are more desirable at the location)</li> <li>Provide speed restrictions (speed limit signs)</li> <li>Repair of the deteriorating shoulders</li> <li>Sensitization of road users and enforcement of safety</li> <li>Redesign the junction to create a staggered intersection</li> </ul> |

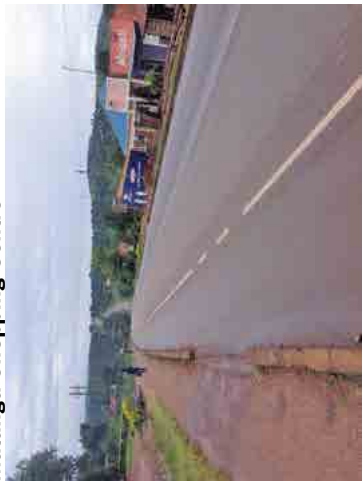
| S/N | Name of the Spot | Chain-age (Km) | Survey Observations and Findings | Analysis/Diagnosis | Suggested Recommendation for improvement |
|---|---|---|---|---|---|
| 16. | <b>Matanga Shopping Centre</b> <p><i>Steep ascent towards Matanga tends to prove difficult for ascending HGVs</i></p> | | <ul style="list-style-type: none"> <li>Built-up area on Rolling terrain with a Crossroad</li> <li>Accidents are due to collision of overtaking vehicles as trucks fail to ascent and small vehicles try to overtake. This ends up in head-on collision</li> <li>Crossing vehicles collide with others on the highway</li> <li>The road is wide with shoulders of about 2.5m either side; a provision for a climbing lane has however not been made</li> <li>No parking space provided hence vehicles park on the road</li> <li>Vandalized road signs</li> <li>Visible road markings</li> </ul> | <ul style="list-style-type: none"> <li>Heavy trucks experience difficulties ascending, overtaking vehicles tend to collide head on with descending traffic</li> </ul> | <ul style="list-style-type: none"> <li>Reconfigure the road marking (to do away with the wide shoulders/reduce the shoulder widths) and create a provision for climbing lanes</li> <li>Provision of appropriate road signs</li> <li>Sensitization to all road users and enforcement of safety</li> <li>Redesign the junction to create a staggered intersection</li> <li>Being a trading centre, provide parking space for taxis and designated bus stops.</li> </ul> |

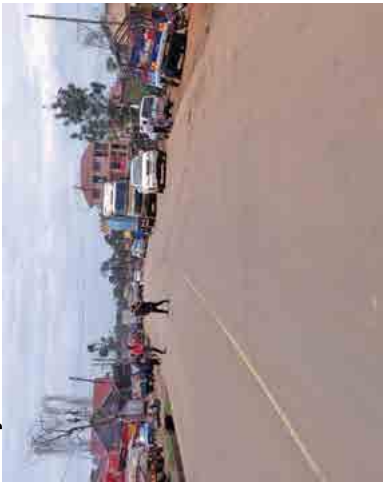
| S/N | Name of the Spot | Chain-age (Km) | Survey Observations and Findings | Analysis/Diagnosis | Suggested Recommendation for improvement |
|---|---|---|---|---|---|
| 19. | <b>Lukaya Town</b><br><br><i>Lack of designated pedestrian crossings. Note the faded edge line markings</i> | | <ul style="list-style-type: none"> <li>Important trading centre</li> <li>Very Busy town where truck drivers park to rest mostly at night (serves as a road side station)</li> <li>Weighbridge located along the stretch</li> <li>Trucks park on either side of the highway narrowing the carriage way due to lack of designated parking</li> <li>Faded edge line markings</li> </ul> | <ul style="list-style-type: none"> <li>Accidents occur due constriction of carriageway by stopping trucks and heightened pedestrian activities.</li> </ul> | <ul style="list-style-type: none"> <li>Provide designated pedestrian crossing (raised pedestrian crossings/table tops are more desirable to calm speeds)</li> <li>Provide appropriate road signs</li> <li>Reinstate the humps and rumble strips</li> <li>Application of retroreflective road marking and installation of delineator road studs</li> <li>Enhance sensitization to all road users and enforcement of safety (vendors to be also restricted from main carriageway)</li> </ul> |

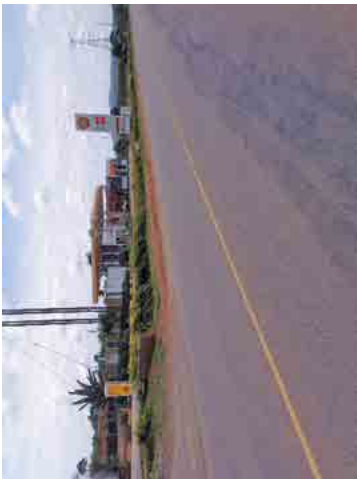
| S/N | Name of the Spot | Chain-age (Km) | Survey Observations and Findings | Analysis/Diagnosis | Suggested Recommendation for improvement |
|---|---|---|---|---|---|
| 21. | <b>Buyaya</b> | | <ul style="list-style-type: none"> <li>• New Shell fuel station on the RHS close to the road along the curve</li> <li>• Vehicles from the main road enter the fuel station use the designated exit and vice versa, which leads to accidents</li> <li>• No road signs</li> <li>• Overtaking common despite presence of a continuous yellow centre line</li> <li>• No protection along the swamp</li> </ul> | <ul style="list-style-type: none"> <li>• Motorists sometimes fail to observe entry and exit points to the newly developed service/petrol station causing accidents</li> </ul> | <ul style="list-style-type: none"> <li>• Provide road signs informing motorists on the station ahead</li> <li>• Provision of speed calm measures in the form of rumble strips on the approaches to the station</li> <li>• Enhance sensitization to all road users and enforcement of safety</li> <li>• Consider provision of acceleration and deceleration lanes at the entry and exit preferably to be implemented by the fuel station</li> <li>• In addition, redesign the section to include storage and weaving lanes to allow for turning movements into and out of the station</li> </ul> |

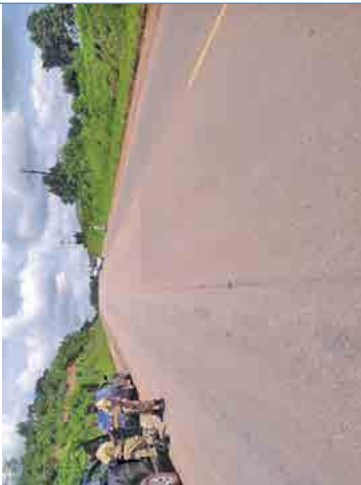
| S/N | Name of the Spot | Chain-age (Km) | Survey Observations and Findings | Analysis/Diagnosis | Suggested Recommendation for improvement |
|---|---|---|---|---|---|
| 23. | <b>Kalandazi</b><br><br><i>Faded climbing lane marking</i> | | <ul style="list-style-type: none"> <li>Rolling terrain section with a climbing lane</li> <li>Accidents are mainly head-on collisions due to overtaking descending vehicles</li> <li>Road markings of climbing lanes are faded</li> <li>Centre line road marking allows descending motorists to overtake</li> </ul> | <ul style="list-style-type: none"> <li>The climbing lane marking needs</li> </ul> | <ul style="list-style-type: none"> <li>Provide appropriate road signs (beginning and end of climbing lanes)</li> <li>Application of retroreflective marking to clearly demarcate the climbing lane and the installation of delineator road studs to mark the lane extents</li> <li>Enhance sensitization to all road users and enforcement of safety</li> <li>Reconfigure the road markings to prohibit descending vehicles from overtaking</li> </ul> |

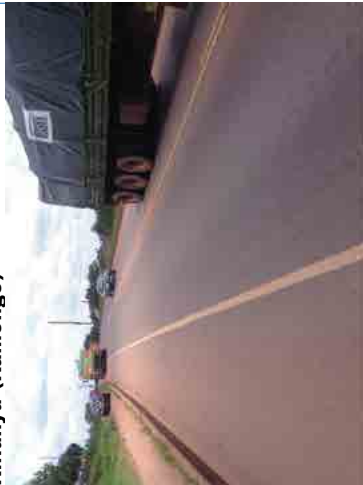
| S/N | Name of the Spot | Chain-age (Km) | Survey Observations and Findings | Analysis/Diagnosis | Suggested Recommendation for improvement |
|---|---|---|---|---|---|
| 24. | <b>Kikunyu (Kamengo)</b><br> | | <ul style="list-style-type: none"> <li>High speed section from Kampala with a blind corner.</li> <li>Road markings give priority to overtake at the corner while there is a market ahead</li> <li>Accidents caused by over speeding and recklessness</li> <li>Type of accidents: hit and run &amp; head-on collision.</li> <li>All categories of accidents at this black spot: minor, serious and fatal</li> </ul> | <ul style="list-style-type: none"> <li>Predominant accidents are mainly hit and run involving pedestrians as well as head on collisions</li> </ul> | <ul style="list-style-type: none"> <li>Provide appropriate road signs</li> <li>Enhance sensitization to all road users and enforcement of safety</li> <li>Reconfigure the road markings to prohibit descending Masaka bound vehicles from overtaking</li> </ul> |

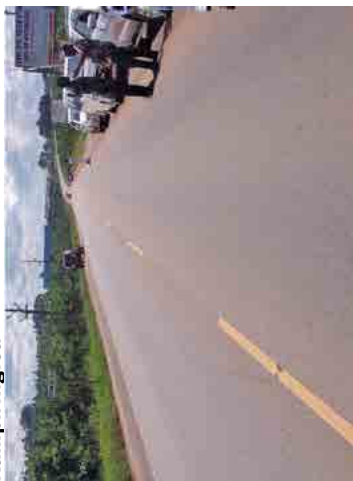
| S/N | Name of the Spot | Chain-age (Km) | Survey Observations and Findings | Analysis/Diagnosis | Suggested Recommendation for improvement |
|---|---|---|---|---|---|
| 25. | <b>Kampiringisa</b><br> | | <ul style="list-style-type: none"> <li>Accidents are mainly due to over speeding and recklessness of the drivers</li> <li>Faded road markings (edge line markings)</li> <li>Missing delineator road studs</li> </ul> | <ul style="list-style-type: none"> <li>A catastrophic accident that killed 23 people occurred at the location</li> <li>Overspeeding and dangerous overtaking need to be curbed to avert future accidents</li> </ul> | <ul style="list-style-type: none"> <li>Provide appropriate road signs</li> <li>Enhance sensitization to all road users and enforcement of safety</li> <li>Install speed cameras for speed monitoring</li> <li>Application of road marking (edge line markings) and installation of delineator road studs</li> </ul> |

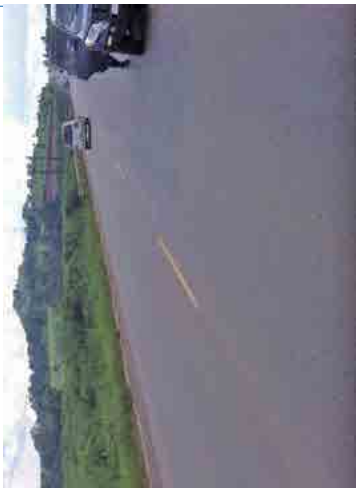
| S/N | Name of the Spot | Chain-age (Km) | Survey Observations and Findings | Analysis/Diagnosis | Suggested Recommendation for improvement |
|---|---|---|---|---|---|
| 26. | <b>Mpambire Swamp</b><br> | | <ul style="list-style-type: none"> <li>Straight stretch</li> <li>Faded road markings</li> <li>Most of accidents are head-on collisions</li> </ul> | <ul style="list-style-type: none"> <li>Accidents are mainly due to over speeding and recklessness of the drivers at the straight section of the road with proper road marking to guide the vehicles</li> </ul> | <ul style="list-style-type: none"> <li>Provide appropriate road signs</li> <li>Enhance sensitization to all road users and enforcement of safety</li> <li>Application of road marking (edge line markings) and installation of delineator road studs</li> <li>Consider reinstating and extending the guardrails to restrain errant motorists in the event of an emergency</li> <li>Install speed cameras for speed monitoring</li> </ul> |

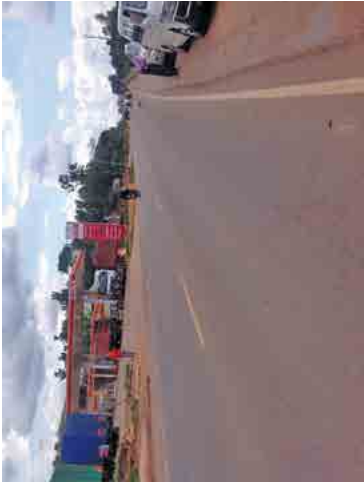
| S/N | Name of the Spot | Chain-age (Km) | Survey Observations and Findings | Analysis/Diagnosis | Suggested Recommendation for improvement |
|---|---|---|---|---|---|
| 27. | <b>Nakirebe (Near Gasline Petrol Station)</b> | | <ul style="list-style-type: none"> <li>• Straight stretch terminating into curves on a rolling-flat terrain</li> <li>• Built-up high speeding area with a fuel station close to the road</li> </ul> | <ul style="list-style-type: none"> <li>• Most accidents are head-on and rear end for vehicles joining the highway from and to the fuel station because of lack maneuverability lane by fueling trucks</li> </ul> | <ul style="list-style-type: none"> <li>• Provision of a 50kph speed limit sign and informative sign on the fuel station ahead</li> <li>• Enhance sensitization to all road users and enforcement of safety especially in regard to overspeeding and overtaking dangerously</li> <li>• Reconfigure the road markings to prohibit overtaking</li> <li>• Consider provision of acceleration and deceleration lanes at the entry and exit preferably to be implemented by the fuel station</li> <li>• In addition, redesign the section to include storage and weaving lanes to allow for turning movements into and out of the station</li> </ul> |

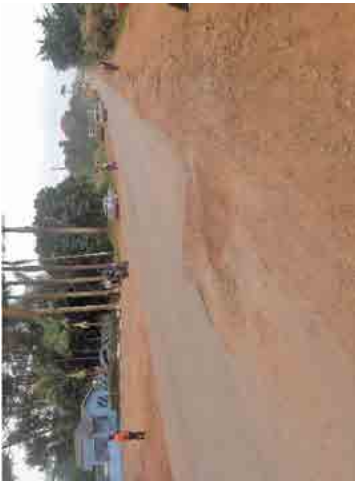
| S/N | Name of the Spot | Chain-age (Km) | Survey Observations and Findings | Analysis/Diagnosis | Suggested Recommendation for improvement |
|---|---|---|---|---|---|
| 1. | <b>Namanve (Near Rwenzori Bottling Company)</b> <p><i>Pothole on the LHS lane. Note the deteriorated edges and faded road marking</i></p> | | <ul style="list-style-type: none"> <li>• Straight section on a gentle sag curve</li> <li>• Road shoulders and part of the carriageway are eroded</li> <li>• The road is under rehabilitation</li> <li>• No road signs</li> <li>• No road markings</li> </ul> | <ul style="list-style-type: none"> <li>• Most accidents are serious to fatal caused by over speeding and reckless overtaking coupled with narrow carriage way and no road furniture</li> </ul> | <ul style="list-style-type: none"> <li>• Widening and rehabilitation of the carriageway (Dualling at the section would be more preferable owing to the traffic volumes)</li> <li>• Provision of NMT facilities along the stretch including cycle tracks and pedestrian walkways</li> <li>• Provide appropriate road signs (speed limit signs etc)</li> <li>• Application of retro-reflective road marking and installation of delineator road studs</li> <li>• Improvement of the access to Rwenzori Bottling Company (complete with speed change lanes)</li> <li>• Provision of streetlights to illuminate the stretch</li> <li>• Enhance sensitization to all road users and enforcement of safety</li> </ul> |
