**NORTHERN CORRIDOR TRANSIT AND  
TRANSPORT COORDINATION AUTHORITY**

# **REPORT ON BLACK SPOTS SURVEY** ALONG THE NORTHERN CORRIDOR ROUTES IN RWANDA AND UGANDA

**February 2020**

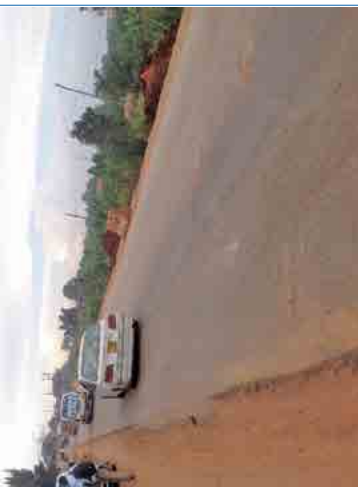
| S/N | Name of the Spot | Chain-age (Km) | Survey Observations and Findings | Analysis/Diagnosis | Suggested Recommendation for improvement |
|---|---|---|---|---|---|
| 3. | <b>Seeta High School</b><br> | | <ul style="list-style-type: none"> <li>• Road shoulders and part of the carriageway are eroded resulting to a narrow carriageway</li> <li>• Need for a climbing lane</li> <li>• Road under rehabilitation</li> <li>• Faded road marking</li> </ul> | | <ul style="list-style-type: none"> <li>• Widening and rehabilitation of the carriageway (Dualing at the section would be more preferable owing to the traffic volumes)</li> <li>• Application of retro-reflective road marking and installation of delineator road studs</li> <li>• Redesign the road markings to prohibit overtaking</li> <li>• Provision of NMT facilities along the stretch including cycle tracks and pedestrian walkways</li> <li>• Provide appropriate road signs</li> <li>• Provide speed restrictions</li> <li>• Provision of streetlights to illuminate the stretch</li> </ul> |

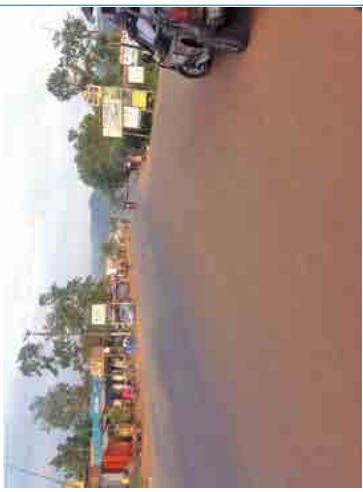
| S/N | Name of the Spot | Chain-age (Km) | Survey Observations and Findings | Analysis/Diagnosis | Suggested Recommendation for improvement |
|---|---|---|---|---|---|
| 4. | <b>Kigombya</b> <p><i>Faded road marking at the RHS junction</i></p> | | <ul style="list-style-type: none"> <li>Built-up area that requires a dual carriageway to separate traffic</li> <li>No pedestrian crossing facilities</li> <li>No road signs</li> <li>No road markings</li> </ul> | | <ul style="list-style-type: none"> <li>Provide appropriate road signs (Junction Ahead and speed limit signs)</li> <li>Application of retro-reflective road marking and installation of delineator road studs</li> <li>Redesign the road markings to prohibit overtaking</li> <li>Channelization of the RHS junction and provision of speed change lanes</li> <li>Widening and rehabilitation of the carriageway (Dualling at the section would be more preferable owing to the traffic volumes)</li> <li>Provision of NMT facilities along the stretch including cycle tracks, pedestrian walkways and designated crossing points</li> <li>Provision of streetlights to illuminate the stretch</li> <li>Provision of service lanes with controlled access in future</li> </ul> |

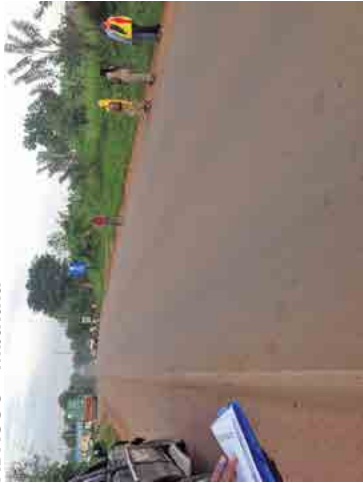
| S/N | Name of the Spot | Chain-age (Km) | Survey Observations and Findings | Analysis/Diagnosis | Suggested Recommendation for improvement |
|---|---|---|---|---|---|
| 5. | <b>ABACUS –Mbalala</b><br> | | <ul style="list-style-type: none"> <li>• Straight section connecting two blind curves</li> <li>• Faded road markings</li> <li>• No road signs</li> <li>• Accidents are roll-ons on either direction due to over speeding and reckless overtaking while avoiding head-on collisions</li> </ul> | | <ul style="list-style-type: none"> <li>• Provide appropriate road signs</li> <li>• Reestablish the road markings</li> <li>• Provide a solid centerline marking to prohibit overtaking</li> <li>• Widening/dualing of the road to enhance its capacity</li> <li>• Provide speed restrictions</li> <li>• Provide safety fences (guard rails) on either side</li> <li>• Enhance sensitization to all road users and enforcement of safety</li> </ul> |

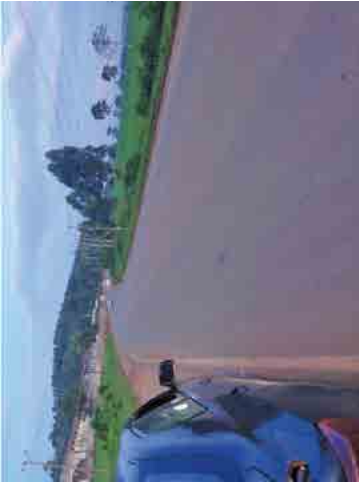
| S/N | Name of the Spot | Chain-age (Km) | Survey Observations and Findings | Analysis/Diagnosis | Suggested Recommendation for improvement |
|---|---|---|---|---|---|
| 9. | Namagongongo (Kikondo)<br> | | <ul style="list-style-type: none"> <li>Curved section on a rolling-flat terrain prone to high speeds</li> <li>No road markings</li> <li>Climbing lane has been provided for though not clearly marked</li> <li>No road signs</li> <li>Accidents are mostly due to overtaking and reckless driving</li> </ul> | | <ul style="list-style-type: none"> <li>Provide appropriate road signs</li> <li>Re-establish the road markings</li> <li>Application of road marking to mark the climbing lane</li> <li>Provide a solid centerline marking to prohibit overtaking</li> <li>Provide speed restrictions</li> </ul> |

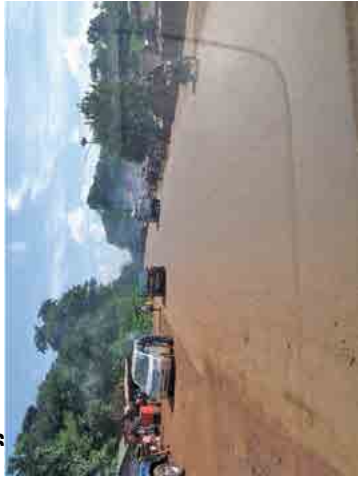
| S/N | Name of the Spot | Chain-age (Km) | Survey Observations and Findings | Analysis/Diagnosis | Suggested Recommendation for improvement |
|---|---|---|---|---|---|
| 17. | <b>Najjembe – Mabira forest</b><br><br><i>Missing bus bays at Najjembe centre</i> | | <ul style="list-style-type: none"> <li>Trading centre</li> <li>Very busy daily road side market with many road side vendors where most travelers stop to buy eats</li> <li>No clearly defined parking areas hence vehicles park on the road</li> <li>No road markings</li> <li>No pedestrian crossing facilities</li> </ul> | | <ul style="list-style-type: none"> <li>Provide appropriate road signs (speed limits on to the centre, pedestrian crossing signs etc)</li> <li>Need to widen the road</li> <li>Provide a designated pedestrian crossing at the centre</li> <li>Application of road marking to mark lane extents</li> <li>Provide a solid centerline marking to prohibit overtaking</li> <li>Limit access to the carriageway and provide service lanes</li> <li>Redesign the section to provide for temporary lay bys and designated bus bays for PSVs</li> </ul> |

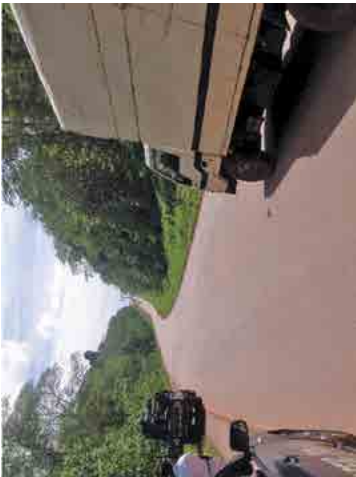
| S/N | Name of the Spot | Chain-age (Km) | Survey Observations and Findings | Analysis/Diagnosis | Suggested Recommendation for improvement |
|---|---|---|---|---|---|
| 21. | <b>Sanga-Mabira Forest</b><br> | | <ul style="list-style-type: none"> <li>A sharp combination of vertical and horizontal alignments terminating at a blind spot</li> <li>Road markings are faded</li> <li>Roadside bushes have encroached into the roadway</li> <li>Blind corner</li> <li>Climbing lane towards Kampala is not clearly visible from the Jinja direction, lacks climbing lanes signage</li> <li>Most accidents are caused by overtaking and careless driving</li> </ul> | <ul style="list-style-type: none"> <li>Vertical alignment prompts vehicle to overspeed leading to dangerous overtaking that often end in head-on accidents</li> <li>Sharp horizontal alignment creates insufficient safe stopping sight distance that causes heads-on accidents in the event of overtaking</li> </ul> | <ul style="list-style-type: none"> <li>Installation of no overtaking and speed limit signage</li> <li>Application of road marking to mark lane extents and clearly define the climbing lanes using retro-reflective paint</li> <li>Installation of beginning and end of climbing lane signage)</li> <li>Road marking prohibiting overtaking</li> <li>Clearing of the marauding roadside vegetation</li> </ul> |

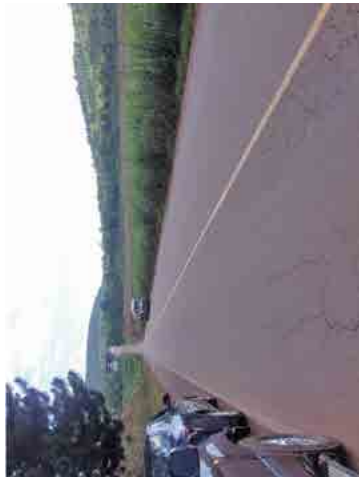
| S/N | Name of the Spot | Chain-age (Km) | Survey Observations and Findings | Analysis/Diagnosis | Suggested Recommendation for improvement |
|---|---|---|---|---|---|
| 22. | <b>Lugalambo</b><br> | | <ul style="list-style-type: none"> <li>A very straight section with gently sloping approaches</li> <li>Overgrown sugarcane obstructing the clear zone</li> <li>No visibility due to overgrowth of cane on road reserve</li> <li>Climbing lane not clearly marked</li> <li>Overtaking from both sides Kampala and Jinja leading to head-on collision</li> <li>Fading road marking</li> </ul> | <ul style="list-style-type: none"> <li>Dangerous overtaking at blind spot often leads to heads-on accidents</li> </ul> | <ul style="list-style-type: none"> <li>Clearing of the sugarcane within the road reserve</li> <li>Installation of speed limit and no overtaking warning signage</li> <li>Revision of road marking to limit overtaking</li> <li>Construction of climbing lane to widen traffic winding area at the curve</li> </ul> |

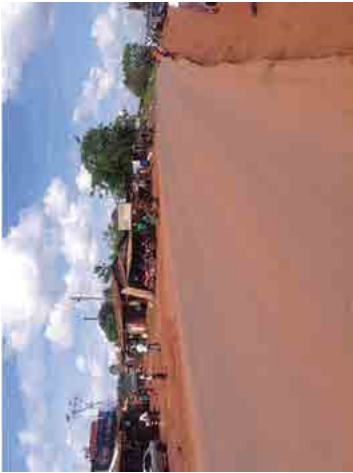
| S/N | Name of the Spot | Chain-age (Km) | Survey Observations and Findings | Analysis/Diagnosis | Suggested Recommendation for improvement |
|---|---|---|---|---|---|
| 23. | <b>Kitigoma Trading Centre</b> <p><i>Missing pedestrian crossings. Note the eroded shoulders and lack of bodaboda parking facilities</i></p> | | <ul style="list-style-type: none"> <li>A straight highway section running through a busy trading center</li> <li>Absence of shoulder and parking areas for Public Service Vehicles (PSVs)</li> <li>Crowding of boda boda facilities at the center</li> <li>Trucks and cars meet on the crest from both sides</li> </ul> | <ul style="list-style-type: none"> <li>Overspeeding through trading normally leads to pedestrian knockdowns</li> </ul> | <ul style="list-style-type: none"> <li>Provision of speed calming measures at the centre</li> <li>Speed limit signage</li> <li>Application of retro-reflective road marking and delineator road studs</li> <li>Provision of a designated pedestrian crossing with accompanying signage</li> <li>Provision of designated bus bays and parking facilities for <i>bodabodas</i></li> <li>Separation of highway traffic from town traffic through service lanes in the long term</li> </ul> |

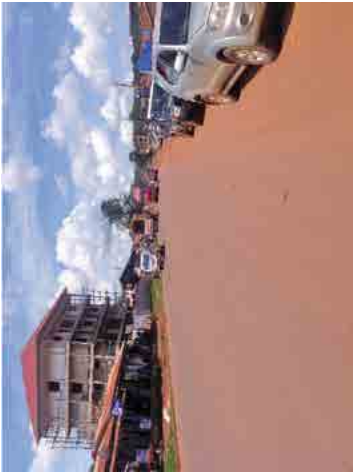
| S/N | Name of the Spot | Chain-age (Km) | Survey Observations and Findings | Analysis/Diagnosis | Suggested Recommendation for improvement |
|---|---|---|---|---|---|
| 25. | <b>Mbiko Trading Centre</b><br> | | <ul style="list-style-type: none"> <li>• Overspeeding vehicles through trading center leads to pedestrian and <i>bodaboda</i> crashes</li> <li>• Absence of road markings and appropriate signage</li> <li>• No designated pedestrian crossings and NMT facilities</li> <li>• Uncontrolled access to the main road</li> </ul> | <ul style="list-style-type: none"> <li>• Overspeeding in a crowded trading center often leads to crashes.</li> </ul> | <ul style="list-style-type: none"> <li>• Speed limit signage</li> <li>• Application of retro-reflective road marking and delineator road studs</li> <li>• Provision of speed calming measures on the approaches to the centre</li> <li>• Provision of pedestrian crossing facilities</li> <li>• In the long term, consider provision of service lanes with controlled access to the main road</li> </ul> |

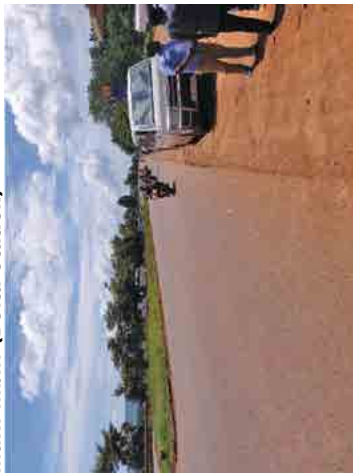
| S/N | Name of the Spot | Chain-age (Km) | Survey Observations and Findings | Analysis/Diagnosis | Suggested Recommendation for improvement |
|---|---|---|---|---|---|
| 27. | Mailii Mbili (Delta Station)<br> | | <ul style="list-style-type: none"> <li>Schools in the surroundings</li> <li>No speed limit signs</li> <li>The traffic U-turn provision for changing opposing traffic to the other at a straight and traffic-fast moving section of the highway.</li> <li>There is no transition lanes at the U-turn</li> <li>Faded road marking</li> <li>Unsafe road user behaviour by bodabodas</li> </ul> | <ul style="list-style-type: none"> <li>Absence of transition lane often leads to collision of changing traffic and the main highway traffic</li> <li>Crossing pedestrians at this straight section with provision of over 100 km traffic get involved in run-overs by speeding motorists</li> </ul> | <ul style="list-style-type: none"> <li>Elimination of the U-turn so that traffic changes are transferred to a roundabout 500 m away.</li> <li>Application of retro-reflective road marking and delineator road studs</li> <li>Enforcement of safe road user behavior by motorcyclists</li> <li>Installation of speed limits to complement the use of speed guns which are already operational</li> <li>Provision of a designated pedestrian crossing at a convenient and safe location</li> </ul> |

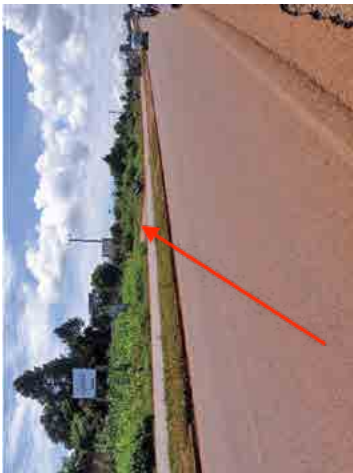
| S/N | Name of the Spot | Chain-age (Km) | Survey Observations and Findings | Analysis/Diagnosis | Suggested Recommendation for improvement |
|---|---|---|---|---|---|
| 28. | Steel Rolling Junction (Jinja Industrial Area)<br><br><i>Insufficient speed change lanes to the factory.<br/>Necessary signage also missing</i> | | <ul style="list-style-type: none"> <li>Heavy goods vehicles turning to the industrial area at a very narrow junction.</li> <li>No sign posts to indicate trucks turning ahead.</li> <li>The turning angle is too narrow for heavy vehicle with long radius of curvature</li> <li>No provision for speed change lanes at the factory</li> <li>Faded road marking</li> </ul> | <ul style="list-style-type: none"> <li>Absence of transition lane leads to either head-tail accident or overturning of heavy truck during turn negotiation</li> </ul> | <ul style="list-style-type: none"> <li>Improvement of the access to the factory to allow for sufficient turning radii</li> <li>Appropriate warning to alert motorists i.e. trucks turning ahead.</li> <li>Provision of adequate speed change lanes for heavy trucks entering or exiting the factory</li> <li>Application of retro-reflective road marking to guide motorists</li> </ul> |

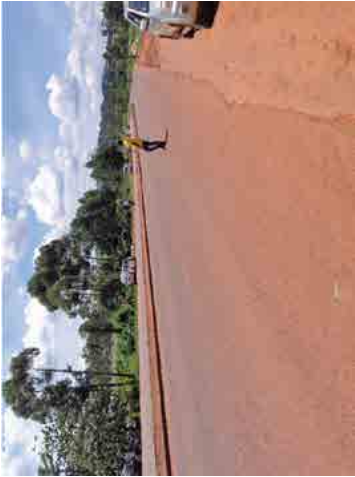
| S/N | Name of the Spot | Chain-age (Km) | Survey Observations and Findings | Analysis/Diagnosis | Suggested Recommendation for improvement |
|---|---|---|---|---|---|
| 29. | <b>Wanyama Road Area</b><br><br><i>Pedestrian crossing at a non-designated area. Road marking completely faded</i> | | <ul style="list-style-type: none"> <li>A straight section of the road through sparsely populated shopping area</li> <li>No pedestrian crossing signs and facilities</li> <li>No provision for designated bus bays</li> </ul> | <ul style="list-style-type: none"> <li>Overspeeding vehicles often involve in pedestrian crashes</li> </ul> | <ul style="list-style-type: none"> <li>Provision of pedestrian crossing facilities</li> <li>Installation of warning signage about crossing pedestrians</li> <li>Improvement of traffic refuge island to prevent motorcyclists from crossing over</li> <li>Provision of designated bus bays</li> <li>Application of retro-reflective road marking to guide motorists</li> </ul> |

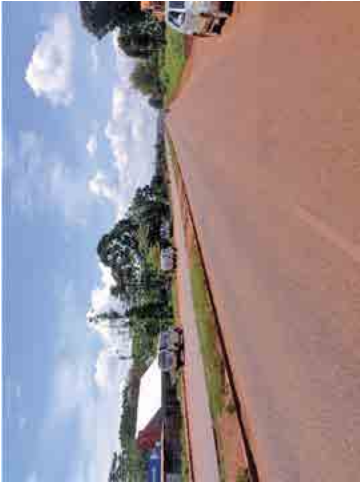
| S/N | Name of the Spot | Chain-age (Km) | Survey Observations and Findings | Analysis/Diagnosis | Suggested Recommendation for improvement |
|---|---|---|---|---|---|
| 31. | Wairaka Trading Centre<br> | | <ul style="list-style-type: none"> <li>• Overspeeding traffic runs through trading center</li> <li>• Absence of pedestrian crossing facilities</li> </ul> | <ul style="list-style-type: none"> <li>• Overspeeding traffic running through trading center leading to pedestrian crashes</li> <li>• Many fatalities are caused by pedestrian knock downs</li> </ul> | <ul style="list-style-type: none"> <li>• Provision of pedestrian crossing facilities adjacent to the provided bus bays</li> <li>• Installation of speed limit signage and road markings</li> <li>• Provision of speed calming measures</li> <li>• Sensitization of the population on dangers of overspeeding traffic through center</li> </ul> |

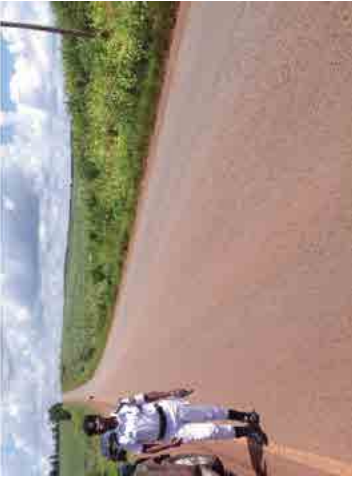
| S/N | Name of the Spot | Chain-age (Km) | Survey Observations and Findings | Analysis/Diagnosis | Suggested Recommendation for improvement |
|---|---|---|---|---|---|
| 32. | Kakira (William)<br> | | <ul style="list-style-type: none"> <li>• Careless driving and overtaking</li> <li>• Most of accidents are head-on collision</li> <li>• Rolling terrain into a deep valley on a straight section</li> <li>• Distressed carriageway pavement and failing road shoulders eats into the traffic lanes</li> </ul> | <ul style="list-style-type: none"> <li>• Overspeeding vehicles on a rolling terrain get involved heads-on collision leading to fatal and serious accidents</li> <li>• Dangerous overtaking at this section leads to accidents too</li> <li>• Traffic police mentioned over ten (10) accidents at this spot this year</li> </ul> | <ul style="list-style-type: none"> <li>• A climbing lane be provided to accommodate heavy goods vehicles and the slower vehicles.</li> <li>• Appropriate signs should be put in place to caution motorists i.e. speed limit.</li> <li>• Rehabilitation of the whole section</li> <li>• Application of retro-reflective road marking along the stretch</li> <li>• Enforcement of speed limits (speed monitoring cameras would be appropriate in light of the high number of accidents reported)</li> </ul> |

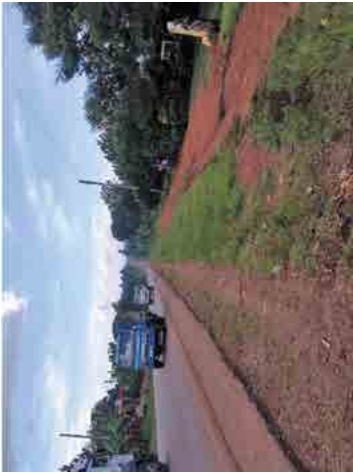
| S/N | Name of the Spot | Chain-age (Km) | Survey Observations and Findings | Analysis/Diagnosis | Suggested Recommendation for improvement |
|---|---|---|---|---|---|
| 33. | <b>Wandago (Mayuge District)</b> | | <ul style="list-style-type: none"> <li>Narrow road in the valley</li> <li>A straight section of the road with over speeding traffic</li> <li>Overtaking, hit and fall</li> <li>Most accidents are head-on collision</li> <li>Distressed pavement and failing road shoulders</li> <li>Faded road markings</li> <li>Unguarded road side ditches at the trough of the vertical curve</li> </ul> | <ul style="list-style-type: none"> <li>Overspeeding vehicles do dangerous overtaking leading to heads-on accidents or self-involving accidents that leads to fall into deep roadside ditches.</li> </ul> | <ul style="list-style-type: none"> <li>Provision of guardrails on the high embankment at the trough of the vertical curve</li> <li>Road marking and installation of road signs</li> <li>Rehabilitation of failing pavement</li> <li>Installation of hazard marker and height restriction signs at the bridge near the location</li> </ul> |

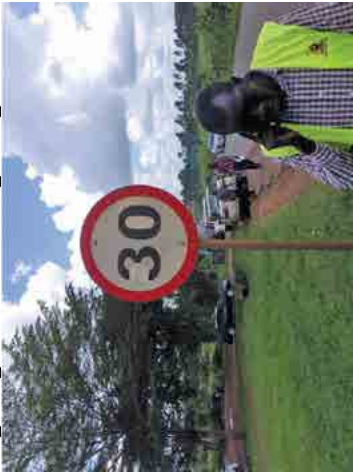
| S/N | Name of the Spot | Chain-age (Km) | Survey Observations and Findings | Analysis/Diagnosis | Suggested Recommendation for improvement |
|---|---|---|---|---|---|
| 34. | <b>Magamaga Police St. Weighbridge</b> <p><i>Speed limit sign erroneously reflects as 80kph during the night</i></p> | | <ul style="list-style-type: none"> <li>Wrong speed limit signage. It was 80Km before installation of the weighbridge which has been changed into 30Km after weighbridge installation. The same sign post reads 30 during the day and 80 during the night.</li> <li>Overspeeding vehicles before the weighbridge</li> <li>Deep roadside ditches</li> <li>Distressed pavement</li> </ul> | <ul style="list-style-type: none"> <li>Dangerous overtaking by overspeeding vehicles leads to heads-on accidents</li> </ul> | <ul style="list-style-type: none"> <li>Improvement of signage and road marking</li> <li>Replacement of the speed limit sign board with a new 30kph speed limit sign</li> <li>Rehabilitation of the stretch</li> <li>Installation of safety guardrail on the high embankment sections</li> </ul> |

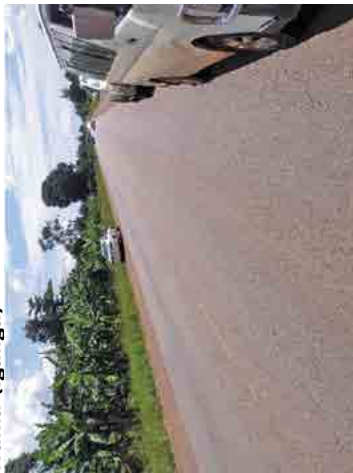
| S/N | Name of the Spot | Chain-age (Km) | Survey Observations and Findings | Analysis/Diagnosis | Suggested Recommendation for improvement |
|---|---|---|---|---|---|
| 35. | <b>Waina (Iganga)</b> | | <ul style="list-style-type: none"> <li>• Straight long road section</li> <li>• Missing speed control markings and signage</li> <li>• Distressed pavement and failing road shoulder reduces traffic lane areas</li> <li>• Most of accidents here are head-on collision</li> </ul> | <ul style="list-style-type: none"> <li>• Overspeeding vehicles on this straight section get involved in heads-on accident due to dangerous overtaking</li> <li>• Four (4) pilgrims reported to have been fatally injured at the location</li> </ul> | <ul style="list-style-type: none"> <li>• Rehabilitation of road pavement</li> <li>• Appropriate road marking and signage</li> <li>• Sensitization and enforcement to ensure safe driving practices</li> </ul> |

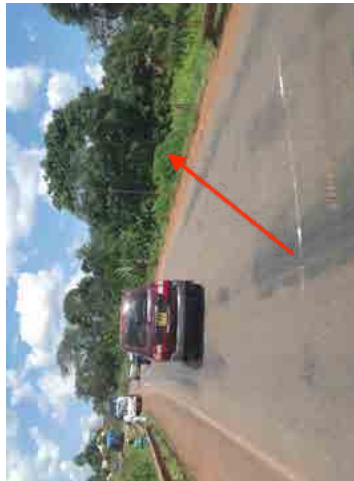
| S/N | Name of the Spot | Chain-age (Km) | Survey Observations and Findings | Analysis/Diagnosis | Suggested Recommendation for improvement |
|---|---|---|---|---|---|
| 36. | <b>Namasoga</b> <p><i>Missing safety fences. Accident involving a medium goods vehicle carrying agricultural produce on the LHS</i></p> | | <ul style="list-style-type: none"> <li>• A long combination of vertical and horizontal alignment</li> <li>• Insufficient road signage and markings</li> <li>• No/faded road markings affecting visibility.</li> <li>• Vehicles Over speeding.</li> <li>• No sign posts to indicate speed limit.</li> </ul> | <ul style="list-style-type: none"> <li>• Dangerous overtaking leads to heads-on accidents.</li> </ul> | <ul style="list-style-type: none"> <li>• Road markings should be repainted and replaced i.e. the overtaking line mark be replaced with a thick line restricting overtaking.</li> <li>• Appropriate signs should be put in place to warn/alert motorists i.e. speed limit.</li> <li>• Reinstatement of damaged safety fences</li> <li>• Sustained sensitization and enforcement</li> </ul> |

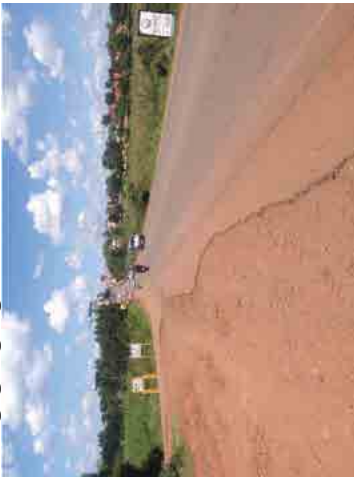
| S/N | Name of the Spot | Chain-age (Km) | Survey Observations and Findings | Analysis/Diagnosis | Suggested Recommendation for improvement |
|---|---|---|---|---|---|
| 38. | <b>Walugogo-Iganga Junction.</b><br> <p><i>Missing speed change lanes at the LHS junction</i></p> | | <ul style="list-style-type: none"> <li>A tight junction joining a main Malaba-Kampala highway</li> <li>Traffic Police mentioned accidents every week at this spot caused by motorists entering Iganga</li> <li>Access on the LHS lacks speed change lanes</li> <li>Missing speed calming measures on the approaches to the junction</li> </ul> | <ul style="list-style-type: none"> <li>Joining traffic often collide with speeding motorists on the highway leading to fatal and serious accidents</li> </ul> | <ul style="list-style-type: none"> <li>Provide retroreflective road marking at the location and delineator road studs at the junction</li> <li>Improvement of the junction and introduction of speed change lanes</li> <li>Widening of the carriageway to accommodate storage lanes</li> <li>Provision of speed calming measures</li> </ul> |

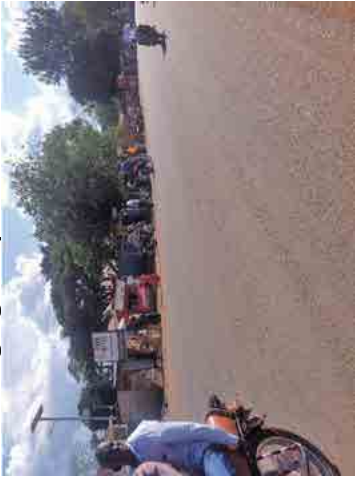
| S/N | Name of the Spot | Chain-age (Km) | Survey Observations and Findings | Analysis/Diagnosis | Suggested Recommendation for improvement |
|---|---|---|---|---|---|
| 39. | <b>Nakavule-Iganga Hospital</b> <p><i>Location has a high number cross road movements by pedestrians but lacks crossing facilities</i></p> | | <ul style="list-style-type: none"> <li>Overspeeding motorists through congested settlements and especially involving pedestrians visiting Iganga hospital</li> <li>Insufficient provision of Public Service Vehicle parking facilities</li> <li>All types of accidents are observed here: minor, serious and fatal</li> </ul> | <ul style="list-style-type: none"> <li>Overspeeding motorists involve pedestrian crashes, involving fatal and serious accidents</li> </ul> | <ul style="list-style-type: none"> <li>Provision of pedestrian crossing facilities</li> <li>Provision of a footbridge as a long term solution</li> <li>Speed control factors in the form of speed calming measures (speed humps, rumble strips)</li> <li>Provide retroreflective road marking at the location and delineator road studs</li> <li>Installation of speed limit signs</li> </ul> |

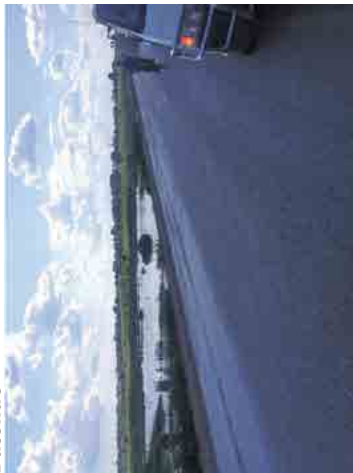
| S/N | Name of the Spot | Chain-age (Km) | Survey Observations and Findings | Analysis/Diagnosis | Suggested Recommendation for improvement |
|---|---|---|---|---|---|
| 41. | <b>Butende</b> | | <ul style="list-style-type: none"> <li>• Deep clear zone at the bridge approach</li> <li>• Bridge with deep clear zone</li> <li>• Distressed pavement</li> </ul> | <ul style="list-style-type: none"> <li>• Deep clear zone at the bridge approach normally leads to tip over.</li> <li>• The area is marred by visibility problems in the morning hours due to fog</li> </ul> | <ul style="list-style-type: none"> <li>• Rehabilitation of the pavement</li> <li>• Provision of proper signage</li> <li>• Provision of retro-reflective road marking(consider restricting overtaking)</li> <li>• Provide guardrails on both sides of the road to avoid cars/trucks going off in the swamp</li> </ul> |

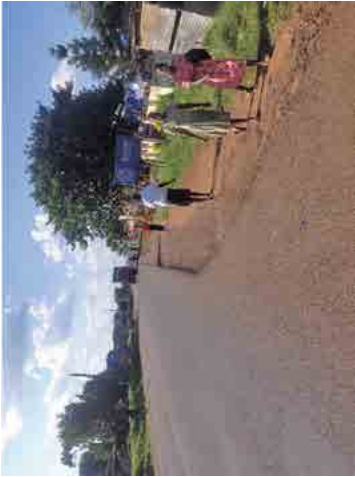
| S/N | Name of the Spot | Chain-age (Km) | Survey Observations and Findings | Analysis/Diagnosis | Suggested Recommendation for improvement |
|---|---|---|---|---|---|
| 47. | <b>Bugiri Town-Centenary Bank</b> | | <ul style="list-style-type: none"> <li>Town located at the end of a descent from the Malaba side</li> <li>Missing/faded road markings affecting judgment of traffic channeling.</li> <li>No signage to indicate speed limit and humps ahead.</li> <li>Dangerous humps ahead.</li> <li>Careless overtaking /over speeding</li> <li>Heavily loaded trucks trying to freewheel/ overtake as they approach the town leading to serious accidents in case of loss of control</li> </ul> | <ul style="list-style-type: none"> <li>Speeding motorists through the center get involved in pedestrian crashes</li> <li>Police traffic mentioned 5 fatal accidents have been reported in the past year involving trailers in head-on collision</li> </ul> | <ul style="list-style-type: none"> <li>Provision of appropriate signs (speed limit and speed humps ahead warning signs)</li> <li>Provision of speed calming measures (rumble strips at regular intervals) on the sloping approach from the Malaba side.</li> <li>Provision of pedestrian crossing facilities at the town (raised pedestrian crossings/ table tops are more desirable at such a town as they double up as speed calming measures)</li> <li>Application of retro-reflective road marking to replace the already faded paint</li> <li>Installation of cameras for speed control especially from the Malaba side approach</li> </ul> |

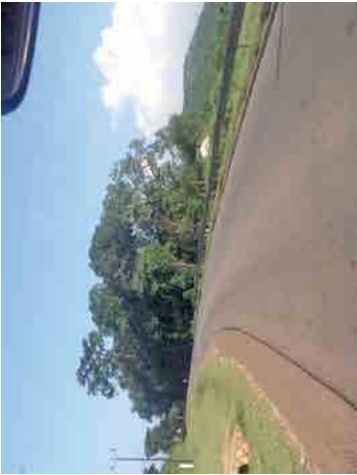
| S/N | Name of the Spot | Chain-age (Km) | Survey Observations and Findings | Analysis/Diagnosis | Suggested Recommendation for improvement |
|---|---|---|---|---|---|
| 54. | <b>Namutere Trading Centre</b> | | <ul style="list-style-type: none"> <li>• Overspeeding traffic through crowded trading center</li> <li>• Sharp corners turning to the center</li> </ul> | <ul style="list-style-type: none"> <li>• Overspeeding vehicles through the center normally get involved in accidents with pedestrians, <i>bodaboda</i> riders and PSVs at the center</li> </ul> | <ul style="list-style-type: none"> <li>• Provision of speed calming measures</li> <li>• Provision of advance warning signs (sharp curve ahead, speed limit, pedestrian crossing signs etc)</li> <li>• Provision of designated <i>bodaboda</i> parking facilities</li> <li>• Provision of appropriate road markings with emphasis on continuous yellow centerlines at the curves</li> <li>• Sensitization of road users including motorists and pedestrians</li> </ul> |

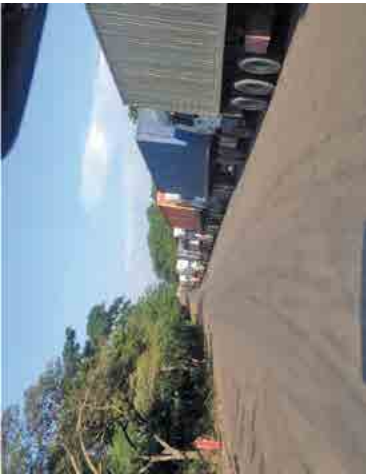
| S/N | Name of the Spot | Chain-age (Km) | Survey Observations and Findings | Analysis/Diagnosis | Suggested Recommendation for improvement |
|---|---|---|---|---|---|
| 55. | <b>Busitema Weighbridge</b> <p><i>Abnormally long queue at the weighbridge entrance by heavy goods vehicles blocking through traffic</i></p> | | <ul style="list-style-type: none"> <li>• Crowding weighbridge traffic spills onto the main carriageway</li> <li>• Distressed pavement</li> <li>• Overgrown tree branches and twigs jutting into the carriageway</li> </ul> | <ul style="list-style-type: none"> <li>• Congestion at the weighbridge points causes traffic jam and accidents as through traffic try to overtake</li> </ul> | <ul style="list-style-type: none"> <li>• Provision of ample traffic storage facilities at the weighbridge to address the long queues (consider separate entrance pavements)</li> <li>• Application of retro-reflective road marking to replace the already faded paint</li> <li>• Trimming of the overgrown twigs and branches to increase sight distances for motorists</li> </ul> |

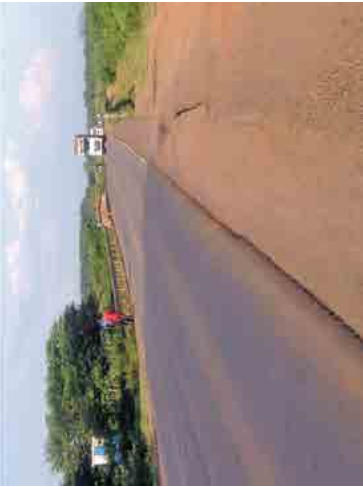
| S/N | Name of the Spot | Chain-age (Km) | Survey Observations and Findings | Analysis/Diagnosis | Suggested Recommendation for improvement |
|---|---|---|---|---|---|
| 59. | <b>Ndaiga Bridge</b><br> <p><i>Missing signage on the approaches to Ndaiga Bridge</i></p> | | <ul style="list-style-type: none"> <li>Blind corner from the Malaba side that most motorists fail to negotiate</li> <li>Missing hazard demarcation and bridge ahead advance warning signs</li> <li>Missing delineator road studs to mark the lane extents at the bridge</li> <li>Careless driving leading to head-on collisions</li> <li>Over speeding</li> </ul> | <ul style="list-style-type: none"> <li>Traffic Police reported that 7 people died at this spot last month due to over speeding when the vehicle lost control</li> </ul> | <ul style="list-style-type: none"> <li>Provision of appropriate signs at and on the approaches to the bridge (hazard marker signs, bridge ahead signs, sharp curve ahead at the Malaba side etc)</li> <li>Application of retro-reflective road marking to replace the already faded paint</li> <li>Installation of delineator road studs at the bridge to separate the live carriageway from the pedestrian footpaths</li> <li>Sensitization of the communities around this section of the road</li> <li>Enforcement by relevant agencies to prevent dangerous practices by road users</li> </ul> |

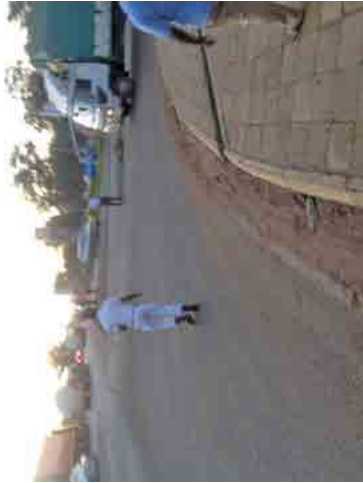
| S/N | Name of the Spot | Chain-age (Km) | Survey Observations and Findings | Analysis/Diagnosis | Suggested Recommendation for improvement |
|---|---|---|---|---|---|
| 62. | <b>Corner (Tororo/Mbale Junction)</b> | | <ul style="list-style-type: none"> <li>• Overspeeding and dangerous driving</li> <li>• Traffic confusion due to lack of storage/weaving lanes</li> <li>• Faded road marking at the junction</li> <li>• Motorcyclist crowding</li> <li>• Bodaboda entering the highway without due regard for other traffic</li> <li>• No street lights</li> </ul> | | <ul style="list-style-type: none"> <li>• Provision of storage/weaving lanes along the main highway to allow for turning movements</li> <li>• Installation of necessary signage at the junction (Advance Directional signs on main road and Stop/Give Way signs at access roads)</li> <li>• Application of retro-reflective road marking and installation of delineator road studs at the junction</li> <li>• Provision of streetlights to illuminate the important junction</li> </ul> |

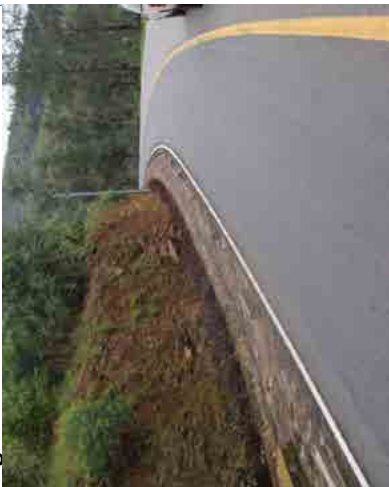
| S/N | Name of the Spot | Chain-age (Km) | Survey Observations and Findings | Analysis/Diagnosis | Suggested Recommendation for improvement |
|---|---|---|---|---|---|
| 1. | <b>Kigali</b><br> | | <ul style="list-style-type: none"> <li>The beginning of the NR2 from Kigali is characterized by a winding alignment ascending a hilly to mountainous terrain leading to successive combinations of horizontal and vertical curves. General observations include: <ul style="list-style-type: none"> <li>Lack of climbing lanes along the long and steep gradients creating significant snarl ups and safety hazards as ascending motorists try to overtake</li> </ul> </li> </ul> | <ul style="list-style-type: none"> <li>Due to the orientation of the road, run off collisions are likely to be catastrophic.</li> <li>To improve on visibility, streetlights have been installed to illuminate the road at night.</li> <li>Further interventions are still required to make the section safer.</li> </ul> | <ul style="list-style-type: none"> <li>The road is 3.5m width, Consider provision of climbing lanes as the ultimate medium to long term solution.</li> <li>Provision of pedestrian walkways especially in the densely populated areas.</li> <li>Clearing of vegetation and protruding branches within the road reserve.</li> <li>Installation of more safety fences to secure the sharp curves on high and steep embankment.</li> <li>Installation of retro-reflective delineator road studs.</li> </ul> |

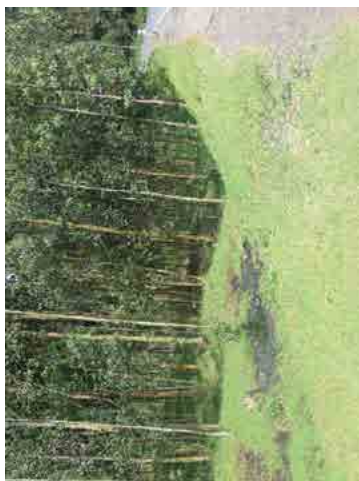
| S/N | Name of the Spot | Chain-age (Km) | Survey Observations and Findings | Analysis/Diagnosis | Suggested Recommendation for improvement |
|---|---|---|---|---|---|
| | <p><i>Evidence of a recent run-off collision</i></p> | | <ul style="list-style-type: none"> <li>Damaged road shoulders/deteriorating pavement edges.</li> </ul> | | <p>In the long term, consider the following:</p> <ul style="list-style-type: none"> <li>Widening of the carriageway and re-designing of the section to allow for a more gentle curve with sufficient super elevation</li> <li>Construction of an off-road truck run-away ramp/arrester bed for emergency use by heavy vehicles that might lose control.</li> </ul> |

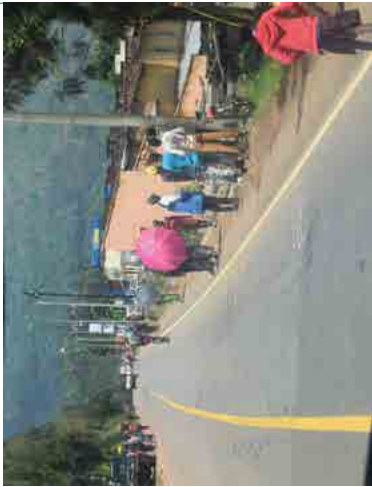
| S/N | Name of the Spot | Chain-age (Km) | Survey Observations and Findings | Analysis/Diagnosis | Suggested Recommendation for improvement |
|---|---|---|---|---|---|
| | <p><i>shoulders at Buranga centre exposing pedestrians to vehicular traffic</i></p> <p><i>Steep vertical slopes with no provision for climbing lanes.</i></p> | | <p><b>Buranga – Musanze section (Gakenke District)</b></p> <p>The section is characterized by long steep, and climbing terrains. Observations made include:</p> <ul style="list-style-type: none"> <li>• No provision for climbing lanes has been made creating snarl ups and safety hazards as ascending motorists try to overtake.</li> <li>• Inadequate warning signage along the mountainous terrain</li> </ul> | <p>Long steep and climbing terrain makes it difficult for ascending motorists and especially heavy goods vehicles. Absence of climbing lane prompts small vehicles to get involved in head-on crashes as they attempt to overtake.</p> | <ul style="list-style-type: none"> <li>• Robust sensitization and awareness campaigns educating locals on the dangers of hanging onto trucks</li> <li>• Enforcement by relevant agencies to eradicate unsafe/risky road user behavior</li> <li>• Installation of enhanced signage warning motorists to proceed with caution, for instance, 'No overtaking', 'Steep slope ahead' and speed limit signs</li> <li>• In the long term, consider provision of climbing lanes alongside the ascending lanes to make the road safer</li> </ul> |
