**NORTHERN CORRIDOR TRANSIT AND  
TRANSPORT COORDINATION AUTHORITY**

# **REPORT ON BLACK SPOTS SURVEY** ALONG THE NORTHERN CORRIDOR ROUTES IN RWANDA AND UGANDA

**February 2020**

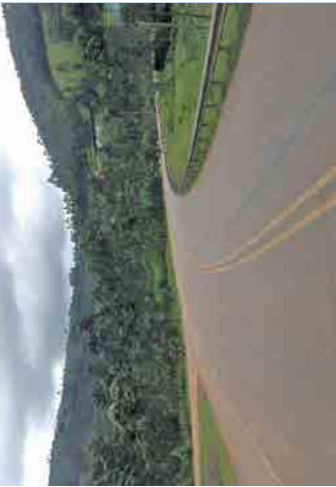
| S/N | Name of the Spot | Chain-age (Km) | Survey Observations and Findings | Analysis/Diagnosis | Suggested Recommendation for improvement |
|---|---|---|---|---|---|
| 1. | <b>Nyakasharara (12Km from Katuna)</b> <p><i>Dangerous combination of horizontal and vertical curves merging at a trading centre</i></p> | 12 | <ul style="list-style-type: none"> <li>Sharp combination of horizontal and vertical alignments merging at a trading center</li> <li>Roadside market draws people along the highway in the evenings</li> <li>Speed calming measures (rumble strips) are provided but far from hazardous spot.</li> <li>No sharp curve ahead and speed limit signs</li> <li>Accidents recorded are mainly fatal involving crossing pedestrians due to over speeding vehicles</li> <li>70% of people killed are pedestrians</li> </ul> | <ul style="list-style-type: none"> <li>Vehicles/ drivers mainly heavy goods vehicles from Kabaale to Katuna fail to negotiate the sharp curve/ corner at the shopping Centre leading to pedestrian deaths.</li> <li>The sharp curve/ corner is in a built-up area.</li> </ul> | <ul style="list-style-type: none"> <li>Provision of a designated pedestrian crossing facility</li> <li>Installation of enhanced road signage to limit approach speeds and warn motorists of the dangerous sharp curve</li> <li>Enhanced road user sensitization and enforcement of safety by relevant agencies</li> <li>Installation of speed cameras to monitor travel speeds</li> <li>Provision of off-road truck run away ramps/sand arrester beds for vehicles that veer off at the curve</li> <li>Provision of streetlights to illuminate the area at night</li> <li>Designation of shopping spot off the road at a safe distance away from the road to decongest the road area</li> </ul> |

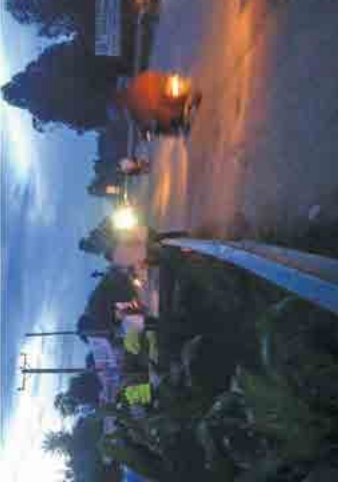
| S/N | Name of the Spot | Chain-age (Km) | Survey Observations and Findings | Analysis/Diagnosis | Suggested Recommendation for improvement |
|---|---|---|---|---|---|
| 8. | <b>Nyamitanga-Isingiro Junction with Kabale-Mbarara Highway (2km from Mbarara)</b><br><br><i>Insufficient turning radii and missing speed change lanes at the junction</i> | | <ul style="list-style-type: none"> <li>Narrow Side road junction joined to the blind sharp curve</li> <li>Lack of enough waiting space for the vehicles joining the highway</li> <li>Insufficient turning radius at the junction hence turning vehicles occupy outer lanes causing side swipe collisions</li> </ul> | <ul style="list-style-type: none"> <li>Medium and heavy goods vehicles mainly carrying agricultural produce tend to overturn while descending towards the junction</li> </ul> | <ul style="list-style-type: none"> <li>Enhance road signage at the junction i.e Give Way/Stop signage from the access road and Junction Ahead signs on the main highway</li> <li>Enhance driver sensitization and training to encourage safe road user behaviour</li> <li>Re-designing and improvement of the junction to provide for adequate turning radii and speed change (acceleration and deceleration) lanes</li> <li>Clearing of vegetation and establishments near the junction to increase visibility splays</li> </ul> |

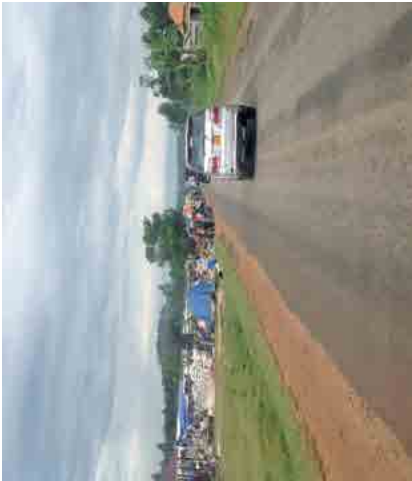
| S/N | Name of the Spot | Chain-age (Km) | Survey Observations and Findings | Analysis/Diagnosis | Suggested Recommendation for improvement |
|---|---|---|---|---|---|
| 1. | <b>Kagango Market (Kabwohe) (26Km from Mbarara)</b> <p><i>Market vendors have encroached into the road reserve. No designated crossing points are in place along the stretch</i></p> | | <ul style="list-style-type: none"> <li>• Straight stretch on a flat terrain</li> <li>• Daily road side market (3 months old at the time of the survey) close to the road</li> <li>• No pedestrian crossing facilities have been provided for</li> <li>• No speed limit signage despite Traffic Police ensuring that speed limit is 50 Km on the stretch</li> </ul> | <ul style="list-style-type: none"> <li>• Accidents mainly involve pedestrians and people chasing grasshoppers ending up on the road</li> <li>• Accidents mainly attributable to reckless driving/overspeeding and pedestrians accessing the live carriageway heedless of traffic</li> </ul> | <ul style="list-style-type: none"> <li>• Provision of appropriate road signs</li> <li>• Installation of speed humps and rumble strips to lower approach speeds to the market centre</li> <li>• Provision of designated pedestrian crossings for safe cross road movements (raised pedestrian crossings/table tops are more desirable as they also act as speed calming measures)</li> <li>• Application of retro-reflective road marking on the road and installation of delineator road studs</li> <li>• Relocation of the market beyond the road reserve</li> <li>• Develop a policy for all developments along the roads</li> </ul> |

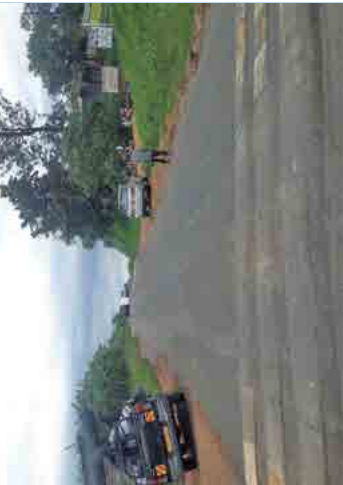
| S/N | Name of the Spot | Chain-age (Km) | Survey Observations and Findings | Analysis/Diagnosis | Suggested Recommendation for improvement |
|---|---|---|---|---|---|
| 3. | <b>Kitojo (Sheema district) (35Km from Mbarara)</b> | | <ul style="list-style-type: none"> <li>A steep slope connecting a small sag and crest curve</li> <li>There is a seasonal market that operates every after two weeks</li> <li>Existing humps which were provided to reduce speed have become a hazard to the ascending trucks which fail and decelerate backwards hence overturning</li> <li>Side road junction located midway along the slope and lacks accelerating and decelerating lanes</li> <li>Deteriorated road edges and faded road marking</li> </ul> | <ul style="list-style-type: none"> <li>Accidents are mainly caused by over speeding, reckless driving and failure of heavy trucks to ascend steep horizontal alignment</li> <li>Slowly climbing heavy trucks block the road leading to unwarranted overtaking by small vehicles, causing head-on or single accidents</li> </ul> | <ul style="list-style-type: none"> <li>Provide appropriate road signs (speed limit and sharp curve ahead signage)</li> <li>Improve on the existing humps</li> <li>Repair of the deteriorated edges and application of appropriate road marking</li> <li>Enhance road user sensitization and driver training</li> <li>Widen the road to provide for a climbing lane</li> <li>Review the geometric design to reduce the crest and sag curves</li> <li>Redesign the side road junction to provide adequate turning radius including acceleration and deceleration lanes</li> <li>Consider installation of speed cameras as long term mitigation measure</li> </ul> |

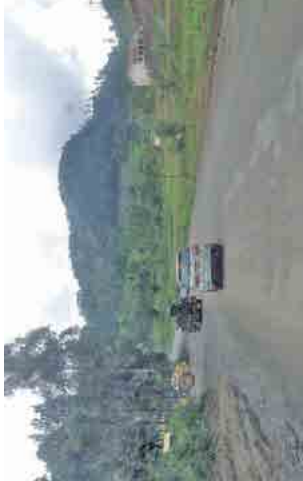
| S/N | Name of the Spot | Chain-age (Km) | Survey Observations and Findings | Analysis/Diagnosis | Suggested Recommendation for improvement |
|---|---|---|---|---|---|
| 10. | <b>Lake Nkunge in Rutoto District</b> <p><i>Sharp curve next to the lake with limited sight distances</i></p> | | <ul style="list-style-type: none"> <li>Sharp curve around lake Nkugute</li> <li>Accidents are due to over speeding and reckless overtaking</li> <li>Dead bodies are thrown in the lake</li> </ul> | | <ul style="list-style-type: none"> <li>Provide appropriate road signs (speed limit and sharp curve ahead)</li> <li>Enhance road user sensitization and driver training</li> <li>Provide adequate curve radius</li> <li>Install speed cameras to monitor speed</li> </ul> |

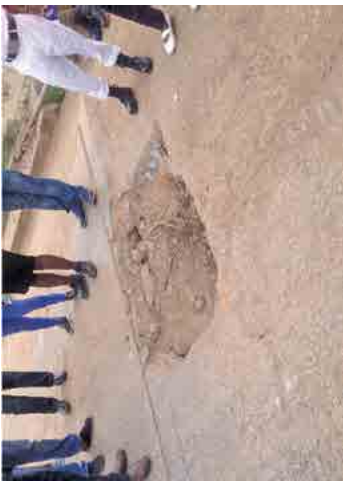
| S/N | Name of the Spot | Chain-age (Km) | Survey Observations and Findings | Analysis/Diagnosis | Suggested Recommendation for improvement |
|---|---|---|---|---|---|
| 13. | <b>Katunguru (Kazinga Channel Bridge) -located at the separation of Lake George and Lake Edward</b><br> <p><i>Gaping hole on the middle of the bridge deck carriageway</i></p> <p><i>Pothole ridden bridge approach with missing hazard marker signs</i></p> | | <ul style="list-style-type: none"> <li>The Bridge is damaged on the Kyambura side approach (bridge deck failure has left a gaping hole in the middle of the carriageway) resulting into a black spot</li> <li>The bridge handles huge volumes of traffic of taxis, trucks and buses on a daily basis hence paralyzing traffic</li> <li>Narrow carriageway with pothole ridden approaches on the Kyambura approach</li> <li>Missing/non-reflective hazard marker signs on the bridge approaches</li> </ul> | <ul style="list-style-type: none"> <li>The portal frame bridge crosses the channel joining Lake George and Lake Edward</li> </ul> | <ul style="list-style-type: none"> <li>During the survey UNRA decided to close Katunguru Bridge, which connects Kasese and Rubirizi districts, after it got damaged.</li> <li>Kasese road traffic was therefore diverted to allow for remedial works</li> <li>Consider rehabilitating the approaches to rid them of potholes</li> <li>Installation of bridge ahead and hazard marker signs</li> <li>In the long term, consider widening the bridge and provision of pedestrian walkways</li> </ul> |

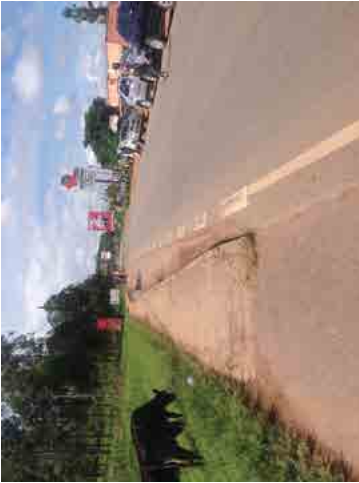
| S/N | Name of the Spot | Chain-age (Km) | Survey Observations and Findings | Analysis/Diagnosis | Suggested Recommendation for improvement |
|---|---|---|---|---|---|
| 1. | <b>Makenke (3km from Mbarara towards Masaka)</b> <p><i>Unclogging of the access culvert due to blockage by debris and tree stumps from the upstream</i></p> <p>Dangerously oriented kerbstone adjacent to the live carriageway</p> | | <ul style="list-style-type: none"> <li>Carriageway is higher than the shoulder</li> <li>Bodaboda riders hit the floor on the side and fall in the road where they are knocked by moving vehicles</li> <li>Bus stop bays on both sides are narrow (i.e. parked vehicles occupy part of the carriageway) and poorly designed leaving no space for the cyclists transiting from the shoulder to carriageway</li> <li>The provided pedestrian walkway has encroached on the road shoulders</li> <li>No pedestrian crossing facilities</li> <li>No speed limit signage</li> </ul> | <ul style="list-style-type: none"> <li>Motorcyclists tend to climb up the kerbstone due to absence/ inadequacy of road shoulders</li> <li>Accidents mainly involve pedestrians' cyclists transiting from shoulders to carriageway at bus stops</li> </ul> | <ul style="list-style-type: none"> <li>Provide appropriate road signs</li> <li>Provide pedestrian crossing facilities</li> <li>Redesign and reconstruct the bus stop bays to allow for adequate stopping</li> <li>Removal of the current pavement</li> <li>Provide smooth transition to carriageway from the shoulder for cyclists</li> </ul> |

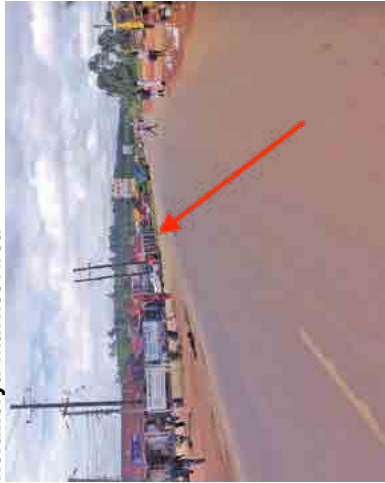
| S/N | Name of the Spot | Chain-age (Km) | Survey Observations and Findings | Analysis/Diagnosis | Suggested Recommendation for improvement |
|---|---|---|---|---|---|
| 2. | <b>Koranorya Market Area</b> <p><i>Access to Koranorya Daily Market. Note the significant cross road movements by pedestrians due to the roadside establishments</i></p> | | <ul style="list-style-type: none"> <li>The area is known for its huge number of accidents in the whole country</li> <li>Straight stretch of about 1Km in a very busy built-up area including a daily market</li> <li>No pedestrian crossing facilities Pedestrians and riders are hit while crossing to the market</li> <li>Road markings give the drivers freedom of overtaking</li> <li>No speed limit signs</li> <li>No designated stopping areas on both sides hence vehicles park on the road shoulders occupying part of the carriageway</li> <li>Side road junction lacks accelerating and decelerating lanes</li> <li>Accidents happen both day and night times</li> </ul> | <ul style="list-style-type: none"> <li>Double parking (both sides) is common during the night due to stoppages by truckers on transit effectively narrowing the road</li> </ul> | <ul style="list-style-type: none"> <li>Provide appropriate road signs</li> <li>Provide designated pedestrian crossing (raised pedestrian crossings/table tops are more desirable as they double up as speed calming measures)</li> <li>Provide speed limits along the area</li> <li>Provide traffic calming measures</li> <li>Enhance sensitization to all road users and enforcement of safety</li> <li>Redesign the side road junction to Koranorya market to provide for adequate turning radius and speed change (acceleration and deceleration) lanes</li> <li>Provide designated parking areas (elongated lay bys) on either side of the road as well as designated bus bays</li> <li>In the long term, consider provision of service lanes with controlled access to the main road</li> </ul> |

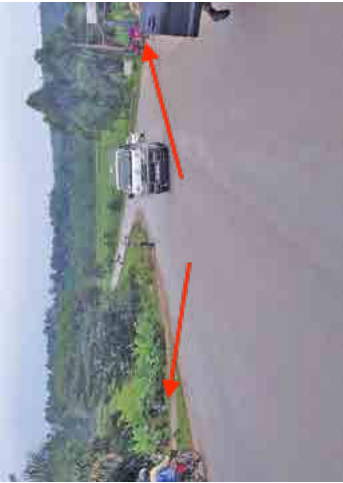
| S/N | Name of the Spot | Chain-age (Km) | Survey Observations and Findings | Analysis/Diagnosis | Suggested Recommendation for improvement |
|---|---|---|---|---|---|
| 15. | <b>Kyakumpi</b> <p><i>Accesses to main carriageway traffic just after a bend</i></p> | | <ul style="list-style-type: none"> <li>Staggered intersection with multiple accesses consisting of side roads with inadequate turning radius at the beginning of a steep ascent</li> <li>Absence of road markings</li> <li>Insufficient signage especially at the feeder roads/accesses to the main highway signage</li> <li>Humps are provided to reduce speed</li> <li>Junctions have no storage and weaving lanes</li> <li>Damaged guardrails at the curve</li> </ul> | <ul style="list-style-type: none"> <li>Accidents mainly involve incoming traffic from the feeder roads</li> <li>Accidents at the location involve all road users –pedestrians, motorcycles and vehicles</li> </ul> | <ul style="list-style-type: none"> <li>Application of retroreflective road marking (emphasis on a continuous centre line to restrict overtaking) and installation of delineator road studs</li> <li>Provide appropriate road signs (speed limit, junction ahead and pedestrian crossing warning signs)</li> <li>Installation of Stop/Give Way signs at the accesses joining the main road</li> <li>Reinstatement of the damaged safety fences</li> <li>Enhance sensitization to all road users and enforcement of safety</li> <li>Junction improvement at the access roads to allow for speed change lanes as well as weaving/storage lanes on the main highway</li> <li>As a long term measure, consider service lanes with controlled accesses</li> </ul> |

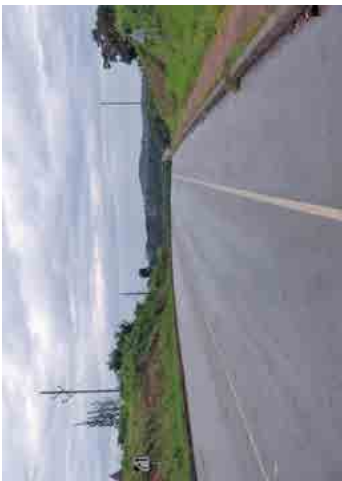
| S/N | Name of the Spot | Chain-age (Km) | Survey Observations and Findings | Analysis/Diagnosis | Suggested Recommendation for improvement |
|---|---|---|---|---|---|
| 17. | <b>Kamutuza</b> <p><i>Both climbing lanes at a vertical crest with limited sight distances</i></p> | | <ul style="list-style-type: none"> <li>Descending vehicles have the freedom to overtake as a result of poor road markings</li> <li>Limited sight distances at the vertical crest from either side</li> <li>Speeding motorists, dangerous overtaking</li> </ul> | <ul style="list-style-type: none"> <li>Accidents occur at climbing lane termination point due to overspeeding and absence of proper markings and signage</li> </ul> | <ul style="list-style-type: none"> <li>Provide appropriate road signs (consider informative signs cautioning against overtaking and urging motorists to observe lane discipline)</li> <li>Enhance sensitization to all road users and enforcement of safety</li> <li>Reconfigure the road markings to prohibit descending vehicles from overtaking</li> </ul> |

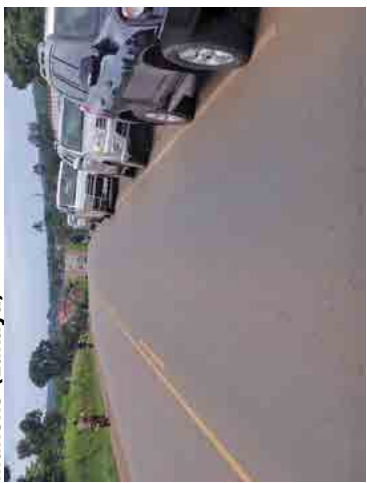
| S/N | Name of the Spot | Chain-age (Km) | Survey Observations and Findings | Analysis/Diagnosis | Suggested Recommendation for improvement |
|---|---|---|---|---|---|
| 18. | <b>Mukoko (Lukaya)</b><br><br><i>Road marking allows Kampala bound traffic to overtake on sections with limited sight distances</i> | | <ul style="list-style-type: none"> <li>Rolling terrain high speed section</li> <li>Road marks are clear</li> <li>Overtaking road markings extend to the middle of the ascent limiting the driver's sight distance</li> </ul> | <ul style="list-style-type: none"> <li>Accidents are due to over speeding and reckless driving</li> <li>Overtaking line misused by drivers</li> </ul> | <ul style="list-style-type: none"> <li>Enhance sensitization to all road users and enforcement of safety (overspeeding and reckless overtaking the main concerns at the location)</li> <li>Prohibit overtaking by providing a solid center line reflective marking with studs</li> <li>Reconfigure the road markings with a focus on safety notwithstanding sight distance at the stretch</li> </ul> |

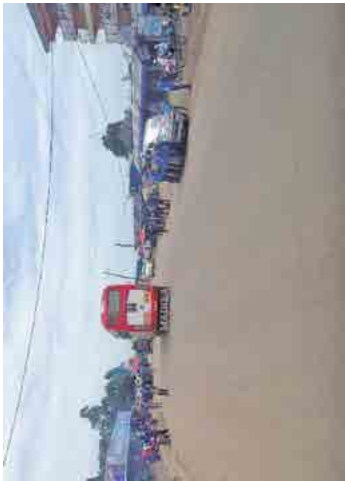
| S/N | Name of the Spot | Chain-age (Km) | Survey Observations and Findings | Analysis/Diagnosis | Suggested Recommendation for improvement |
|---|---|---|---|---|---|
| | <p><i>Missing designated bus bays and parking facilities</i></p> | | <ul style="list-style-type: none"> <li>No parking lanes and bus stops</li> <li>Humps are worn out</li> <li>Road markings are worn out</li> <li>Inadequate provision pedestrian facilities (e.g. crossings and walkways)</li> <li>Uncontrolled access to the main highway</li> </ul> | | <ul style="list-style-type: none"> <li>Provision of street lights to illuminate the town</li> <li>Provision of designated parking spaces and bus stops.</li> <li>Consider provision of a roadside station with amenities near the town</li> <li>In the long term, consider provision of service lanes with controlled access</li> </ul> |

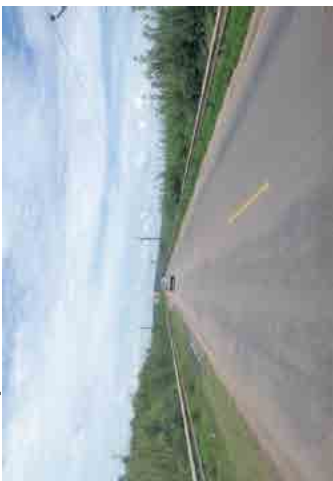
| S/N | Name of the Spot | Chain-age (Km) | Survey Observations and Findings | Analysis/Diagnosis | Suggested Recommendation for improvement |
|---|---|---|---|---|---|
| 20. | <p><b>Lwera swamp (91 km to Kampala from Masaka)</b></p> | | <ul style="list-style-type: none"> <li>Flat terrain section with roadside fish vendors</li> <li>Drivers park along the road on either side narrowing the carriageway to buy fish</li> <li>Pavement deformation at the culvert crossing which creates an uneven surface</li> <li>Section is characterized of seasonal bush burning and the smoke affects visibility</li> </ul> | <ul style="list-style-type: none"> <li>Most of accidents involve roadside vendors and overspeeding vehicles</li> <li>Seasonal bush fire present danger to traffic and other road users.</li> </ul> | <ul style="list-style-type: none"> <li>Immediate repair of the depression on the pavement is required</li> <li>Provide appropriate road signs</li> <li>Reinstate the faded road markings</li> <li>Routine maintenance of the road</li> <li>Provision of guardrails along the swamp to prevent vehicles from running off the road during emergencies</li> <li>Enhance sensitization to all road users and enforcement of safety</li> <li>Provide gazetted parking places for drivers buying fish.</li> </ul> |

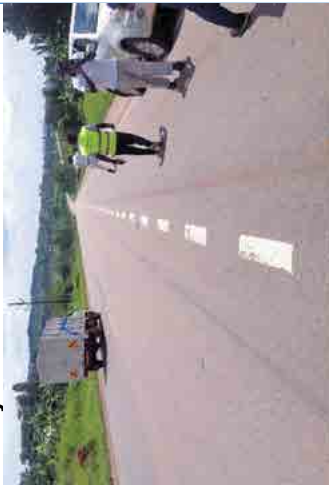
| S/N | Name of the Spot | Chain-age (Km) | Survey Observations and Findings | Analysis/Diagnosis | Suggested Recommendation for improvement |
|---|---|---|---|---|---|
| 22. | <b>Mbizinya</b> | | <ul style="list-style-type: none"> <li>• Rolling terrain section with a climbing lane of about 400m which terminates in a crest</li> <li>• Accidents are mainly head-on collisions due to careless driving and overtaking descending vehicles</li> </ul> | <ul style="list-style-type: none"> <li>• Road in good condition and wide enough with climbing lanes on the LHS</li> <li>• Speeding and dangerous overtaking however need to be curbed to avert future accidents</li> </ul> | <ul style="list-style-type: none"> <li>• Provide appropriate road signs (beginning and end of climbing lanes)</li> <li>• Enhance sensitization to all road users and enforcement of safety</li> <li>• Reconfigure the road markings to prohibit descending vehicles from overtaking</li> </ul> |

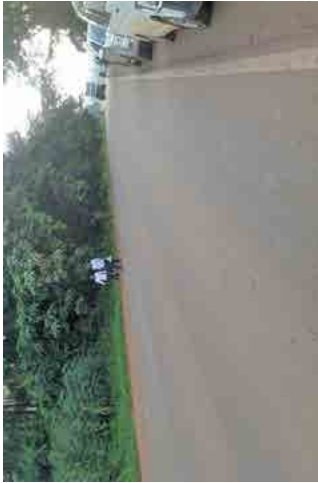
| S/N | Name of the Spot | Chain-age (Km) | Survey Observations and Findings | Analysis/Diagnosis | Suggested Recommendation for improvement |
|---|---|---|---|---|---|
| 6. | <b>Forest Hill</b><br> <p><i>Overgrown twigs on the RHS jutting into the carriageway obstructing sight distances</i></p> | | <ul style="list-style-type: none"> <li>• Rolling terrain section with a short sag curve and a crest</li> <li>• High speeding zone that prompts drivers to recklessly overtake</li> <li>• No road markings</li> <li>• Overgrown vegetation</li> <li>• Accidents are mostly fatal due to over speeding and overtaking</li> </ul> | | <ul style="list-style-type: none"> <li>• Provide appropriate road signs</li> <li>• Re-establish the road markings</li> <li>• Provide a solid centerline marking to prohibit overtaking</li> <li>• Provide speed restrictions</li> <li>• Clearing of overgrown vegetation to improve sight distances</li> <li>• Enhance sensitization to all road users and enforcement of safety</li> </ul> |

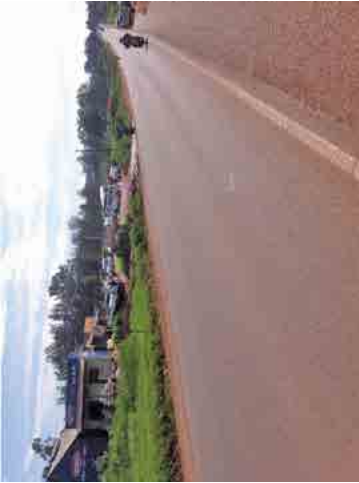
| S/N | Name of the Spot | Chain-age (Km) | Survey Observations and Findings | Analysis/Diagnosis | Suggested Recommendation for improvement |
|---|---|---|---|---|---|
| 12. | <b>Kitega – Lugazi</b><br> | | <ul style="list-style-type: none"> <li>Built-up area with two opposite washing bays on each side of the road</li> <li>Eroded shoulders and part of the carriageway due to poor maintenance</li> <li>Serious/ fatal accidents</li> <li>Accidents are mainly head-on collisions due to overtaking</li> <li>Speed limit signs in place; they however do not extend beyond the car washes</li> </ul> | | <ul style="list-style-type: none"> <li>Provide appropriate road signs and extend the speed limits to cover the car wash area</li> <li>Enhance sensitization to all road users and enforcement of safety</li> <li>Application of retro-reflective road marking and installation of delineator road studs</li> <li>Improvement of the drainage system especially at the entrances to the car washes</li> <li>Carry out routine maintenance (regular desilting of the road edges)</li> <li>Widen the roadway</li> </ul> |

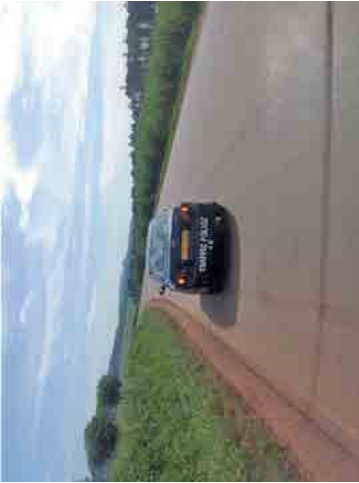
| S/N | Name of the Spot | Chain-age (Km) | Survey Observations and Findings | Analysis/Diagnosis | Suggested Recommendation for improvement |
|---|---|---|---|---|---|
| 13. | <b>Kawolo Hospital</b><br><br><i>Relatively dangerous curve near the hospital that is prone to overspeeding and reckless overtaking</i> | | <ul style="list-style-type: none"> <li>Rolling terrain stretch with a climbing lane connecting two blind curves</li> <li>No road signs</li> <li>Faded road markings</li> <li>Blind corners either side</li> <li>Road marking are faded on climbing lanes (extents and length of the climbing lane not clearly defined)</li> <li>Numerous Fatal and Serious Accidents mainly head-on due to careless driving</li> <li>Limited visibility due to lack of maintenance for vegetation along the highway</li> </ul> | | <ul style="list-style-type: none"> <li>Provide appropriate road signs/replace defaced signs</li> <li>Enhance sensitization to all road users and enforcement of safety</li> <li>Provide road markings to prohibit overtaking</li> <li>Application of road marking to define the lengths and extents of the climbing lane</li> <li>Maintenance of the road side by clearing bushes and vegetation within the road reserve</li> </ul> |

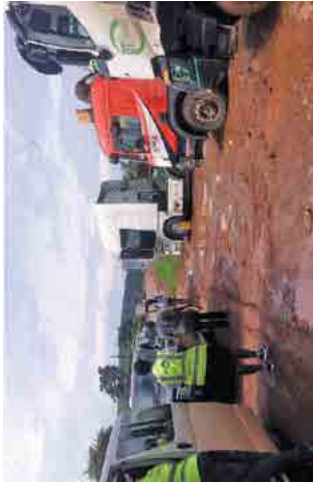
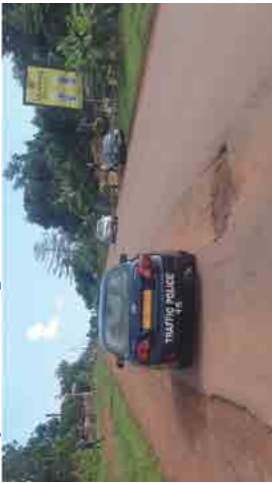
| S/N | Name of the Spot | Chain-age (Km) | Survey Observations and Findings | Analysis/Diagnosis | Suggested Recommendation for improvement |
|---|---|---|---|---|---|
| 14. | <b>Buryantete</b><br><br><i>Heavy trucks washing area on the LHS</i><br> | | <ul style="list-style-type: none"> <li>Steep ascent with a climbing lane which has developed potholes</li> <li>No road markings</li> <li>Presence of heavy trucks washing area on the LHS</li> <li>Visibility affected by overgrown bush and cane plantation in the road reserve</li> <li>Road markings give priority to descending vehicles to overtake</li> </ul> | | <ul style="list-style-type: none"> <li>Provide appropriate road signs</li> <li>Enhance sensitization to all road users and enforcement of safety</li> <li>Provide road markings to prohibit descending vehicles from overtaking</li> <li>Carry out bush clearing and ensure routine maintenance</li> <li>Engage owners of cane plantations not to use the road reserve</li> <li>Designation of a proper heavy vehicles washing facility at a safe distance from the live carriageway</li> </ul> |

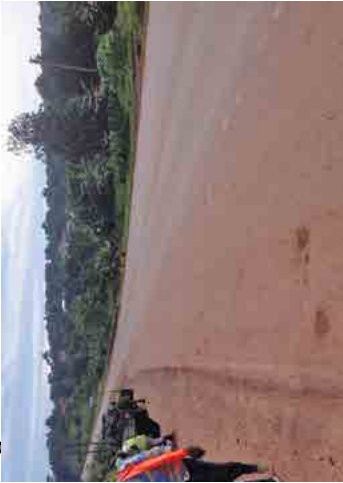
| S/N | Name of the Spot | Chain-age (Km) | Survey Observations and Findings | Analysis/Diagnosis | Suggested Recommendation for improvement |
|---|---|---|---|---|---|
| 15. | <b>Sagazi</b><br> | | <ul style="list-style-type: none"> <li>A rolling section terminating in a blind curve and sag curve</li> <li>Presence of a market</li> <li>Climbing lanes from the vertical trough</li> <li>Overspeeding and failure to observe lane discipline a safety concern</li> <li>Faded road markings</li> <li>No road signs</li> <li>Bus stop located close to a sag curve (poorly located)</li> </ul> | <ul style="list-style-type: none"> <li>Horizontal curve at the trough of the vertical curve makes the location susceptible to dangerous driving</li> </ul> | <ul style="list-style-type: none"> <li>Provide appropriate road signs</li> <li>Enhance sensitization to all road users and enforcement of safety</li> <li>Application of road marking to mark lane extents and clearly define the climbing lanes</li> <li>Provide road markings to prohibit descending vehicles from overtaking</li> <li>Redesign and relocate the bus stop to a safer location</li> </ul> |

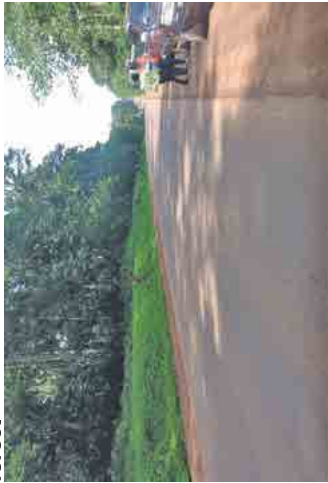
| S/N | Name of the Spot | Chain-age (Km) | Survey Observations and Findings | Analysis/Diagnosis | Suggested Recommendation for improvement |
|---|---|---|---|---|---|
| 16. | <b>Rwankiima (Place of Monkeys) Mabira forest</b><br> | | <ul style="list-style-type: none"> <li>Faded road markings hence drivers overtake any how since the prohibition markings are not visible</li> <li>Numerous Fatal and Serious Accidents mainly head-on due to over speeding and overtaking</li> <li>Motorists lack discipline as they compete for lanes</li> <li>Limited visibility due to trees (forest) protruding into the carriageway</li> <li>Pitch darkness at night</li> </ul> | <ul style="list-style-type: none"> <li>Traffic police has mentioned this stretch as one of the most dangerous section in the country</li> </ul> | <ul style="list-style-type: none"> <li>Provide enhanced retro-reflective road signs warning motorists accordingly</li> <li>Enhance sensitization to all road users and enforcement of safety</li> <li>Application of road marking to mark lane extents with special emphasis on continuous yellow centreline to prohibit overtaking at dangerous spots</li> <li>Installation of delineator road studs along the forest</li> <li>Provide street lights</li> </ul> |

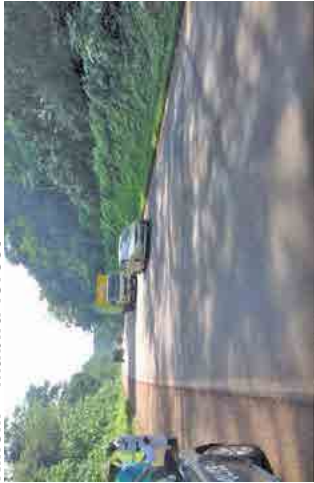
| S/N | Name of the Spot | Chain-age (Km) | Survey Observations and Findings | Analysis/Diagnosis | Suggested Recommendation for improvement |
|---|---|---|---|---|---|
| 18. | <b>Kinoni - Mabira forest</b><br> | | <ul style="list-style-type: none"> <li>Long steep ascent with no climbing lane</li> <li>Overgrown bush in the embankment slopes which affects visibility</li> <li>No road markings</li> <li>Type of accidents are head-on or drivers go off the road</li> <li>Sloping from up and meet with those coming up</li> </ul> | | <ul style="list-style-type: none"> <li>Re-establish the road markings</li> <li>Provide a solid centerline marking to prohibit overtaking</li> <li>Provide speed restrictions</li> <li>Redesign the section to provide a climbing lane</li> </ul> |

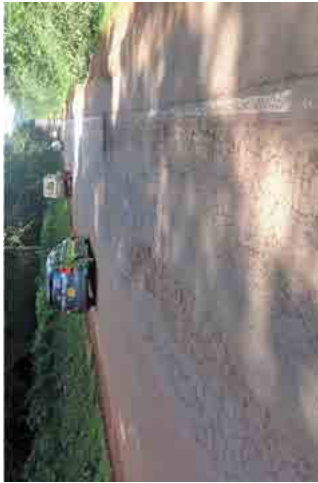
| S/N | Name of the Spot | Chain-age (Km) | Survey Observations and Findings | Analysis/Diagnosis | Suggested Recommendation for improvement |
|---|---|---|---|---|---|
| 19. | <b>Old Picnic – Mabira forest</b><br><br><i>Heavy pavement distress symptoms (alligator cracking, potholes)</i> | | <ul style="list-style-type: none"> <li>No road markings</li> <li>Poorly maintained surface with potholes</li> <li>Heavy pavement distress symptoms in the form of alligator cracking and potholes</li> <li>Accidents are due to over speeding and overtaking</li> </ul> | <ul style="list-style-type: none"> <li>Police Traffic mentioned that whenever the potholes are refilled on this section, it doesn't take 6 months</li> <li>Head on, run off collisions common as motorists try to evade the potholes</li> </ul> | <ul style="list-style-type: none"> <li>Re-establish the road markings</li> <li>Provide a solid centerline marking to prohibit overtaking</li> <li>Rehabilitation of the pavement to motorable standards</li> <li>Provide speed restrictions</li> <li>Routine maintenance i.e pothole patching, clearing of vegetation beside the road etc</li> </ul> |

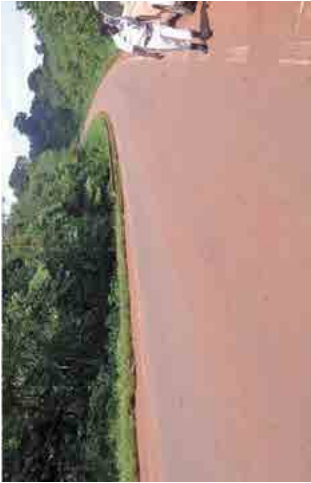
| S/N | Name of the Spot | Chain-age (Km) | Survey Observations and Findings | Analysis/Diagnosis | Suggested Recommendation for improvement |
|---|---|---|---|---|---|
| 20. | <b>Buwola-Mabira Forest</b><br> | | <ul style="list-style-type: none"> <li>A combination of horizontal and vertical alignments</li> <li>Missing signage</li> <li>Missing directional arrow (chevron) signs</li> <li>Faded road marking</li> <li>Missing climbing lanes signage</li> </ul> | <ul style="list-style-type: none"> <li>This rolling terrain encourages dangerous overtaking which leads to head-on, serious and fatal accidents. It was mentioned that a number of Kenyan pilgrims perished here in a road accident.</li> </ul> | <ul style="list-style-type: none"> <li>Installation of road signs (directional arrow signs at the horizontal curve, beginning of climbing lane signage)</li> <li>Application of road marking to mark lane extents and clearly define the climbing lanes using retro-reflective paint</li> <li>Installation of delineator road studs especially at the curve</li> </ul> |

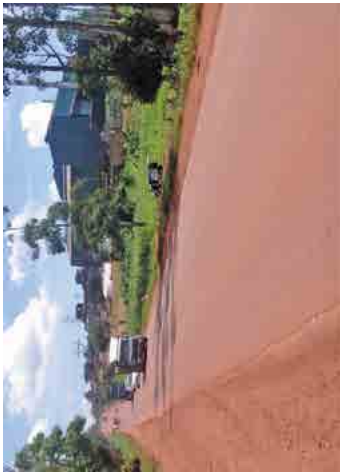
| S/N | Name of the Spot | Chain-age (Km) | Survey Observations and Findings | Analysis/Diagnosis | Suggested Recommendation for improvement |
|---|---|---|---|---|---|
| 24. | <b>Bulumaji GM Sugar Factory</b> | | <ul style="list-style-type: none"> <li>Road marking is faded; allows for overtaking from both sides but drivers lack adequate sight distances because of the crest</li> <li>Poor road marking</li> <li>Missing signage</li> </ul> | <ul style="list-style-type: none"> <li>Dangerous overtaking leads to frequent pedestrian crashes</li> </ul> | <ul style="list-style-type: none"> <li>Speed limit signage</li> <li>Application of retro-reflective road marking and delineator road studs</li> <li>Expansion of road to provide for overtaking and climbing lanes</li> </ul> |

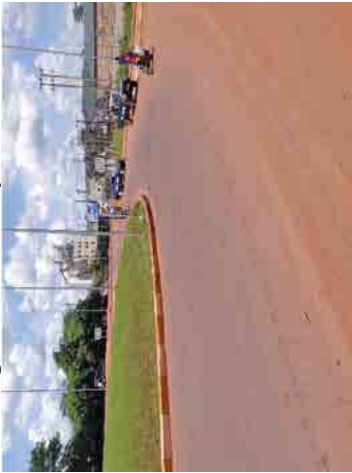
| S/N | Name of the Spot | Chain-age (Km) | Survey Observations and Findings | Analysis/Diagnosis | Suggested Recommendation for improvement |
|---|---|---|---|---|---|
| 26. | <b>Nile Bridge Roundabout-Njeru District</b><br><br><i>Sharp curve at the Nile Bridge roundabout</i> | | <ul style="list-style-type: none"> <li>• Insufficient traffic winding area at the roundabout</li> <li>• Trucks from Kampala to Jinja overtake</li> <li>• Lack of speed limits</li> <li>• Faded road marking at the roundabout</li> </ul> | <ul style="list-style-type: none"> <li>• Insufficient space often leads to veering off of heavy when they are unable to negotiate the curve</li> </ul> | <ul style="list-style-type: none"> <li>• Review of the roundabout designs</li> <li>• There is a need for reduction of roundabout central island to create more traffic circulatory roadway</li> <li>• Provide for speed limit signs</li> <li>• Application of appropriate road marking at the roundabout to channelize traffic properly</li> </ul> |

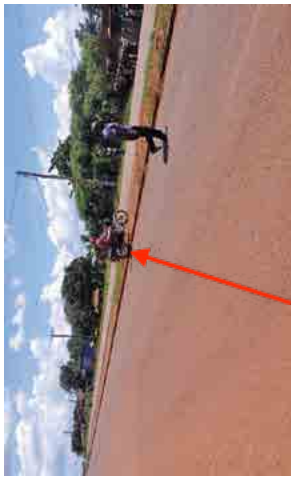
| S/N | Name of the Spot | Chain-age (Km) | Survey Observations and Findings | Analysis/Diagnosis | Suggested Recommendation for improvement |
|---|---|---|---|---|---|
| 30. | <b>Mungano Wanyange Area</b><br><br><i>Unsafe road user behavior by motorcyclists</i> | | <ul style="list-style-type: none"> <li>Straight section of the road with overspeeding traffic</li> <li>There is no designated pedestrian crossing point</li> <li>Lack of road markings</li> <li>Pedestrians are knocked when crossing to join the stage</li> <li>No gazetted stage or bus stop</li> <li>Unsafe road user behavior especially by motorcyclists</li> </ul> | <ul style="list-style-type: none"> <li>Absence of pedestrian crossing facilities leads to pedestrians crashes by overspeeding motorists</li> </ul> | <ul style="list-style-type: none"> <li>Provision of pedestrians crossing facilities</li> <li>Installation of pedestrian crossing signage</li> <li>Need for designated bus bays</li> <li>Application of retro-reflective road marking</li> <li>Sensitization and enforcement to ensure safe road user behavior by all</li> </ul> |

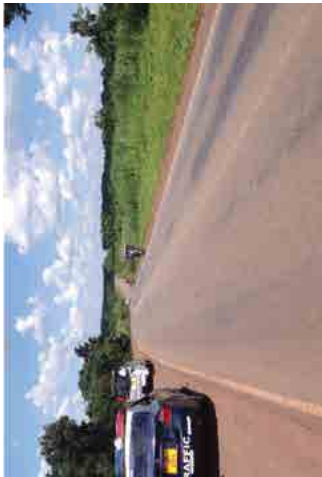
| S/N | Name of the Spot | Chain-age (Km) | Survey Observations and Findings | Analysis/Diagnosis | Suggested Recommendation for improvement |
|---|---|---|---|---|---|
| 37. | <b>Namasoga-Igenge</b><br> <p><i>Completely faded centre line marking</i></p> | | <ul style="list-style-type: none"> <li>Blind corner</li> <li>A long and sharp combination of horizontal and vertical alignment</li> <li>A steep crest bound by two deep valleys leading into blind spots at both ends</li> <li>Most accidents are head-on collision due to careless overtaking</li> </ul> | <ul style="list-style-type: none"> <li>This sharp combination of vertical and horizontal has often caused overspeeding of rolling traffic at the blind spots leading to frequent serious and fatal heads-on collision</li> </ul> | <ul style="list-style-type: none"> <li>Expansion of the carriageway by construction of overtaking and climbing lanes</li> <li>Installation of speed limit signage and marking</li> <li>Installation of a big warning sign of cautioning motorists</li> </ul> |

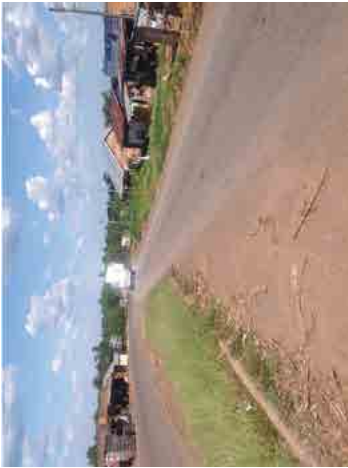
| S/N | Name of the Spot | Chain-age (Km) | Survey Observations and Findings | Analysis/Diagnosis | Suggested Recommendation for improvement |
|---|---|---|---|---|---|
| 40. | <b>Nakalama Junction</b> | | <ul style="list-style-type: none"> <li>Traffic conflicting junction to Mbale</li> <li>A blind spot overtaking as the vehicles enter or leave the junction</li> <li>Improper overtaking</li> </ul> | <ul style="list-style-type: none"> <li>Occurrence of heads-on accidents due to dangerous overtaking at the blind spot</li> </ul> | <ul style="list-style-type: none"> <li>Provision of appropriate signage (Junction Ahead, Speed Limit, Advance Directional signs etc)</li> <li>Enforcement to prevent dangerous overtaking or overspeeding at the junction</li> <li>Extend the traffic island beyond the horizontal curve towards the Kampala side</li> <li>Expansion of the junction to accommodate speed change lanes and proper channelization</li> </ul> |

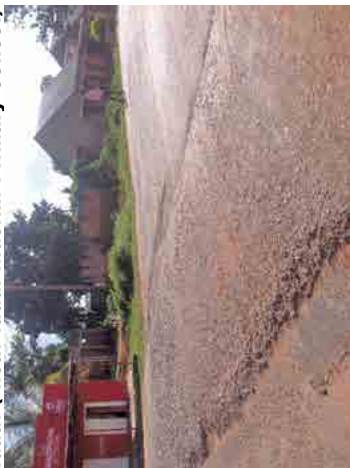
| S/N | Name of the Spot | Chain-age (Km) | Survey Observations and Findings | Analysis/Diagnosis | Suggested Recommendation for improvement |
|---|---|---|---|---|---|
| 43. | <b>Idudi ( near Idudi Muslim Primary School)</b><br> <p><i>Unstandardized speed hump (too large) with no proper warning signs</i></p> | | <ul style="list-style-type: none"> <li>Too wide and too high speed hump leading to rear end collisions due to difficulties in climbing over it by vehicles</li> <li>No warning signage before reaching the traffic hump</li> <li>Faded road marking</li> </ul> | <ul style="list-style-type: none"> <li>This out of proportion speed hump causes vehicles to make abrupt stops leading to rear end and run off accidents</li> </ul> | <ul style="list-style-type: none"> <li>Redesign and standardize the hump to allow for safe passage of traffic</li> <li>Provision of sufficient speed rumble strips on the approaches to the hump</li> <li>Appropriate warning signage i.e speed hump ahead signs</li> <li>Application of retro-reflective road marking both on the carriageway and on the speed hump</li> </ul> |

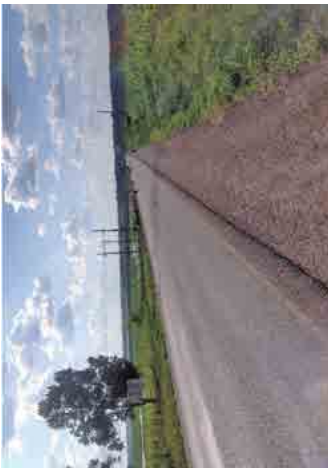
| S/N | Name of the Spot | Chain-age (Km) | Survey Observations and Findings | Analysis/Diagnosis | Suggested Recommendation for improvement |
|---|---|---|---|---|---|
| 45. | <b>Igogero Valley (rice fields) in Bujiri District</b><br> | | <ul style="list-style-type: none"> <li>Straight section with no signage to indicate speed limit and a bridge ahead.</li> <li>Missing/faded road markings.</li> <li>Motorists killed due to careless overtaking and over speeding</li> <li>Truck drivers using free gear</li> <li>Damaged safety fences</li> </ul> | <ul style="list-style-type: none"> <li>Dangerous overtaking leads to heads-on accidents</li> </ul> | <ul style="list-style-type: none"> <li>Appropriate signs should be put in place to warn/alert motorists i.e. speed limit and bridge ahead signage.</li> <li>Application of retro-reflective road marking to replace the already faded paint</li> </ul> |

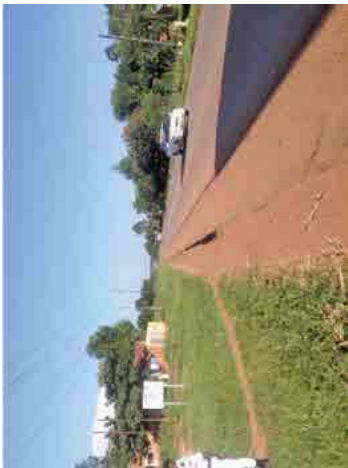
| S/N | Name of the Spot | Chain-age (Km) | Survey Observations and Findings | Analysis/Diagnosis | Suggested Recommendation for improvement |
|---|---|---|---|---|---|
| 50. | <b>Namaserere</b> <p><i>The very straight section prompts motorists to overspeed and overtake dangerously</i></p> | | <ul style="list-style-type: none"> <li>• Straight section without proper road markings</li> <li>• Over speeding</li> <li>• Faded markings</li> <li>• Distressed pavement</li> </ul> | <ul style="list-style-type: none"> <li>• Straight section without proper markings encourages vehicles to make dangerous overtaking which leads to heads-on and self-involving accidents</li> </ul> | <ul style="list-style-type: none"> <li>• Provision of visible road markings and signage</li> </ul> |

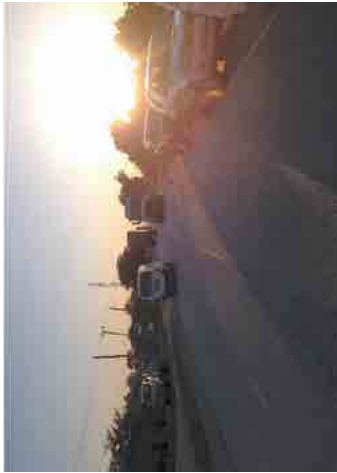
| S/N | Name of the Spot | Chain-age (Km) | Survey Observations and Findings | Analysis/Diagnosis | Suggested Recommendation for improvement |
|---|---|---|---|---|---|
| 60. | <b>Mile 8 (Magola)</b><br> | | <ul style="list-style-type: none"> <li>Faded rumble strips and humps.</li> <li>Missing/vandalized speed limit signs</li> <li>No designated pedestrian crossings.</li> <li>Pedestrians heedless of traffic</li> <li>Many motorcyclists most of which ride dangerously</li> <li>School in the neighborhood</li> </ul> | | <ul style="list-style-type: none"> <li>Provision of a designated pedestrian (preferably an elevated one for clear visibility by on-coming traffic).</li> <li>Provision of speed limit and advance warning signs i.e speed humps ahead, pedestrian crossing signs etc</li> <li>Rumble strips should be repaired/replaced.</li> <li>Sensitization of pedestrians and motorcyclists on safe road user behaviour</li> <li>Sustained enforcement by relevant agencies</li> </ul> |

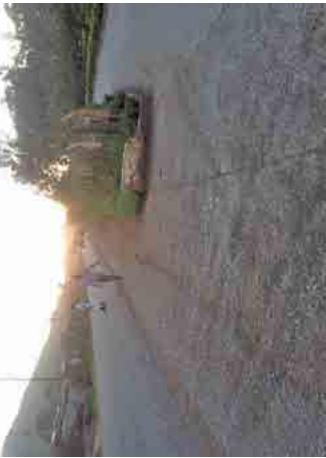
| S/N | Name of the Spot | Chain-age (Km) | Survey Observations and Findings | Analysis/Diagnosis | Suggested Recommendation for improvement |
|---|---|---|---|---|---|
| 61. | <b>Uganda Cement Industry (UCI)/Tororo Cement</b> <p><i>Missing speed change lanes at the factory/insufficient turning radius for trucks</i></p> | | <ul style="list-style-type: none"> <li>• Congestion due to trucks coming in and going out of the factory</li> <li>• Missing/completely faded road markings affecting visibility.</li> <li>• No sign posts to indicate speed limit and trucks turning.</li> <li>• No speed calming measures on the approaches to the factory</li> <li>• Stretch of 500m where occur fatal accidents</li> <li>• Missing speed change lanes and insufficient turning radius for trucks exiting the factory towards Kampala</li> </ul> | | <ul style="list-style-type: none"> <li>• Provision of speed change (acceleration and deceleration) lanes into and out of the factory</li> <li>• Reconfiguration of the access to increase the turning radius for Kampala bound trucks</li> <li>• Appropriate signage to warn motorists i.e. speed limit and trucks turning signs.</li> <li>• Speed calming measures be put in place on approaches to the factory i.e. Rumble strips or speed humps.</li> <li>• Consider separation of the directions of traffic at the location using a traffic island to avoid head on collision with on-coming traffic.</li> <li>• Some of the above recommendations could be implemented by the factory as Corporate Social Responsibility (CSR) projects</li> </ul> |

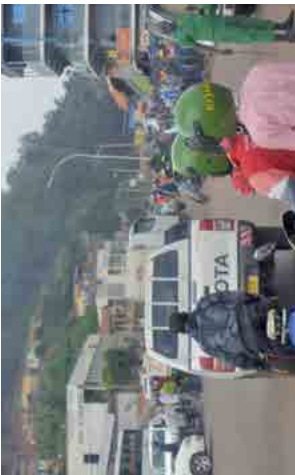
| S/N | Name of the Spot | Chain-age (Km) | Survey Observations and Findings | Analysis/Diagnosis | Suggested Recommendation for improvement |
|---|---|---|---|---|---|
| 1. | <b>Urban Exit road</b><br> | 2.39 | <p>The area has a high contingent of motorcyclists and pedestrians walking along the road and making cross road movements.</p> <ul style="list-style-type: none"> <li>• The carriageway is narrow inhibiting motorability of the road.</li> <li>• Inadequate provision for Non-Motorized Traffic (NMT).</li> <li>• No traffic separation facilities have been provided to segregate the directions of traffic.</li> </ul> | <p>Confluence of factors observed can lead to vehicle-motorcycle and vehicle-pedestrian crashes.</p> | <ul style="list-style-type: none"> <li>• Expansion and channelization of the junction to cater for turning movements.</li> <li>• Provision of adequate NMT facilities i.e pedestrian walkways, cyclist tracks, pedestrian footbridge if justified by pedestrian numbers etc.</li> <li>• Separation of traffic directions to limit interaction between opposing traffic.</li> </ul> |

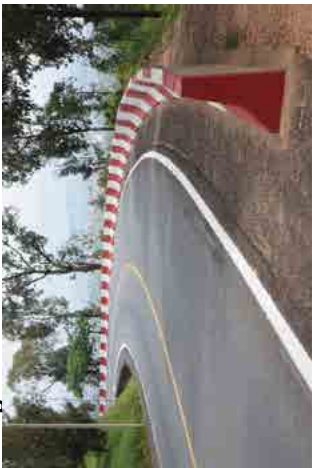
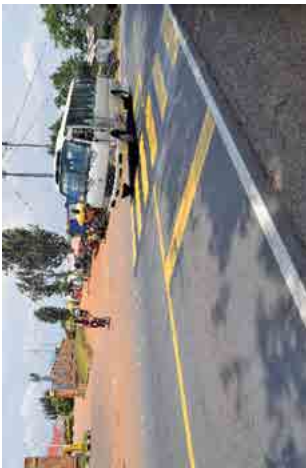
| S/N | Name of the Spot | Chain-age (Km) | Survey Observations and Findings | Analysis/Diagnosis | Suggested Recommendation for improvement |
|---|---|---|---|---|---|
| 2. | <b>Gihinga</b><br><br><br><i>Incorrectly positioned pedestrian crossing (at an access junction)</i> | 21.4-22.4 | <p>The alignment is characterized by a combination of sharp horizontal and vertical curves winding through a hilly terrain. The following observations were also made:</p> <ul style="list-style-type: none"> <li>• Incorrectly positioned pedestrian crossing at the middle of an access junction near the 'Kamonyi District headquarters.</li> <li>• Missing pedestrian walkways along the relatively built up area.</li> <li>• The 'Sharp Left Curve Ahead' road sign just before the crash barriers has been partially obstructed by overgrown twigs.</li> <li>• Missing directional arrow signs at the crash barriers to warn motorists of sharp change of direction.</li> <li>• Narrow carriageway with lane widths of 3m and 1.5m wide shoulders.</li> <li>• Missing safety fences along sharp curves on high and steep embankment.</li> </ul> | <ul style="list-style-type: none"> <li>• The narrowed carriageway in a sharply winding terrain might prompt motorists to veer off due to the increased centrifugal forces.</li> <li>• New Jersey crash barriers have however since been installed at some of the most hazardous locations.</li> <li>• Static speed cameras have also been installed to monitor speed limits along the stretch.</li> </ul> | <ul style="list-style-type: none"> <li>• Installation of rumble strips at standard intervals at the beginning of the descent.</li> <li>• Provision of more concrete crash barriers along the alignment to prevent possible run off collisions.</li> <li>• Trimming vegetation around the road signs to increase visibility.</li> <li>• Installation of directional arrow signs and hazard marker signs at the beginning of the crash barriers.</li> <li>• Installation of delineator road studs to mark the lane extents on the carriageway.</li> <li>• Relocation of the pedestrian crossing to a safer location and provision of pedestrian walkways on either side.</li> <li>• In the long term, consider widening the carriageway (at least 3.5m lane width and 1.5m wide shoulders) with adequate NMT facilities and provision of climbing lanes where necessary.</li> </ul> |

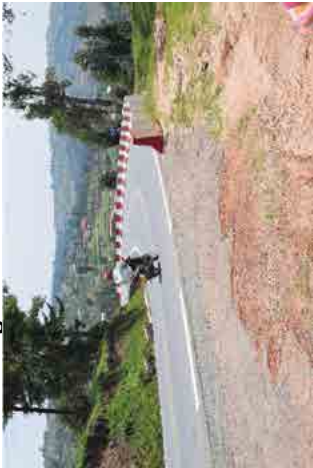
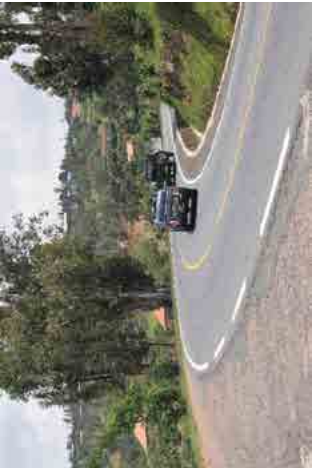
| S/N | Name of the Spot | Chain-age (Km) | Survey Observations and Findings | Analysis/Diagnosis | Suggested Recommendation for improvement |
|---|---|---|---|---|---|
| 3. | <b>Gacurabwenge</b> <p><i>Sharp curves on high and steep embankment with no provision for safety fences</i></p> | 24.4<br>-<br>25.4 | <ul style="list-style-type: none"> <li>The stretch is on a rolling to mountainous terrain and is also characterized by sharp successive curves</li> <li>Premature termination of crash barriers on the RHS along the sharp curves on high and steep embankment</li> <li>Missing speed calming measures in the form of rumble strips.</li> <li>Missing delineator road studs to improve on visibility at night.</li> <li>Lack of directional arrow signs at the crash barriers and hazard marker signs at the beginning of the barriers.</li> </ul> | <ul style="list-style-type: none"> <li>The sharp curves along the section limit the sight distances for motorists increasing the likelihood of run off collisions.</li> </ul> | <ul style="list-style-type: none"> <li>Extension of the safety barriers to cover the curves on high and steep embankment.</li> <li>Installation of rumble strips at standard intervals at the beginning of the descent.</li> <li>Installation of retro-reflective delineator road studs to mark the lane extents at night.</li> <li>Installation of the missing directional arrow and hazard marker signs to warn motorists accordingly.</li> <li>Consider provision of street lighting to illuminate the stretch and hence improve on visibility at night.</li> <li>Realignment and widening of the road width in the long term.</li> </ul> |

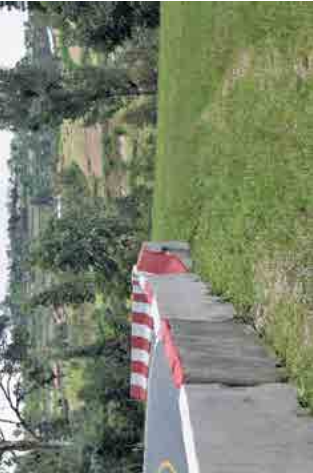
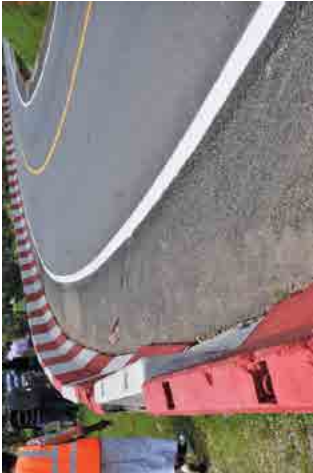
| S/N | Name of the Spot | Chain-age (Km) | Survey Observations and Findings | Analysis/Diagnosis | Suggested Recommendation for improvement |
|---|---|---|---|---|---|
| 4. | <b>Karengera curve</b><br><br><i>Dislodged crash barrier</i><br><br><i>Concrete crash barriers on the LHS. Note the tangential skid off marks</i> | 36.2 | <ul style="list-style-type: none"> <li>The section is a long, steep and winding descent necessitating crash barriers on the sharp curves.</li> <li>Some crash barriers have been knocked off and are dislodged from their natural positions.</li> <li>Missing directional arrow signs and hazard marker signs at the beginning of the crash barriers.</li> <li>Overgrown tree branches and twigs jutting into the motorable carriageway</li> <li>Missing drainage chutes at the foot of the crash barriers to channel surface run off.</li> </ul> | <ul style="list-style-type: none"> <li>The sharp curves make the descent prone to tangential skids and run-off collisions.</li> <li>An informative sign cautioning motorists and especially truck drivers to engage low gear is however in place at the beginning of the descent.</li> </ul> | <ul style="list-style-type: none"> <li>Installation of rumble strips at the beginning of the descent to act as a speed calming measure.</li> <li>Installation of retro-reflective delineator road studs to mark the lane extents at night.</li> <li>Installation of the missing directional arrow and hazard marker signs to warn motorists accordingly.</li> <li>Provision of street lighting to illuminate the stretch and hence improve on visibility at night.</li> <li>Trimming of the overgrown vegetation.</li> </ul> |

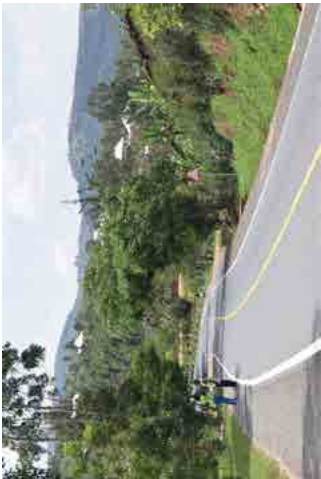
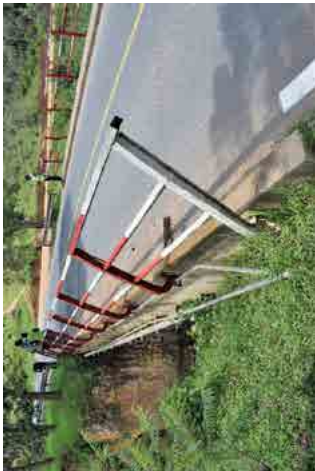
| S/N | Name of the Spot | Chain-age (Km) | Survey Observations and Findings | Analysis/Diagnosis | Suggested Recommendation for improvement |
|---|---|---|---|---|---|
| 5. | <b>Karengera Bridge</b><br><br><i>Bridge located on a sharp horizontal curve with obstructed visibility</i><br><br><i>Damaged/inadequate handrails with no sufficient provision for pedestrian walkways</i> | 37.1 | <ul style="list-style-type: none"> <li>The narrow bridge is at the trough of the vertical curve from Musambira.</li> <li>Obstructed visibility due to the presence of a sharp horizontal curve and overgrown vegetation from the Kigali direction.</li> <li>Faded directional arrow signs and hazard demarcation signs at the Bridge.</li> <li>Damaged/visibly weak handrails with no sufficient provision for pedestrian walkways on either side of the bridge.</li> <li>Poorly terminated/ inadequate flex beam guardrails to sufficiently cover the open windows before and after the Bridge.</li> <li>Dangerously located access on the RHS just after the Bridge.</li> <li>Missing delineator road studs to mark the lane extents at the Bridge.</li> </ul> | <ul style="list-style-type: none"> <li>The location and orientation of the bridge makes it prone to run-off and possibly head on collisions.</li> <li>In the short term, requisite signage and reflective elements to guide motorists at night should be prioritized on to avert any further crashes.</li> </ul> | <ul style="list-style-type: none"> <li>Replacement of directional arrow signs to caution motorists on the sharp change of direction.</li> <li>Installation of hazard marker signs on both sides of the bridge.</li> <li>Replacement of the existing handrails and provision of pedestrian walkways on either side.</li> <li>Installation of flex beam guardrails (preferably with retro-reflective studs on the inner side) to cover the open windows on both approaches.</li> <li>Installation of 'Stop' sign on the RHS access.</li> <li>Relocation of the access to a safer location should be considered in the long term.</li> <li>Installation of retro-reflective delineator road studs to mark lane extents.</li> <li>In the long term, consider widening the carriageway complete with pedestrian walkways and realignment of the section to eliminate the sharp curves.</li> </ul> |

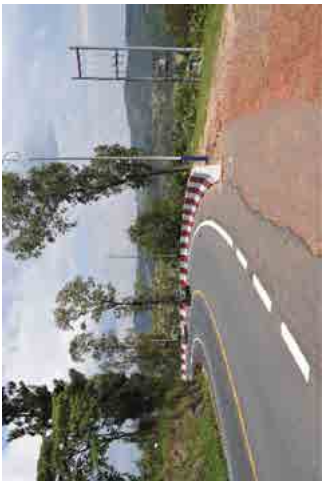
| S/N | Name of the Spot | Chain-age (Km) | Survey Observations and Findings | Analysis/Diagnosis | Suggested Recommendation for improvement |
|---|---|---|---|---|---|
| 6. | <b>Kivumu</b><br> | 41 | <p>Sharp curves on a rolling terrain characterize the section. Other observations include:</p> <ul style="list-style-type: none"> <li>Missing directional arrow signs at the curve and hazard marker signs at the beginning of the crash barriers.</li> <li>Missing delineator road studs to mark the carriageway.</li> <li>Lack of speed calming measures prompting motorists to speed downhill.</li> </ul> | <ul style="list-style-type: none"> <li>The location is on a sharp descent with sharp curves making it difficult for descending motorists to control their vehicles. Risk of loss of control therefore exists making it important to lower speed limits.</li> <li>To improve on visibility at night, streetlights have been provided to illuminate the section.</li> </ul> | <ul style="list-style-type: none"> <li>Installation of the missing directional arrow and hazard marker signs to warn motorists accordingly.</li> <li>Installation of speed limits and warning signs cautioning motorists to lower their approach speeds.</li> <li>Enforcement of speed regulations by relevant authorities.</li> <li>Installation of retro-reflective delineator road studs to mark lane extents.</li> <li>In the long term, consider widening the carriageway and provision of climbing lanes in light of the long and steep gradients.</li> </ul> |
