**NORTHERN CORRIDOR TRANSIT AND  
TRANSPORT COORDINATION AUTHORITY**

# **REPORT ON BLACK SPOTS SURVEY** ALONG THE NORTHERN CORRIDOR ROUTES IN RWANDA AND UGANDA

**February 2020**

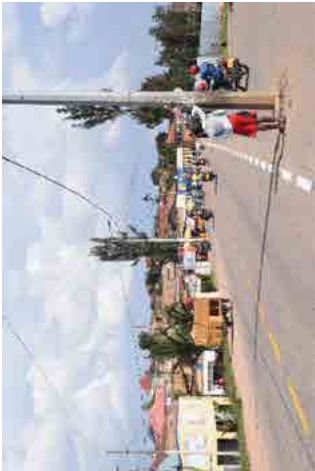
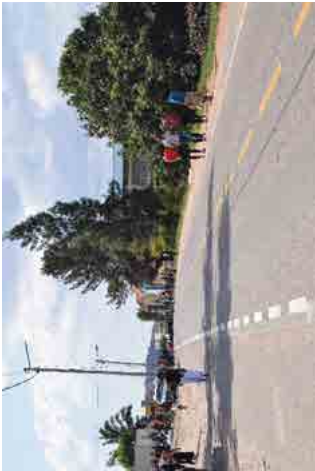
| S/N | Name of the Spot | Chain-age (Km) | Survey Observations and Findings | Analysis/Diagnosis | Suggested Recommendation for improvement |
|---|---|---|---|---|---|
| 7. | <p><b>Gahogo</b></p> <p><i>Narrow carriageway with no provision for NMT. Note the obstruction of the shoulders by the street lighting pole</i></p> <p><i>Pedestrians walking on the shoulders due to lack of designated footpaths</i></p> | 51.7<br><br>52.7 | <p>The built up area has a high pedestrian volume with a narrow carriageway making it susceptible to vehicle-pedestrian collisions. Other observations include:</p> <ul style="list-style-type: none"> <li>• Narrow carriageway (6m width) and reduced shoulders with no provision for NMT facilities i.e pedestrian footpaths.</li> <li>• Absence of designated pedestrian crossing facilities creating arbitrary crossing points.</li> <li>• Absence of speed calming measures on the approaches to the town.</li> <li>• Obstruction of the shoulders by street lighting poles.</li> </ul> | <ul style="list-style-type: none"> <li>• In addition to the high number of pedestrians, motorcyclists comprise a high population of road users in the town.</li> <li>• Safe road user behavior should therefore be advocated for to reduce or eliminate the vehicle-motorcyclist collisions.</li> <li>• Collisions involving school going children are not uncommon apparently due to speeding traffic with no designated children crossing points.</li> </ul> | <ul style="list-style-type: none"> <li>• Consider provision of pedestrian footpaths with channelized designated crossing points</li> <li>• Provision of raised pedestrian crossings (table tops) at suitable locations and near schools since they double up as speed calming measures.</li> <li>• Sensitization of motorcyclists and pedestrians on safe road user behavior.</li> </ul> <p>In the long term, consider the following:</p> <ul style="list-style-type: none"> <li>• Widening the carriageway and provision of NMT facilities i.e pedestrian footpaths and cycle tracks to limit interaction with motorized traffic.</li> <li>• Construction of a footbridge at the town if justified by the pedestrian numbers.</li> </ul> |

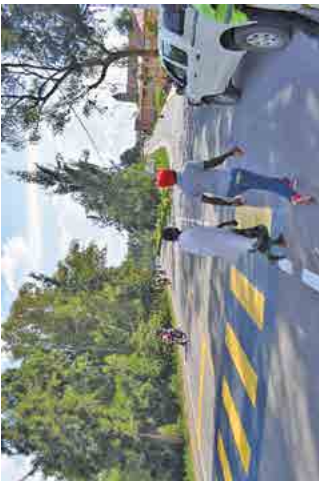
| S/N | Name of the Spot | Chain-age (Km) | Survey Observations and Findings | Analysis/Diagnosis | Suggested Recommendation for improvement |
|---|---|---|---|---|---|
| 8. | <b>Kabgayi District Hospital</b><br> | 53.5 | <p>The Kabgayi District Hospital area is heavily trafficked by pedestrians especially during weekends. Observations made at the location include:</p> <ul style="list-style-type: none"> <li>Absence of a raised pedestrian crossing to cater for the high number of pedestrians making cross road movements.</li> <li>Lack of designated pedestrian walkways along the main highway.</li> <li>Lack of speed limit signs and speed calming measures on the approaches to the hospital.</li> </ul> | <ul style="list-style-type: none"> <li>Pedestrians accessing the Kabgayi District Hospital tend to walk on the shoulders to the main highway making them susceptible to vehicle knock downs.</li> <li>Further, no speed calming measures are in place on the approaches to the hospital access.</li> </ul> | <ul style="list-style-type: none"> <li>Provision of a raised pedestrian crossing in place of the grade level one.</li> <li>Provision of pedestrian walkways on either side of the main road.</li> <li>Installation of rumble strips as a speed calming measure on both approaches to the hospital access.</li> <li>Provision of speed limits and enforcement of speed regulations by relevant agencies.</li> </ul> |

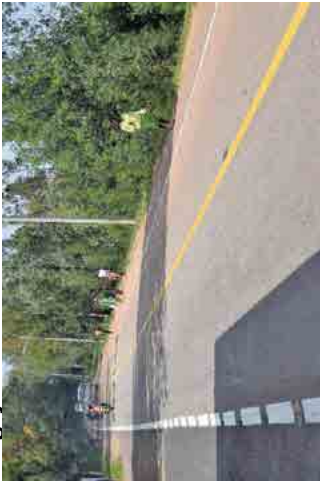
| S/N | Name of the Spot | Chain-age (Km) | Survey Observations and Findings | Analysis/Diagnosis | Suggested Recommendation for improvement |
|---|---|---|---|---|---|
| 9. | <b>Kabgayi Descent</b><br><br><i>No speed calming measures are in place along the descent</i> | | <p>The following observations were made:</p> <ul style="list-style-type: none"> <li>Dangerous cross junction across the descent just before the right curve. The LHS access is in a depression hence insufficient visibility plays for motorists joining the main highway.</li> </ul> | <ul style="list-style-type: none"> <li>The pedestrian crossing lacks speed calming rumble strips which would otherwise lower the speed for descending motorists.</li> </ul> | <ul style="list-style-type: none"> <li>Consider staggering the cross junction to a distance of at least 50m between the access legs.</li> <li>Provision of pedestrian walkways to prevent pedestrians from walking on the road shoulders</li> <li>Installation of rumble strips both at the beginning of the descent and before the designated crossing to calm approach speeds</li> </ul> |

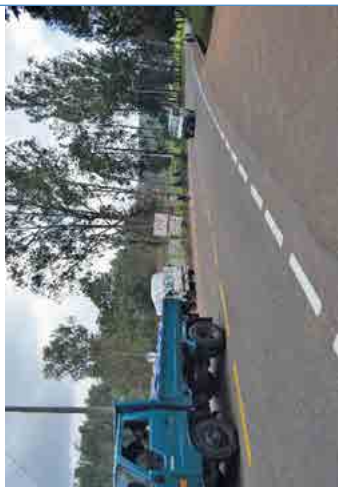
| S/N | Name of the Spot | Chain-age (Km) | Survey Observations and Findings | Analysis/Diagnosis | Suggested Recommendation for improvement |
|---|---|---|---|---|---|
| | <p><i>Dangerous cross junction with unsafely staggered legs. Motorists from the LHS have to join the main road from a depression</i></p> | | <ul style="list-style-type: none"> <li>Irregular parking by motorcyclists on the shoulders to the main highway further reducing visibility splays at the cross junction.</li> <li>Narrow carriageway with no provision for NMT facilities.</li> <li>Lack of speed calming measures prompting motorists to drive downhill at high speeds.</li> </ul> | <ul style="list-style-type: none"> <li>The orientation of the cross junction is dangerous as minimum staggering distance has not been met.</li> </ul> | <ul style="list-style-type: none"> <li>Provision of speed limits and enforcement of speed regulations by relevant agencies</li> </ul> |

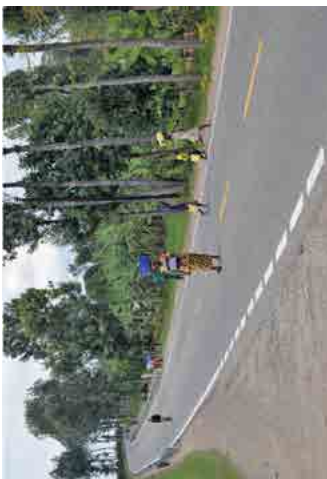
| S/N | Name of the Spot | Chain-age (Km) | Survey Observations and Findings | Analysis/Diagnosis | Suggested Recommendation for improvement |
|---|---|---|---|---|---|
| 10. | <p><b>Byimana (Ntenyo)</b></p> <p><i>Pedestrians crossing arbitrarily due to lack of a designated pedestrian crossing</i></p> | 64.5 | <p>Safety fences in the form of flex beam guardrails have since been installed reducing the run off collisions. However, the following safety concerns still exist:</p> <ul style="list-style-type: none"> <li>No provision for pedestrian walkways and designated crossing points has been made despite the high number of pedestrians at the significantly populated area</li> <li>Lack of a provision for speed calming measures as you approach the sharp curve</li> </ul> | <ul style="list-style-type: none"> <li>Two horizontal curves on a rolling terrain converge at the trough of a vertical curve.</li> <li>Skidding off by speeding motorists at the curve is likely to occur.</li> <li>Head on collisions as well as vehicle-pedestrian and vehicle-pedal cyclist collisions are also common at the location.</li> </ul> | <ul style="list-style-type: none"> <li>Provision of speed limits and enforcement of speed regulations by relevant agencies</li> <li>Installation of rumble strips on either approaches</li> <li>Provision of pedestrian walkways and a designated pedestrian crossing at a suitable location</li> <li>Installation of elaborate road signs prohibiting overtaking and overspeeding at the curve and cautioning motorists to exercise caution</li> <li>In the long term, consider widening the carriageway with sufficient provision for widening at the horizontal curve</li> </ul> |

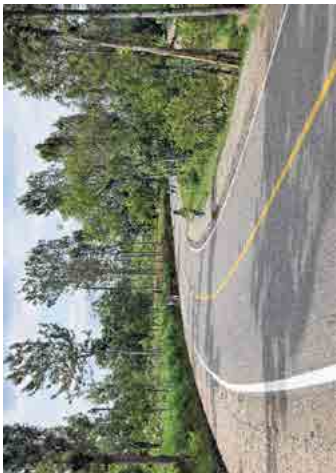
| S/N | Name of the Spot | Chain-age (Km) | Survey Observations and Findings | Analysis/Diagnosis | Suggested Recommendation for improvement |
|---|---|---|---|---|---|
| | <p><i>Skid off marks showing difficulties encountered by motorists in negotiating the curve</i></p> | | <ul style="list-style-type: none"> <li>Lack of enhanced signage prohibiting motorists against overspeeding and overtaking</li> </ul> | | |

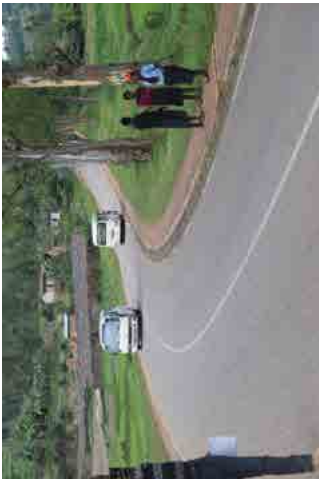
| S/N | Name of the Spot | Chain-age (Km) | Survey Observations and Findings | Analysis/Diagnosis | Suggested Recommendation for improvement |
|---|---|---|---|---|---|
| 11. | <p><b>Ngoma</b><br/>(‘Umukobwa Mwiza Corner’)</p> <p><i>Approach from the Kigali side</i></p> | 122.2 | <ul style="list-style-type: none"> <li>The location is on an extremely sharp horizontal curve especially for motorists approaching from the Akanyaru direction</li> <li>The road is narrow with insufficient provision for super elevation to counteract the centrifugal acceleration forces encountered by motorists.</li> <li>Faded road marking at the location might not be clearly visible at night.</li> <li>Insufficient speed calming measures on the approaches to the location.</li> </ul> | <ul style="list-style-type: none"> <li>Motorists and especially truckers tend to lose control and run off the carriageway due to increased centrifugal acceleration as they negotiate the tight curve. The area is characterized by multiple skid off marks indicating difficulties encountered by motorists in holding their vehicles within the carriageway.</li> </ul> | <ul style="list-style-type: none"> <li>Redesigning of the horizontal curve to allow for sufficient super elevation and widening at the curve.</li> <li>Application of retro-reflective road marking to guide motorists accordingly especially at night.</li> <li>Installation of delineator road studs to mark the lane extents at night.</li> <li>Installation of rumble strips as a speed calming measure on both approaches to the curve.</li> <li>Clearing of the roadside vegetation to improve sight distances</li> </ul> |

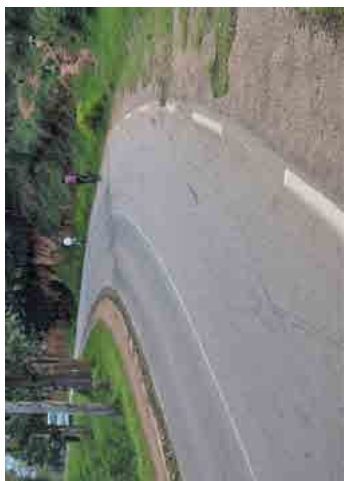
| S/N | Name of the Spot | Chain-age (Km) | Survey Observations and Findings | Analysis/Diagnosis | Suggested Recommendation for improvement |
|---|---|---|---|---|---|
| | <p><i>Multiple skid off marks. Note the lack of super elevation at the tight horizontal curve</i></p> | | | <ul style="list-style-type: none"> <li>Roll over and head on collisions mostly fatal are common at the spot.</li> <li>'Danger' signs have been erected along the long descent to warn motorists.</li> </ul> | <p>In the long term, consider the following measures;</p> <ul style="list-style-type: none"> <li>Widening of the carriageway and realignment of the section to allow for a more gentle curve.</li> <li>Consider provision of off-road truck run away ramps/arrester beds to cater for heavy vehicles that might lose control.</li> </ul> |

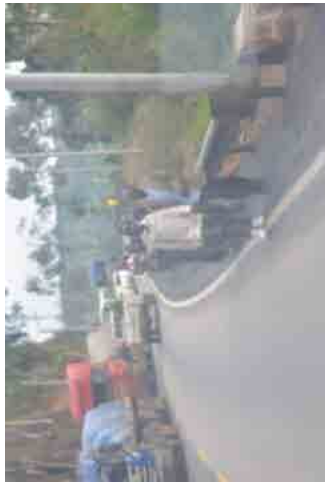
| S/N | Name of the Spot | Chain-age (Km) | Survey Observations and Findings | Analysis/Diagnosis | Suggested Recommendation for improvement |
|---|---|---|---|---|---|
| | <p><i>Lack of NMT facilities forcing pedestrians to walk on the carriageway shoulders</i></p> | 0-10 | <ul style="list-style-type: none"> <li>Narrow carriageway with very sharp curves on steep embankment.</li> <li>Lack of a provision for NMT facilities causing pedestrians to walk precariously on the narrow shoulders</li> <li>Obstruction by vegetation and tree branches impairing sight distances.</li> <li>Missing delineator road studs to delineate the road.</li> <li>Inadequate warning signs.</li> </ul> | | <ul style="list-style-type: none"> <li>Installation of adequate warning signs cautioning road users on all the possible danger spots.</li> </ul> |

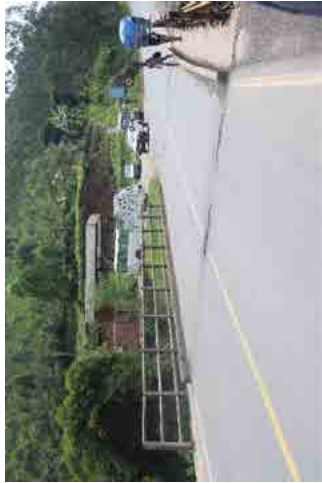
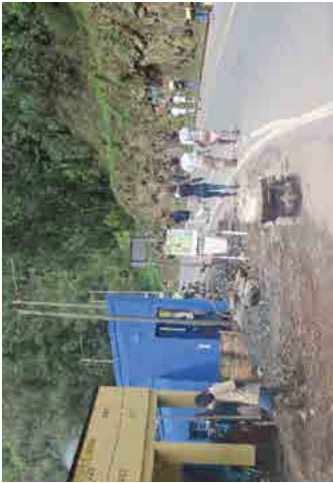
| S/N | Name of the Spot | Chain-age (Km) | Survey Observations and Findings | Analysis/Diagnosis | Suggested Recommendation for improvement |
|---|---|---|---|---|---|
| 3. | <p><b>Nyirangarama</b></p> <p><i>Narrow bridge with insufficient reflective elements and signage</i></p> <p><i>Obstruction of sight distances by roadside establishments</i></p> | 45-47 | <p><b>Nyirangarama Bridge</b></p> <ul style="list-style-type: none"> <li>• Conflicting junction at the rolling terrain with a narrow bridge near the junction</li> <li>• The Nyirangarama Bridge is located on a sharp curve with an acute blind spot especially for motorists heading towards Kigali from Musanze</li> <li>• The pedestrian walkways are separated from the carriageway by unmarked raised kerbstone which are a safety hazard by themselves.</li> <li>• The expansion joints of the bridge are exposed compromising its structural integrity.</li> <li>• Missing hazard marker signs at the bridge as well as missing signs warning of a narrow bridge ahead.</li> <li>• Missing safety fences on either side of the bridge handrails leaving dangerous open windows; motorists who lose control might plunge into the river.</li> </ul> | <ul style="list-style-type: none"> <li>• Sharp curve makes it difficult for heavy vehicles to negotiate the turns. Likelihood of veering off the carriageway is increased as a result.</li> <li>• The narrow bridge reduces the available motorable width increasing the chances of motorists colliding with the bridge furniture and also getting involved in head on and side swipe collisions.</li> </ul> | <ul style="list-style-type: none"> <li>• Consider re-construction of a wider bridge with sufficient provision for pedestrian footpaths in the medium to long term. In the short to medium term, consider: <ul style="list-style-type: none"> <li>• Installation of hazard marker signs on all the four edges of the bridge (to warn motorists from a distance).</li> <li>• Installation of 'Narrow Bridge Ahead' signage from both approaches.</li> <li>• Application of retro-reflective paint on all the four faces to the kerbstone to prevent motorists from hitting them.</li> <li>• Installation of flex beam guardrails (preferably with reflective studs on the inner side) on the approaches to the handrails to seal off the dangerous open windows.</li> <li>• Clearing of the roadside establishments near the bridge to improve sight distances for motorists.</li> </ul> </li> </ul> |

| S/N | Name of the Spot | Chain-age (Km) | Survey Observations and Findings | Analysis/Diagnosis | Suggested Recommendation for improvement |
|---|---|---|---|---|---|
| | | | <ul style="list-style-type: none"> <li>Obstruction of visibility splays by establishments on the LHS; they are too close to the road blocking the sight distances for motorists.</li> </ul> <p><b>Junction with Base – Gicumbi – Rukomo – Nyagatare Road</b></p> <ul style="list-style-type: none"> <li>Lack of speed change lanes at the merger with the NR2 (Deceleration lane from the Kigali side and acceleration lane towards Musanze are missing)</li> </ul> | | |

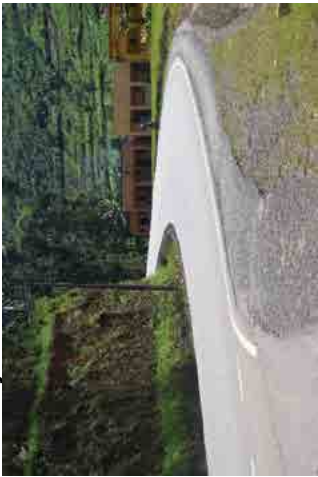
| S/N | Name of the Spot | Chain-age (Km) | Survey Observations and Findings | Analysis/Diagnosis | Suggested Recommendation for improvement |
|---|---|---|---|---|---|
| 4. | <b>Rwamenyo</b> <p><i>Dangerous sharp curve with little sight distance</i></p> | 45-47 | <ul style="list-style-type: none"> <li>Very sharp corner with a gentle descent from the Kigali side.</li> <li>Lack of adequate warning signage cautioning motorists on the sharp curve.</li> <li>Missing safety fences on the LHS to offer restraint vehicles that might lose control.</li> <li>Lack of adequate speed calming measures on the approaches to the hazardous spot.</li> </ul> | <ul style="list-style-type: none"> <li>Heavy goods vehicles manoeuvring the curve tend to lose control and topple over into the adjacent ditch.</li> </ul> | <ul style="list-style-type: none"> <li>Provision of speed limits and enforcement of speed regulations by relevant agencies.</li> <li>Installation of enhanced signage warning motorists of the dangerous curve.</li> <li>Installation of flex beam guardrails on the LHS (preferably with reflective studs on the inner side) to offer restraint in the event of an emergency</li> <li>Consider provision of rumble strips as speed calming measures on the approaches</li> <li>Repair of the deteriorating shoulder edges to safeguard the pavement's design life</li> </ul> |

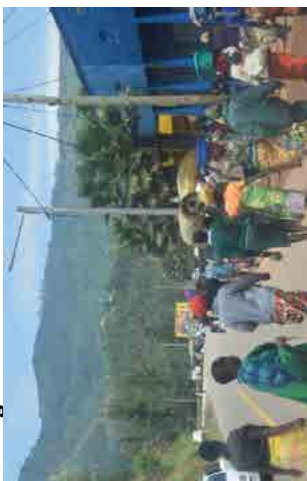
| S/N | Name of the Spot | Chain-age (Km) | Survey Observations and Findings | Analysis/Diagnosis | Suggested Recommendation for improvement |
|---|---|---|---|---|---|
| 5. | <p><b>Buranga-Musanze section</b></p> <p><i>Pedestrians walking on the road edges due to lack of NMT facilities</i></p> | 54-64 | <p>The densely populated area has a high population of pedestrians mainly accessing the nearby market. Road safety concerns identified include:</p> <ul style="list-style-type: none"> <li>Narrow carriageway (3.5m lane width) with no provision of NMT facilities. Pedestrians are forced to walk on or near the road edge as a result.</li> <li>Open side drains too close to the road edges.</li> <li>Deteriorating shoulders leaving rugged shoulder edges.</li> <li>Missing delineator road studs to guide motorists along the centre at night.</li> <li>Inadequate bus bays forcing vehicles to pick and drop passengers on the road edges.</li> </ul> | <p>Pedestrians walking on or near the road edges are exposed to vehicular traffic making them prone to vehicle-pedestrian collisions</p> | <ul style="list-style-type: none"> <li>Consider 2m shoulders) and provision of separate NMT facilities along the center i.e. pedestrian walkways, designated pedestrian crossings etc.</li> <li>Covering the open drains that are too close to the carriageway or reducing the gradient of the their slopes</li> <li>Repair of the damaged shoulder edges</li> <li>Installation of delineator road studs to mark the lane extents at night</li> <li>Provision of standard sized bus bays to allow for safe stops</li> </ul> |

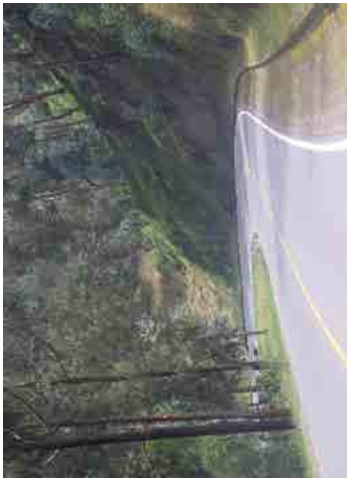
| S/N | Name of the Spot | Chain-age (Km) | Survey Observations and Findings | Analysis/Diagnosis | Suggested Recommendation for improvement |
|---|---|---|---|---|---|
| | <p><i>shoulders at Buranga centre exposing pedestrians to vehicular traffic</i></p> <p><i>Steep vertical slopes with no provision for climbing lanes.</i></p> | | <p><b>Buranga – Musanze section (Gakenke District)</b></p> <p>The section is characterized by long steep, and climbing terrains. Observations made include:</p> <ul style="list-style-type: none"> <li>• No provision for climbing lanes has been made creating snarl ups and safety hazards as ascending motorists try to overtake.</li> <li>• Inadequate warning signage along the mountainous terrain</li> </ul> | <p>Long steep and climbing terrain makes it difficult for ascending motorists and especially heavy goods vehicles. Absence of climbing lane prompts small vehicles to get involved in head-on crashes as they attempt to overtake.</p> | <ul style="list-style-type: none"> <li>• Robust sensitization and awareness campaigns educating locals on the dangers of hanging onto trucks</li> <li>• Enforcement by relevant agencies to eradicate unsafe/risky road user behavior</li> <li>• Installation of enhanced signage warning motorists to proceed with caution, for instance, 'No overtaking', 'Steep slope ahead' and speed limit signs</li> <li>• In the long term, consider provision of climbing lanes alongside the ascending lanes to make the road safer</li> </ul> |

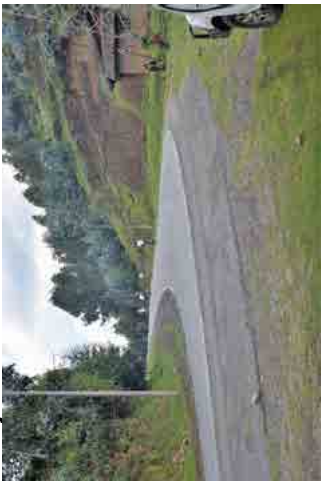
| S/N | Name of the Spot | Chain-age (Km) | Survey Observations and Findings | Analysis/Diagnosis | Suggested Recommendation for improvement |
|---|---|---|---|---|---|
| 6. | <b>Bwanju Corner</b> | 99.2 | <p>Sharp horizontal curve combined with a gentle vertical curve</p> <ul style="list-style-type: none"> <li>Missing warning signs to caution motorists on the sharp curve</li> <li>Fading road marking (No yellow centreline marking).</li> <li>Missing delineator road studs to guide motorists at night.</li> </ul> | <ul style="list-style-type: none"> <li>Most crashes at this location are run-off and are mainly prevalent during the night.</li> <li>Despite the spot being illuminated by streetlights, more interventions are still required to make the spot safer.</li> </ul> | <ul style="list-style-type: none"> <li>Installation of directional arrow signs on the outer edge of the curve to warn motorists on sharp change of direction.</li> <li>Installation of road signage warning motorists of the dangerous curve ahead and prohibiting overtaking at blind corners.</li> <li>Installation of retro-reflective delineator road studs especially on the outer lane edges.</li> <li>Application of retro-reflective road marking to replace the fading one (consider using yellow paint for the centerline to harmonize the road network).</li> </ul> |

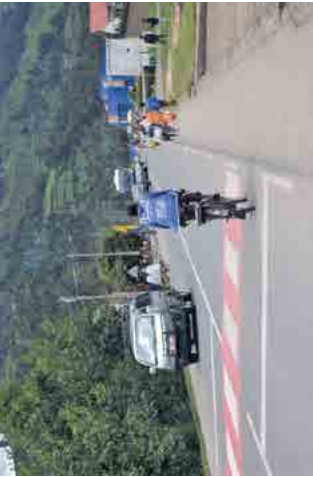
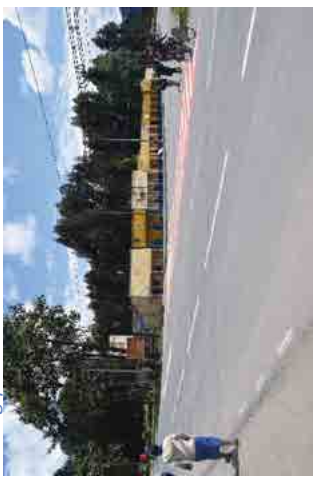
| S/N | Name of the Spot | Chain-age (Km) | Survey Observations and Findings | Analysis/Diagnosis | Suggested Recommendation for improvement |
|---|---|---|---|---|---|
| 7. | <b>Mukamira</b> <p><i>Missing provision for MMT facilities</i></p> <p><i>Un-channelized junction lacking speed change and storage/weaving lanes</i></p> | 110.8 | <ul style="list-style-type: none"> <li>Heavy presence of pedestrians and school children with no provision for designated pedestrian walkways.</li> <li>Missing warning signs to caution drivers of the designated pedestrian crossings.</li> <li>The junction to Muhanga is un-channelized and lacks a provision for speed change (acceleration and deceleration) lanes and storage lanes on the main highway.</li> <li>Petrol station has no designated entry and exit lanes for use by motorists fueling their vehicles.</li> <li>Uncontrolled access to the main highway by the multiple roadside shops and establishments.</li> </ul> | <ul style="list-style-type: none"> <li>Crashes involving pedestrians and motorcycle riders at the junction and along the town are common.</li> <li>Vehicles entering and exiting the petrol station cause traffic confusion can lead to crashes that involve motor vehicles and motorcyclists.</li> </ul> | <ul style="list-style-type: none"> <li>Consider provision of designated pedestrian walkways separate from the main carriageway to shield Vulnerable Road Users (VRUs) from motorized traffic.</li> <li>Installation of both warning and informative signs before and at the designated crossings.</li> <li>Installation of delineator road studs and especially at the junction to guide motorists at night.</li> <li>Improvement of the junction through provision of speed change lanes and widening the main carriageway to allow for storage lanes for turning motorists.</li> <li>Provision of acceleration and deceleration lanes for all petrol/service stations to allow easier transition into and out of the main road.</li> </ul> <p>In the long term:</p> <ul style="list-style-type: none"> <li>Consider provision of <b>service lanes with controlled entry and exit points</b> to the main highway.</li> </ul> |

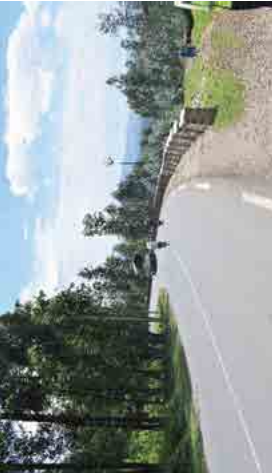
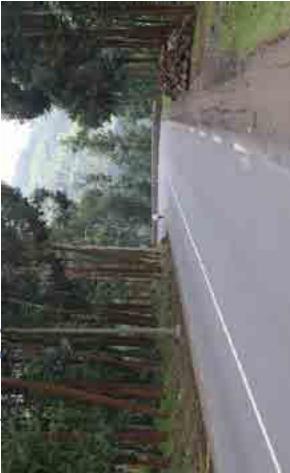
| S/N | Name of the Spot | Chain-<br>age<br>(Km) | Survey Observations and Findings | Analysis/Diagnosis | Suggested Recommendation for improvement |
|---|---|---|---|---|---|
| 8. | <b>Nyakiriba Descent/Kanzeze</b><br><br><i>Overspeeding cyclists</i><br><br><i>Sharp left curve with no directional arrow signs</i> | 122.6<br>-128.7 | <p>Long continuous descent with sharp curves</p> <ul style="list-style-type: none"> <li>Missing/damaged signboard cautioning motorists to engage low gears while descending.</li> <li>Non-reflective stone barriers on the sharp curves.</li> <li>Fading road marking and missing delineator studs to mark the lane extents.</li> <li>Overspeeding motorists and pedal cyclists partially due to lack of speed calming measures .</li> </ul> | <ul style="list-style-type: none"> <li>The curvy descent is prone to overspeeding especially by pedal and motorcyclists.</li> </ul> | <ul style="list-style-type: none"> <li>Installation of enhanced signage warning motorists on the dangerous descent and informatory signage cautioning them to engage low gears.</li> <li>Installation of directional arrow signs at the stone barriers.</li> <li>Consider provision of standard reinforced crash barriers (with reflective elements) as safety fences instead of the masonry stone wall barriers.</li> <li>Installation of delineator road studs to mark the lane extents.</li> <li>Provision of rumble strips at standard intervals to calm speeds.</li> <li>Consider instituting speed limits and speed regulation through speed monitoring cameras.</li> </ul> |

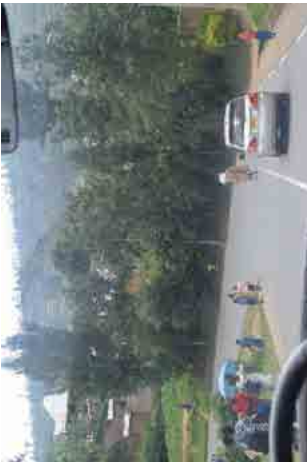
| S/N | Name of the Spot | Chain-<br>age<br>(Km) | Survey Observations and Findings | Analysis/Diagnosis | Suggested Recommendation for improvement |
|---|---|---|---|---|---|
| 9. | <b>Giza/Rwaza (Rugerero)</b><br><br><i>Sharp descent with no provision for pedestrian walkways</i> | 139.9<br>-<br>141.2 | <ul style="list-style-type: none"> <li>Winding terrain with sharp curves.</li> <li>Absence of warning road signage.</li> <li>Lack of a provision for NMT facilities.</li> </ul> | <ul style="list-style-type: none"> <li>Sharp curve on a rolling terrain makes it difficult for heavy trucks on high speed to negotiate the corners.</li> </ul> | <ul style="list-style-type: none"> <li>Provision of separate NMT facilities to safeguard eg. pedestrian walkways and cycle tracks to safeguard Vulnerable Road Users (VRUs) from vehicular traffic.</li> <li>Provision of warning signs on all the hazardous elements along the road.</li> <li>Provision of speed calming measures and speed limits along the descent.</li> </ul> |

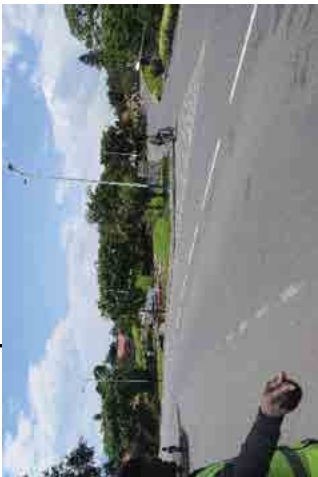
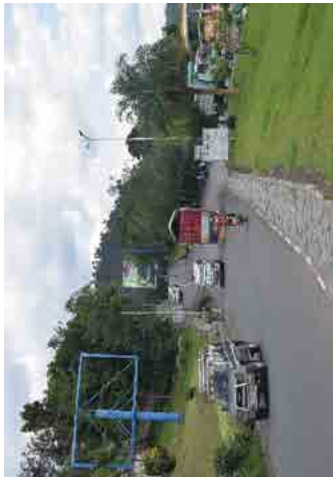
| S/N | Name of the Spot | Chain-age (Km) | Survey Observations and Findings | Analysis/Diagnosis | Suggested Recommendation for improvement |
|---|---|---|---|---|---|
| 10. | <b>Rubavu Hospital Junction</b><br> | 139.9<br>–<br>141.2 | <p>Approach to the junction is on a descent</p> <ul style="list-style-type: none"> <li>Conflicting junction placed at the end of rolling and winding terrain entering Rubavu town.</li> <li>Missing speed calming measures on the approach to the dangerous intersection.</li> <li>Fading road marking.</li> <li>Inadequate signage warning and informing motorists at the hazardous location.</li> </ul> | <p>The three way intersection is dangerous and is characterized by multiple conflict zones.</p> | <ul style="list-style-type: none"> <li>Consider carrying out a detailed traffic study at the location in light of the unfavourable terrain to inform the most effective solution, for instance, improved roundabout, signalized junction etc.</li> <li>Provision of speed calming measures on the descent to the junction (consider rumble strips at standard intervals); speed regulation through speed monitoring cameras could also be considered.</li> <li>Installation of delineator studs to guide motorists at night</li> <li>Installation of enhanced warning and informative signage, for instance, 'Give Way', and speed limit signs.</li> </ul> |

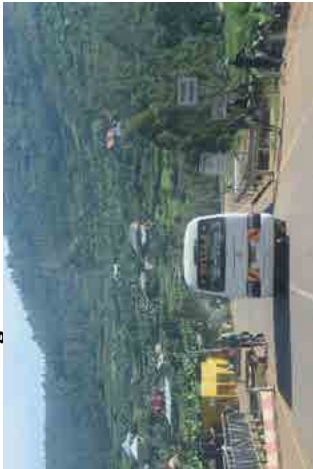
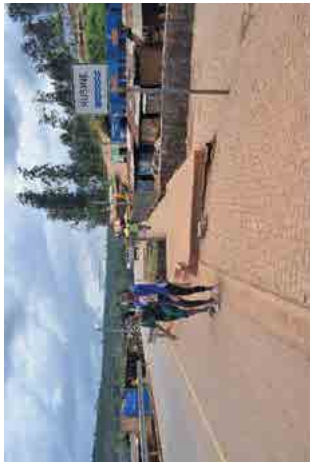
| S/N | Name of the Spot | Chain-age (Km) | Survey Observations and Findings | Analysis/Diagnosis | Suggested Recommendation for improvement |
|---|---|---|---|---|---|
| 2. | <b>Rusine Bridge</b> | 30.4 | <p>The narrow bridge lacks sufficient restraints with the provided tapes and cones being inadequate</p> <ul style="list-style-type: none"> <li>The narrowed bridge (6m width) lacks parapets on either side; the LHS guardrails are completely missing</li> <li>Missing safety fences on the approaches to the bridge leaving gapping open windows</li> <li>Missing hazard marker signs at the bridge and warning signs to caution motorists on the narrow bridge</li> <li>The pedestrian footbridge is unfriendly to the elderly and Persons With Disability (PWDs) as it lacks a ramp to join it to the surface level</li> </ul> <p><i>Abrupt termination of the footbridge making it unfriendly to the elderly and PWDs</i></p> | <ul style="list-style-type: none"> <li>The narrow bridge is a safety hazard as motorists are forced to pass through a constricted roadway.</li> <li>Head on and side swipe collisions are likely as a result</li> </ul> | <ul style="list-style-type: none"> <li>As an immediate intervention, there is need for installation of safety guardrails on the bridge</li> <li>Installation of hazard marker signs on the bridge and warning signs on the narrow bridge from either approaches</li> <li>Installation of delineator road studs to show the extents of the bridge at night</li> <li>In the medium to long term, consider: <ul style="list-style-type: none"> <li>Expansion/widening the bridge with a sufficient provision for pedestrians on either side</li> <li>Provision of parapets to the newly constructed bridge to offer restraint in the event of an emergency.</li> </ul> </li> </ul> |

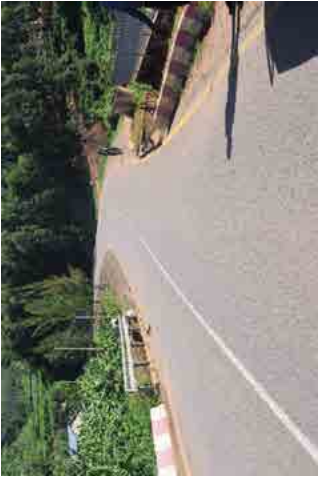
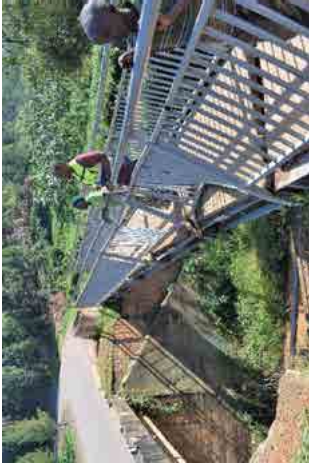
| S/N | Name of the Spot | Chain-age (Km) | Survey Observations and Findings | Analysis/Diagnosis | Suggested Recommendation for improvement |
|---|---|---|---|---|---|
| 3. | <b>Musenyi (Idigiri Bridge)</b> <p><i>Damaged pedestrian footbridge</i></p> | 30.4 | <ul style="list-style-type: none"> <li>Two sharp combinations of horizontal and vertical alignments converge into a narrow bridge which has already been structurally compromised by previous crashes</li> <li>The narrowed bridge (6m width) has damaged guardrails on either side; the LHS guardrail is completely missing</li> <li>The bridge parapets are too short to offer any significant restraint in case of an emergency</li> <li>Missing safety fences on the approaches to the bridge leaving gapping open windows</li> <li>Missing hazard marker signs at the bridge and warning signs to caution motorists on the narrow bridge</li> <li>Damaged pedestrian footbridge on the RHS; it presents a safety hazard as it might cave in at any time</li> </ul> | <ul style="list-style-type: none"> <li>The narrow bridge with insufficient safe stopping sight distance at the convergence of two winding terrains creates a hazard to motorists. The problem is further exacerbated by damaged/missing parapets and safety fences.</li> <li>Collapsed pedestrian bridge is a safety hazard to the pedestrians</li> </ul> | <ul style="list-style-type: none"> <li>As an immediate intervention, there is need for installation of safety guardrails on the bridge and repair of pedestrian footbridge</li> <li>Installation of hazard marker signs on the bridge and warning signs on the narrow bridge from either approaches</li> <li>Installation of delineator road studs to show the extents of the bridge at night</li> </ul> <p>In the medium to long term, consider:</p> <ul style="list-style-type: none"> <li>Expansion/widening the bridge with a sufficient provision for pedestrians on either side and realignment of the section to eliminate the sharp curves</li> <li>Provision of parapets to the newly constructed bridge to offer restraint in the event of an emergency.</li> </ul> |

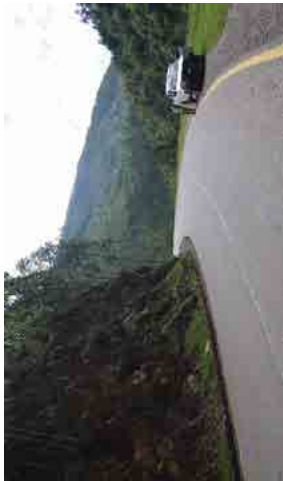
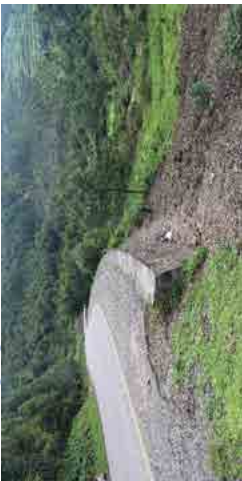
| S/N | Name of the Spot | Chain-age (Km) | Survey Observations and Findings | Analysis/Diagnosis | Suggested Recommendation for improvement |
|---|---|---|---|---|---|
| 4. | <b>Rwafandi Corner</b><br><br><i>Very sharp curve with a huge rock outcrop obstructing sight distances</i><br><br><i>Missing safety fences on the LHS</i> | 32.9 | <ul style="list-style-type: none"> <li>The corner is on a successive combination of sharp horizontal curves and has a huge boulder obstructing sight distance for motorists</li> <li>Missing safety fences on the LHS</li> <li>Lack of warning signs on the approaches as well as directional arrow signs to warn motorists on the sharp change of direction</li> <li>Vehicles negotiating the curve tend to drive on the middle of the road for fear of toppling over due to centrifugal forces</li> </ul> | <p>Steep and winding terrains without safety guardrails can lead to unforgiving crashes should they occur.</p> | <ul style="list-style-type: none"> <li>Provision of safety fences on the LHS of the curve to restrain errant motorists in case of loss of control</li> <li>Installation of directional arrow signs to warn motorists on the sharp change of direction</li> <li>Installation of warning signs on the approaches to the sharp corner</li> <li>In the long term, consider redesigning of the section to eliminate the sharp curve and further provide sufficient widening at the curves</li> </ul> |

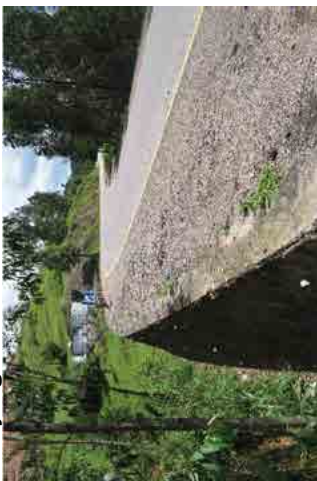
| S/N | Name of the Spot | Chain-age (Km) | Survey Observations and Findings | Analysis/Diagnosis | Suggested Recommendation for improvement |
|---|---|---|---|---|---|
| 5. | <b>Ku Inyange</b><br><br><i>Sharp curve with knocked off safety fences on high embankment</i> | | <ul style="list-style-type: none"> <li>The hazardous spot is on a descent from Gatuna towards Kigali</li> <li>Damaged safety fences on the sharp curve leaving a dangerous open window</li> <li>Lack of directional arrow signs to guide motorists</li> </ul> | | <ul style="list-style-type: none"> <li>Replacement of the knocked off safety fences (consider flex beam guardrails with reflective studs on the inner side)</li> <li>Installation of directional arrow signs to guide motorists through the sharp curve</li> <li>Installation of warning signage on the successive sharp curve ahead and informative signage cautioning motorists to drive on low gear</li> </ul> |

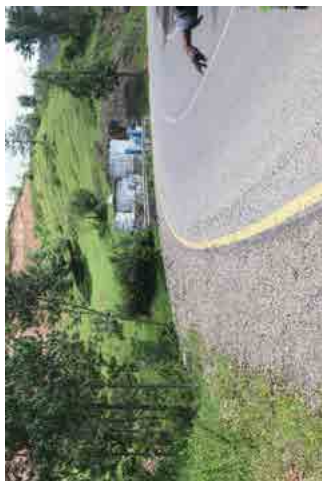
| S/N | Name of the Spot | Chain-age (Km) | Survey Observations and Findings | Analysis/Diagnosis | Suggested Recommendation for improvement |
|---|---|---|---|---|---|
| 5. | | 44.1 | <ul style="list-style-type: none"> <li>• Dangerous termination of the existing guardrail section; The dangerously exposed ends might pierce onto oncoming traffic upon impact</li> <li>• Lack of proper warning signage cautioning motorists on the sharp curve</li> </ul> | | <ul style="list-style-type: none"> <li>• Installation of fishtail end pieces on the dangerously exposed guardrail section to buffer motorists upon impact</li> <li>• Installation of delineator retro-reflective studs to mark the lane extents</li> </ul> |

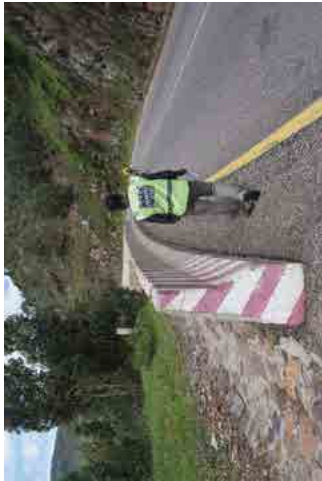
| S/N | Name of the Spot | Chain-age (Km) | Survey Observations and Findings | Analysis/Diagnosis | Suggested Recommendation for improvement |
|---|---|---|---|---|---|
| 6. | <b>Mudahakaniwa</b><br><br><i>1.2m high reinforced concrete crash barrier</i> | 44-48 | <ul style="list-style-type: none"> <li>• The road winds through a hilly terrain and is on high embankment for majority of the stretch.</li> <li>• The section is well guarded with 1.2m high reinforced concrete barriers. They are however not painted with reflective paint</li> <li>• Safety fences are however missing on some sections on high embankment</li> <li>• The sharp curves lack directional arrow signs to warn motorists</li> </ul> | The high embankment has been secured with concrete crash barriers for most of the stretch | <ul style="list-style-type: none"> <li>• Consider extending the crash barriers to cover all the curves on high embankment</li> <li>• Installation of reflective tapes on the barriers/ painting them with retro-reflective paint</li> <li>• Installation of directional arrow signs to guide motorists through the sharp curves</li> <li>• Installation of delineator retro-reflective studs to mark the lane extents of way.</li> </ul> |
